**SLED TESTS OF THREE-POINT SYSTEMS INCLUDING
AIR BELT RESTRAINTS**

**JANUARY 1976
FINAL REPORT**

**Prepared For:
U.S. DEPARTMENT OF TRANSPORTATION
NATIONAL HIGHWAY TRAFFIC SAFETY ADMINISTRATION
OFFICE OF VEHICLE SAFETY RESEARCH
WASHINGTON, D.C. 20590**

6. Performing Organization Code	
7. Author(s) Michael J. Walsh		8. Performing Organization Report No. ZP-5852-V-1	
9. Performing Organization Name and Address Calspan Corporation 4455 Genesee Street Buffalo, New York 14221		10. Work Unit No.

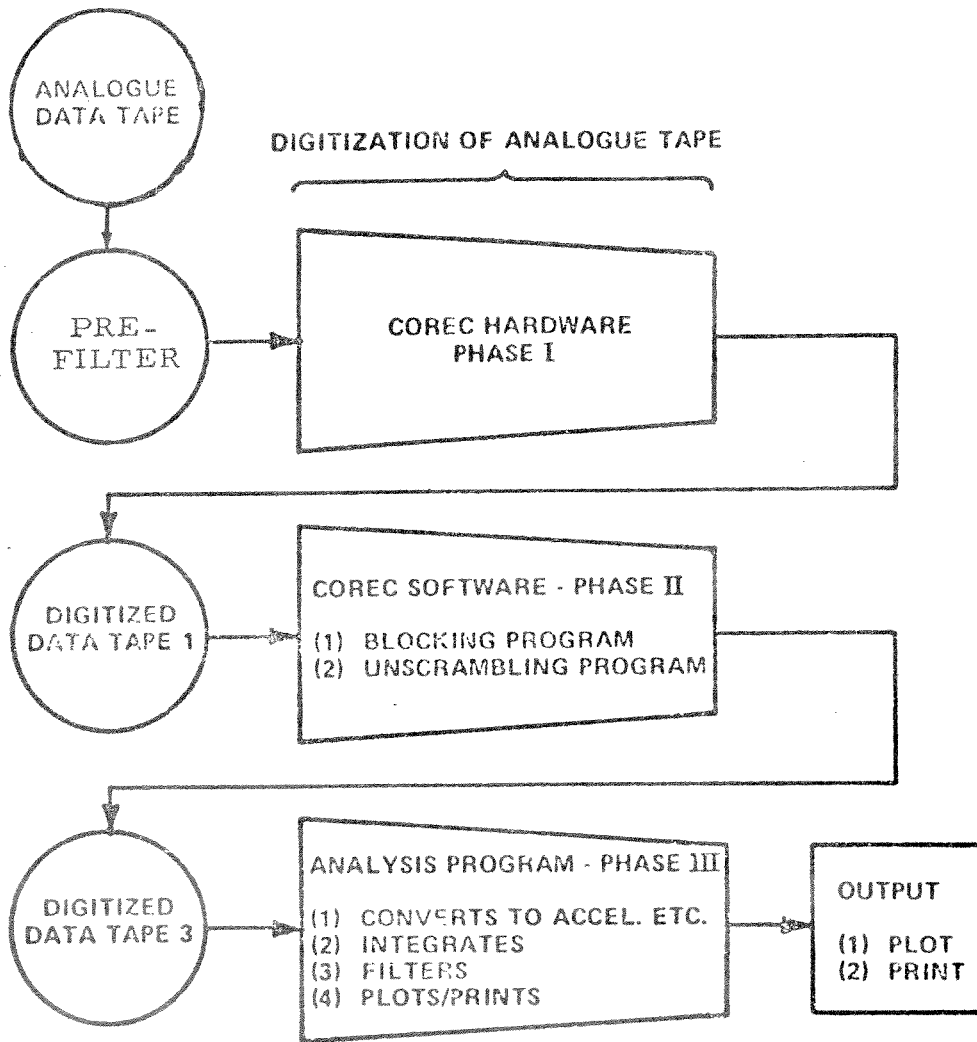
SCHEMATIC OF DIGITAL DATA REDUCTION SYSTEM

This portion of the system converts the analogue signals to their digital equivalents (A/D conversion). The data are recorded on the analogue tape at 60 inches per second (IPS) and played back for digitization at 15 IPS, thereby effecting a 4-1 time stretch. The digitized data are recorded on a digital tape (digitized data tape 1) at 45 IPS. As noted in the previous Figure, one analogue record on a given channel consists of six files or segments of information. Each file is sampled for 0.5 sec. of real time at 60 IPS, or in the slowed time for 2 sec. at a tape speed of 15 IPS. Thus, a record consists of 3 sec. of real time data distributed as follows:

0.5 sec. - DLR ZERO DATA
0.5 sec. - DLR DATA
0.5 sec. - DATA ZERO
0.5 sec. - DATA
0.5 sec. - END ZERO DATA
0.5 sec. - END DLR DATA
