VEHICLE INTEGRATION AND EVALUATION OF ADVANCED RESTRAINT SYSTEMS Volume II: Phase B

This report presents the results of eight full-scale crash tests conducted to evaluate the performance of four advanced restraint systems; RSV Driver Airbag, RSV Passenger Airbag, Force Limited Airbelt, and the Force Limited 2-inch Belt, when structurally integrated into a production vehicle. The vehicle chosen by NTHSA for this was the Volvo 244. The tests consisted of car-to-car impacts using the Volvo 244 with Ford Torinos serving as bullet vehicles. These tests were conducted to help determine the performance limits of the four advanced restraint systems in terms of meeting the FMVSS 208 crashworthiness criteria.

A series of eighteen full-scale crash tests were conducted to evaluate the performance of four advanced restraint systems that were structurally integrated into the Volvo 244. These tests were split into two phases; Phase A consisted of car-tocar and car-to-barrier impact tests using only Volvo 244's as test vehicles while the Phase B impact test configurations were car-to-car using Volvo 244's with Ford Torinos serving as bullet vehicles. This report presents the test results from Ph

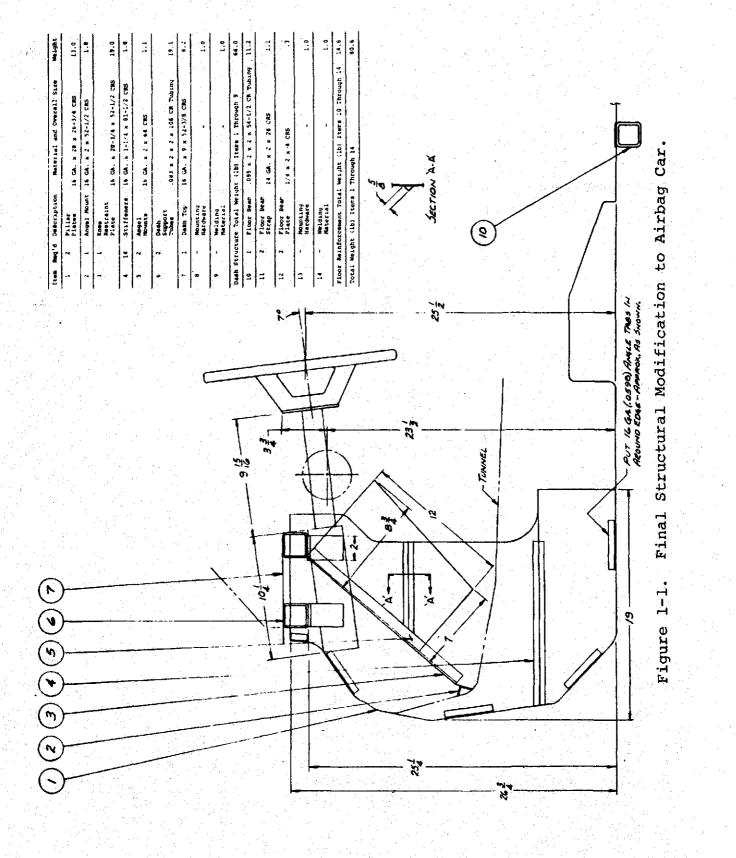
The Volvos used for the Torino-to-Volvo phase of the test series were structurally modified to provide mounting hardware for the restraint systems and to retain the structural integrity of the occupant compartment, particularly in the cowling region. The structural modifications for both cars evolved during Phase A to those shown in Figures 1-1 and 1-2. These modifications, as shown, were made to the Volvo airbag cars and the Volvo belt cars, respectively, for the Phase B tests.

For this test, Vehicle A was a 1975 Ford Torino and Vehicle B was a 1976 Volvo 244. No structural modifications were made to Vehicle A, while Vehicle B was modified in the dash, A pillar, and B pillar areas to preserve occupant compartment integrity and to accept the restraint systems that were installed in it. The extent of these modifications is shown in Figure 1-1.

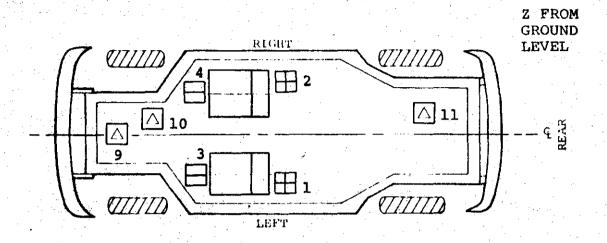
Figure 3-36. Vehicle Accelerometer Locations - Test 13.

VI	CHICLE B ACCELEROMETER LOCATIONS AND	COORI	DINATES	5
NO.	DESCRIPTION OF LOCATION	x	¥	Z
1	Left Floor Pan near B-Pillar	x	X	<u></u>
2	Right Floor Pan near B-Pillar	x	х	
3	Le ft Firewall on CL of Driver's Sea t	х		
4	Right Firewall on CL of Passenger's Seat	х		· · · · · · · · · · · · · · · · · · ·
9	Engine Block	х	x	X
10	Front Crossmember	X	x	X
11	Rear Axle	х	x	X

which are followed by Figure 3-36 defining vehicle accelerometer locations. The plotted data from the test are presented after this figure, and following the data plots are photos showing the before and after conditions of the vehicles and restraint systems.
