VEHICLE INTEGRATION AND EVALUATION OF ADVANCED RESTRAINT SYSTEMS

RESTRAINT SYSTEM ANALYSIS REPORT

DECEMBER 1977
FINAL REPORT

1. Report No. DOT HS-803 343		2. Government Accession No.		3. Recipient's Catalog No.	
4. Title and Subtitle Vehicle Integration and Evaluation of Advanced Restraint Systems - Restraint Systems Analyses				5. Report Date December 1977

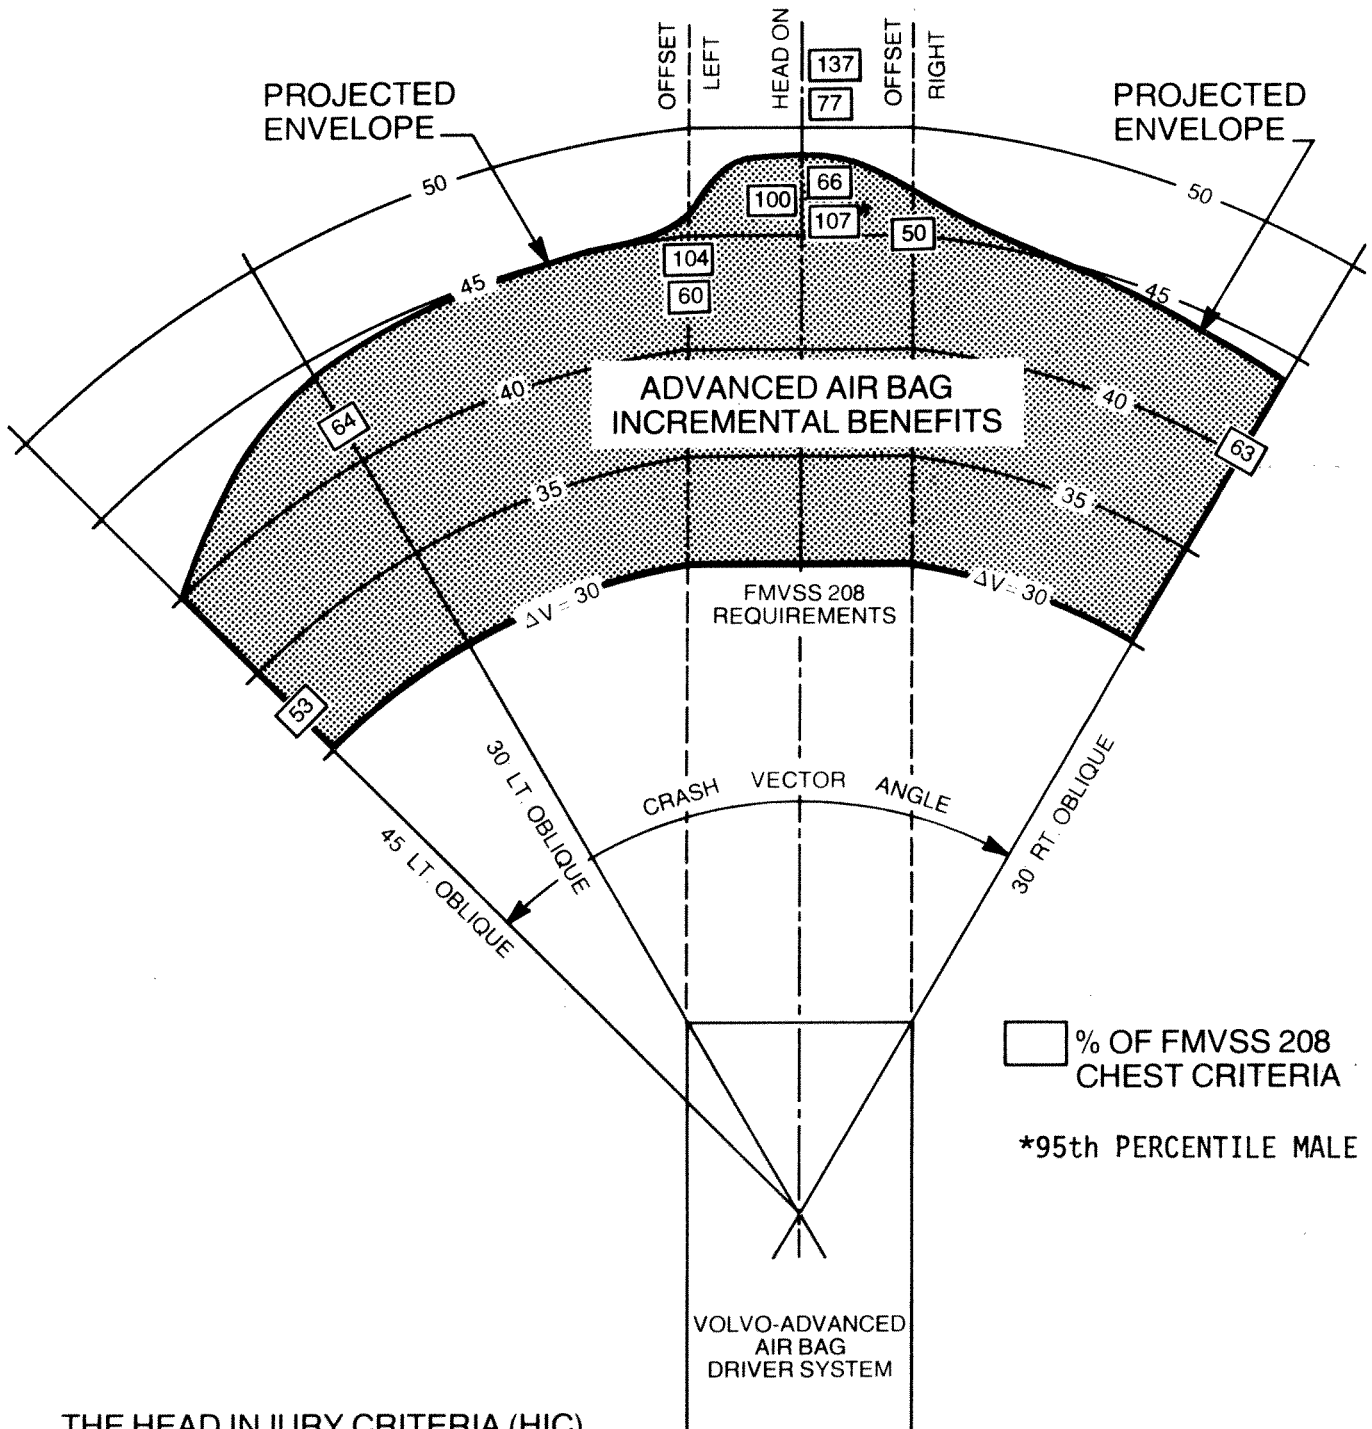
ADVANCED AIR BAG PERFORMANCE Driver System

THE HEAD INJURY CRITERIA (HIC) WERE RELATIVELY LOWER THAN THE CHEST ACCELERATION IN EVERY CASE AND THUS, THE LATTER WERE USED TO ESTABLISH SYSTEM PERFORMANCE LIMITS

Figure 2-4. Crash Survivability Envelope - Driver Airbag System

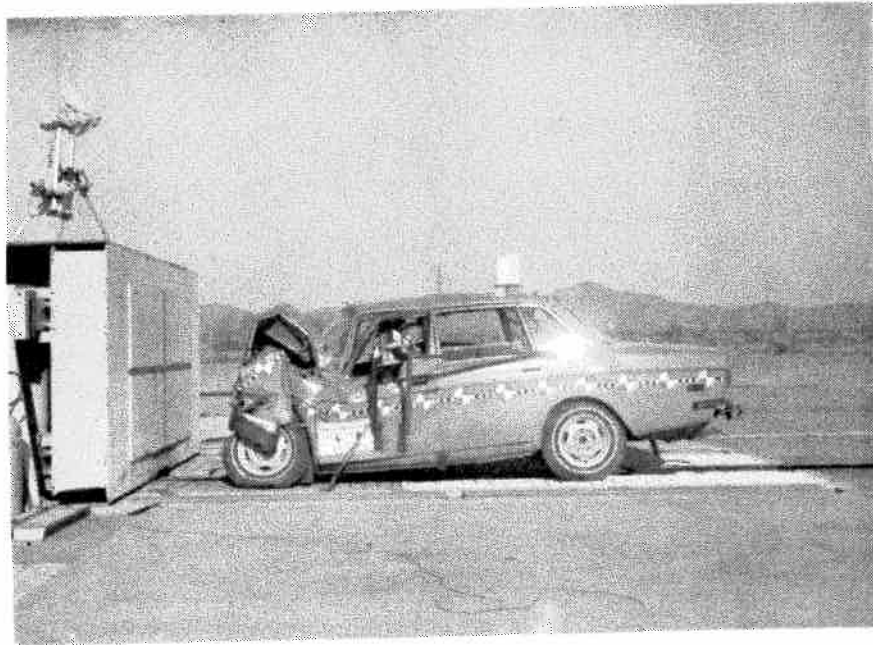
In these two tests both vehicles deformed in a practically identical fashion with a static crush of 37 inches in each vehicle. However, there was one important difference - a difference that had also been there in previous tests but not important until now. The difference was this. The airbag car as previously described required two transverse beams from A-post to A-post to support the Minicars RSV steering column. In the belt car, only one beam

Figure 7-20. Vehicle Damage, Test 6-B
