# JRS Dynamic Rollover Test

## 2009 Nissan Versa

**Automotive Safety Research Institute  
Charlottesville, VA.**

Center for Injury Research conducted a JRS dynamic rollover test consisting of two rolls of a 2009 Nissan Versa on April 27 and 28, 2010. This test report is organized in sections containing test information, data tables and photographs as follows:

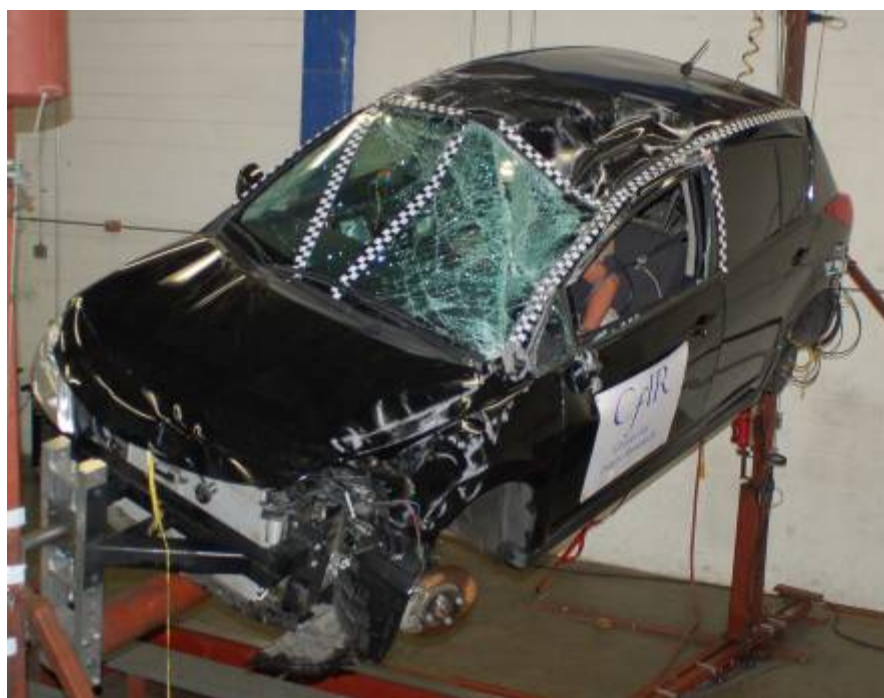
Figure 4: Vehicle Post Roll 2

During the second roll the windshield fractured further. The driver's side window shattered completely. The deformation of the C-pillar buckle increased.

A test was conducted on the door handles to evaluate if any of the doors were jammed due to the second impact test. 80 lbs was applied at the handle of the driver door and it did not open, indicating it was jammed. Visual inspection shows that the top rear corner of the front driver's side door was 'tucked' behind the top front corner of the rear driver's side door. The rear door on the driver's side required 14 lbs to open. After the rear driver's side door was opened, the front driver door took 60 lbs to open. An average of 40 lbs was further required to fully open the front driver door.

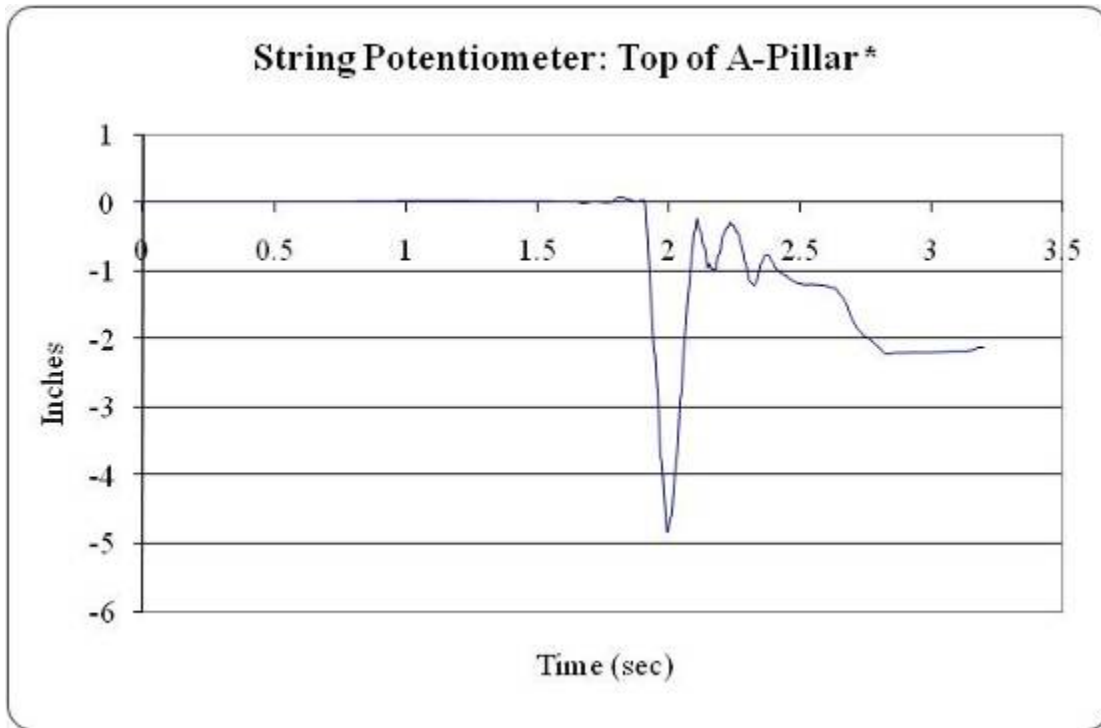
Plot 1: String Potentiometer Driver's Side A-Pillar Displacement v. Time  
 \*A-Pillar trim interfered with string pot. Peak Values estimated based on video analysis  
 Data Sampling Rate: 10 kHz

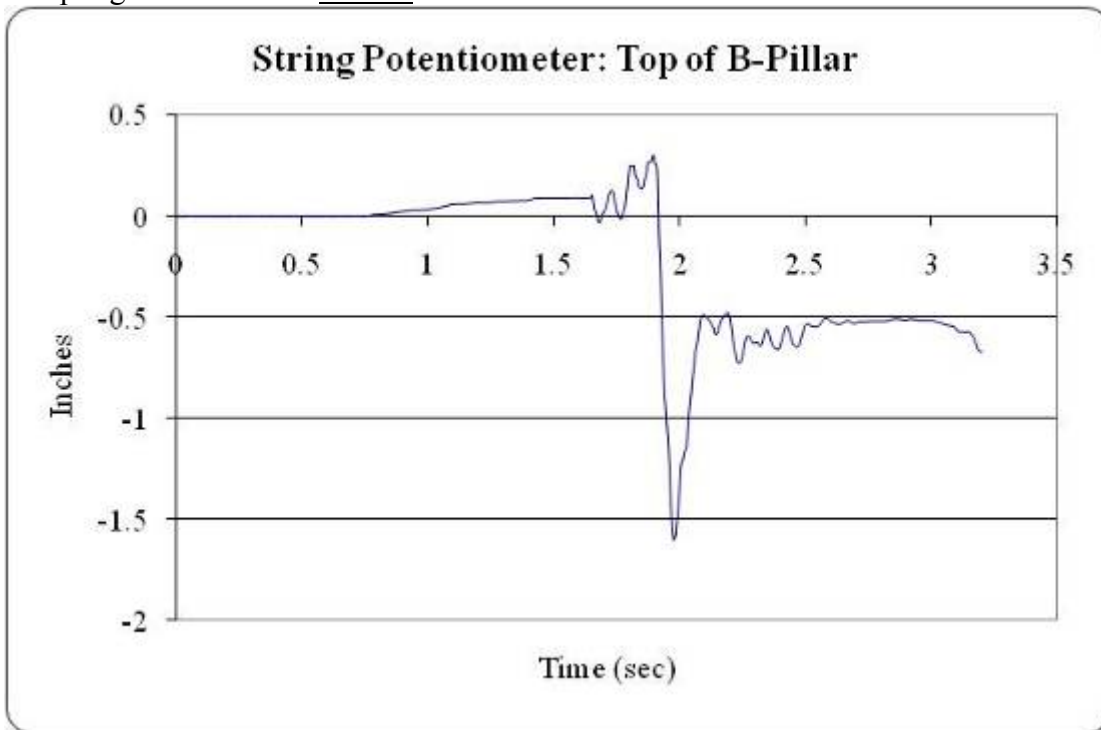
Plot 2: String Potentiometer Driver's Side B-Pillar Displacement v. Time

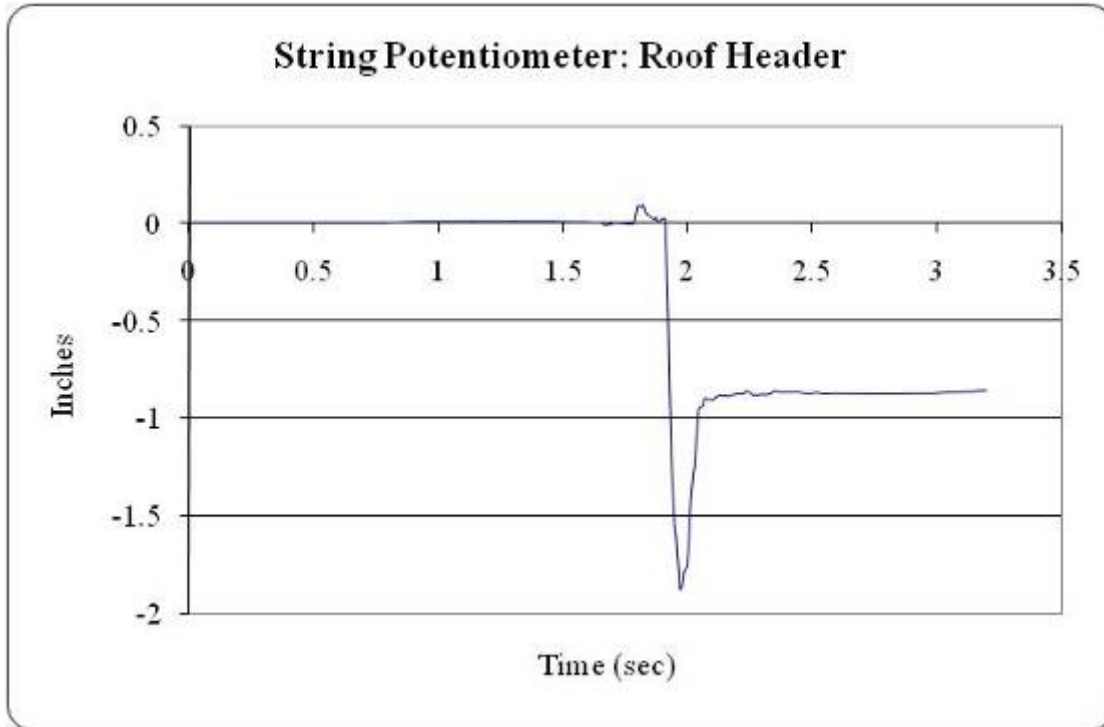
Plot 3: String Potentiometer Driver's Side Roof Header Displacement v. Time

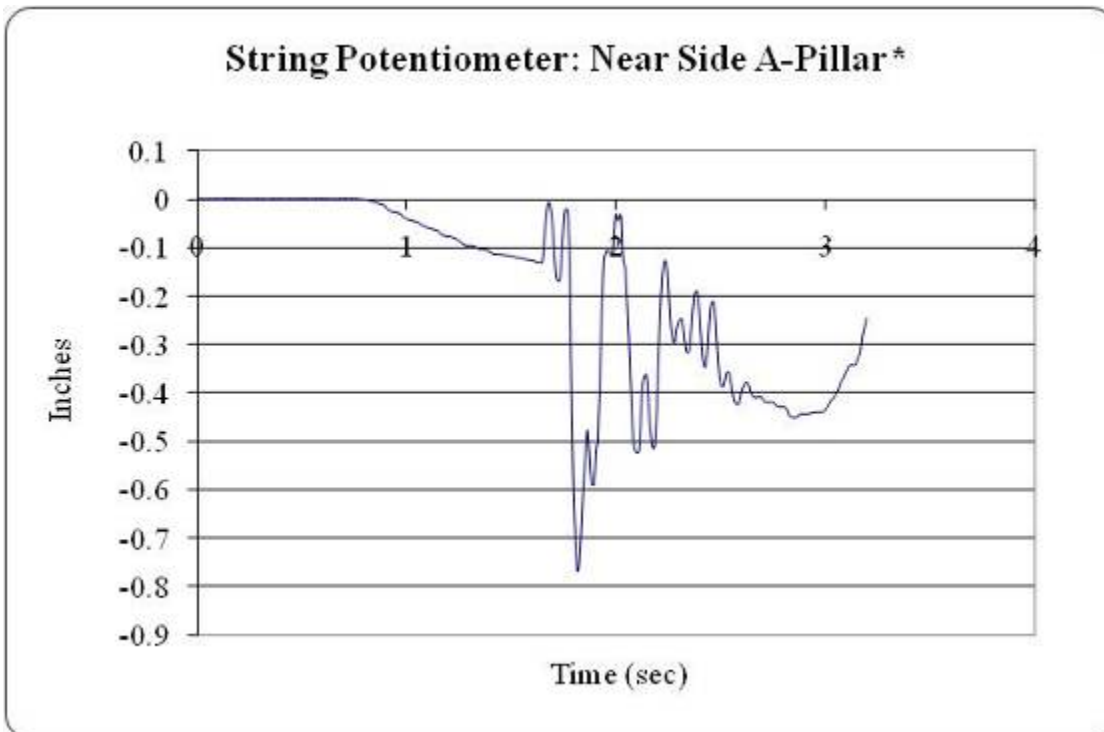
Plot 4: String Potentiometer Passenger's Side A-Pillar Displacement v. Time

\*\* Dummy interfered with string pot during test. Values estimated based on video analysis

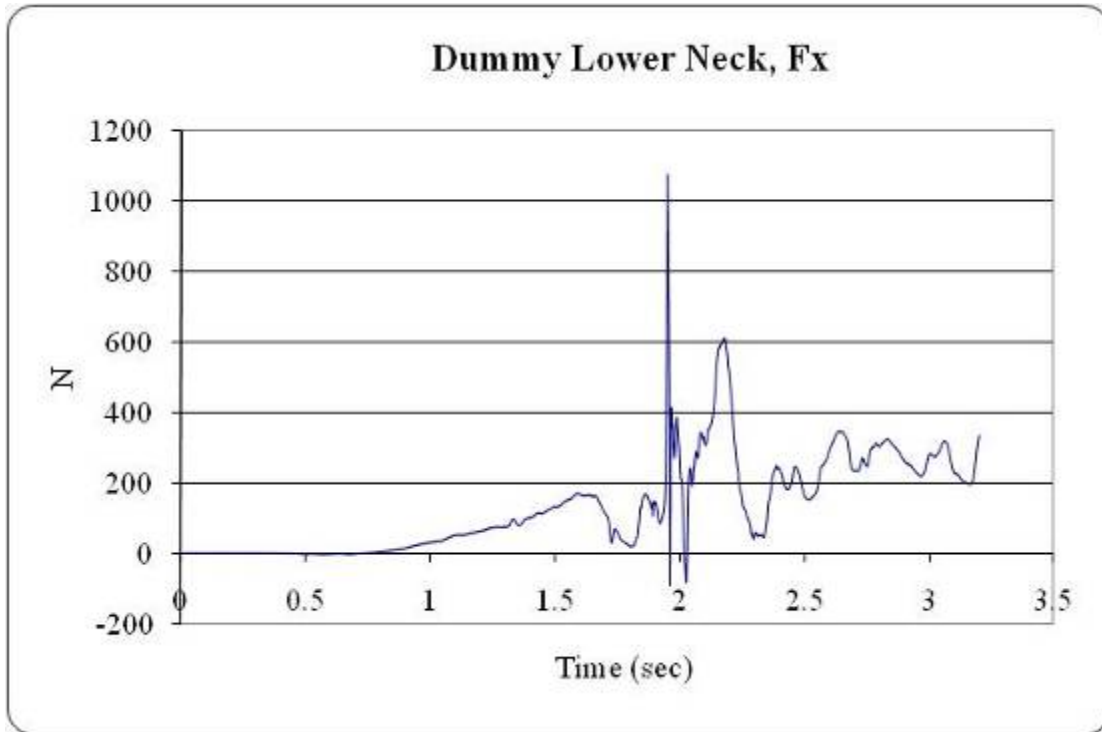
Plot 5: Lower Neck Load, Fx, v. Time

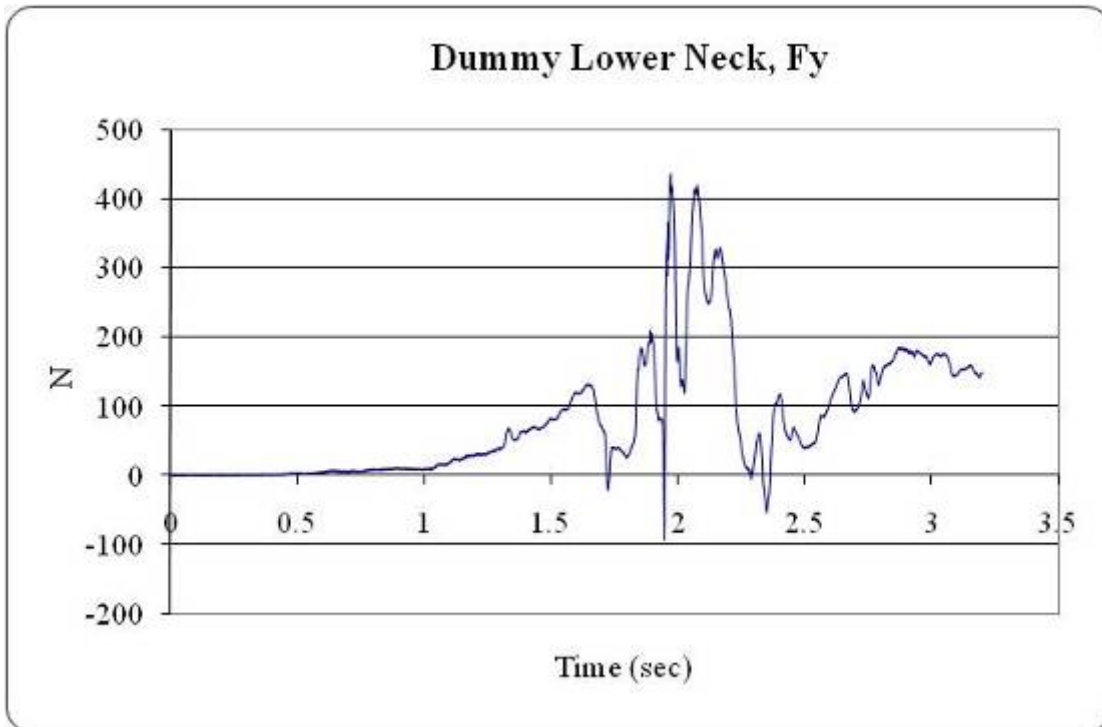
Plot 6: Lower Neck Load, Fy, v. Time

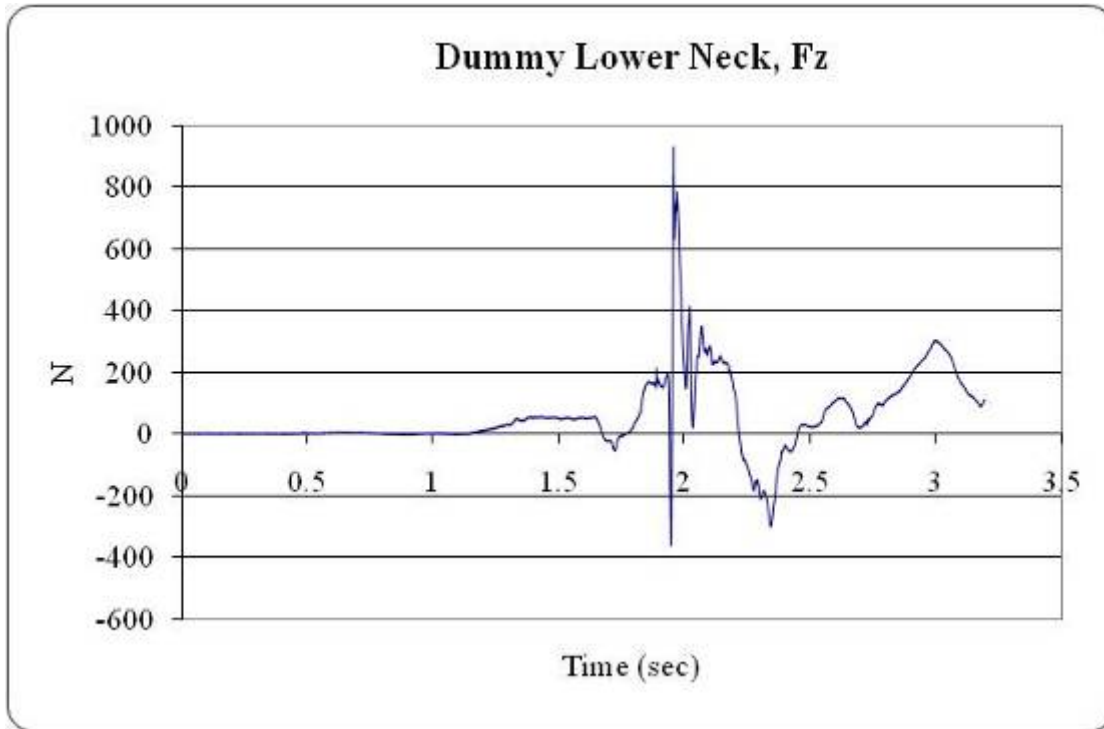
Plot 7: Lower Neck Load, Fz, v. Time

In Roll 1, the peak lower neck compressive load was 362 N and the peak lower neck moment was 19 Nm in flexion and 41 Nm in extension. The peak intrusion speed at the top of the A-Pillar was 5.0 mph with a peak crush of 4.5 inches.

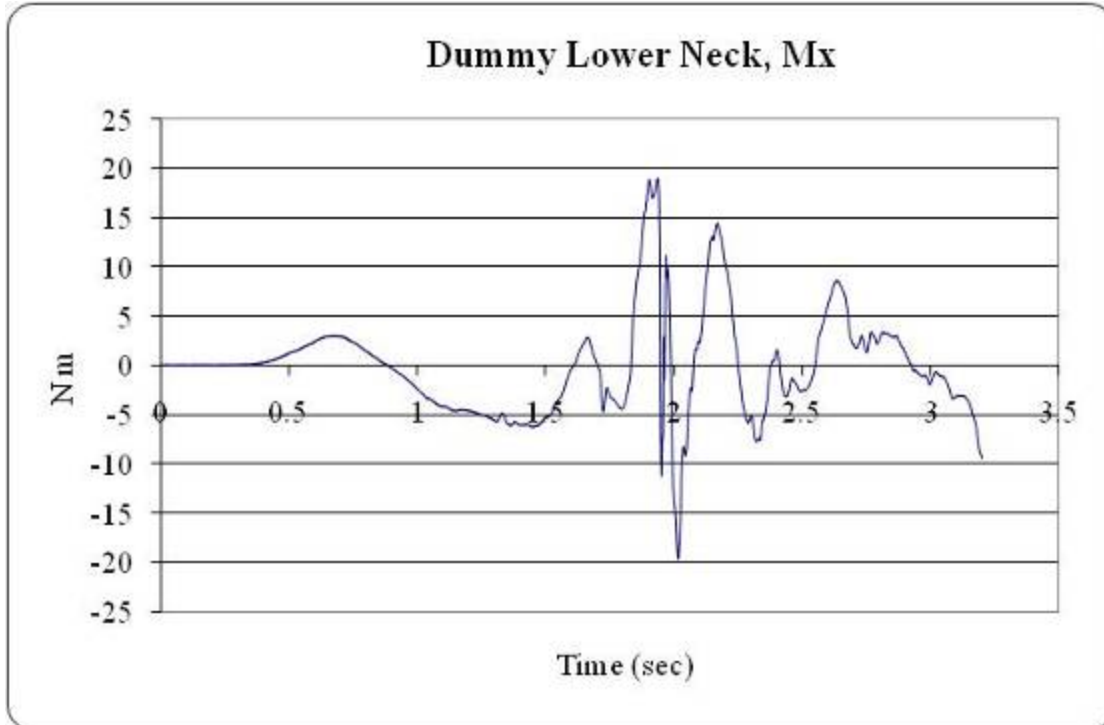
Plot 8: Lower Neck Load, Mx, v. Time

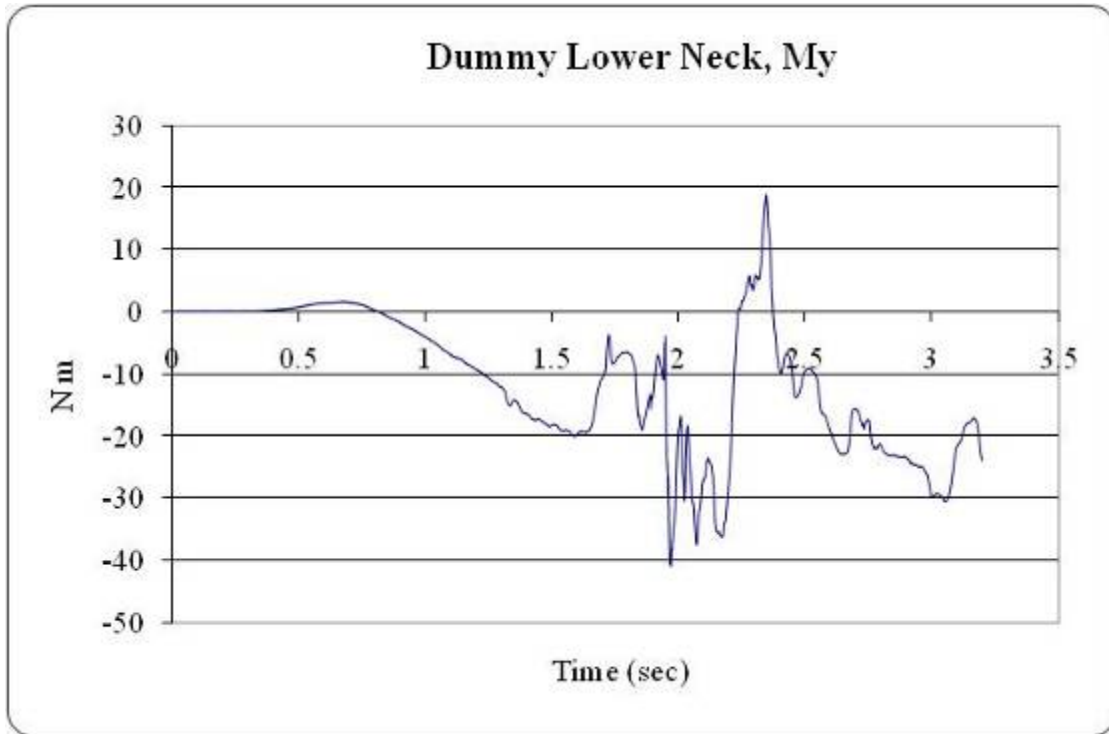
Plot 9: Lower Neck Load, My, v. Time

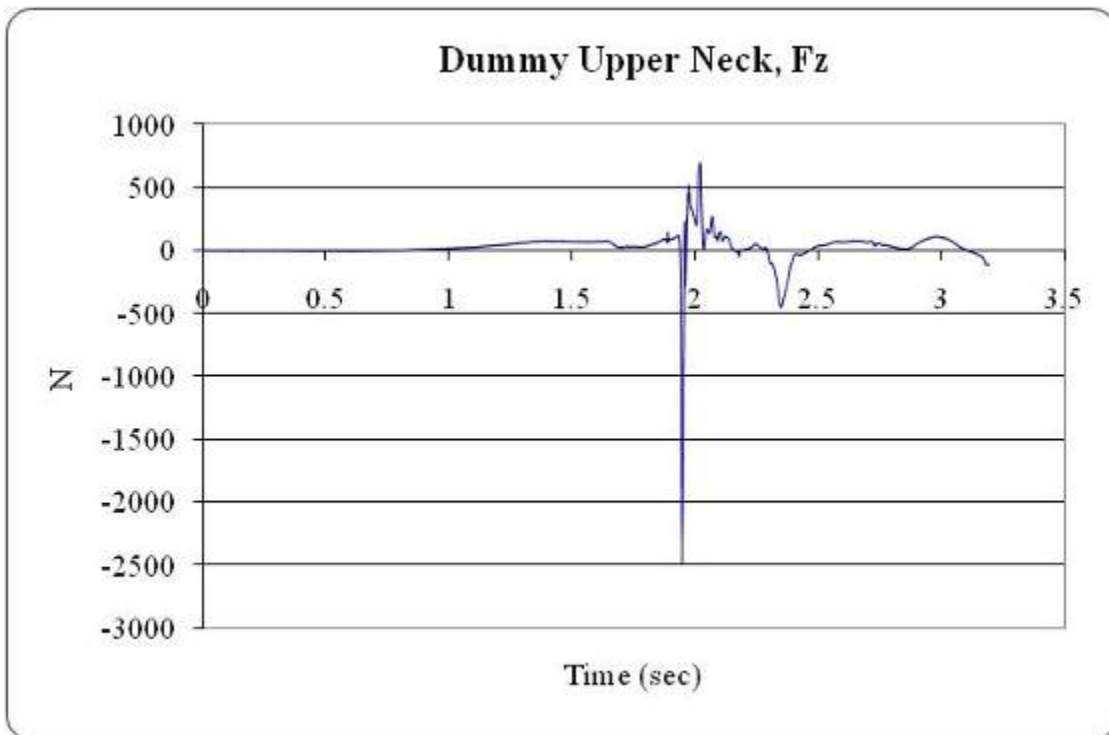
Plot 10: Upper Neck Load, Fz, v. Time

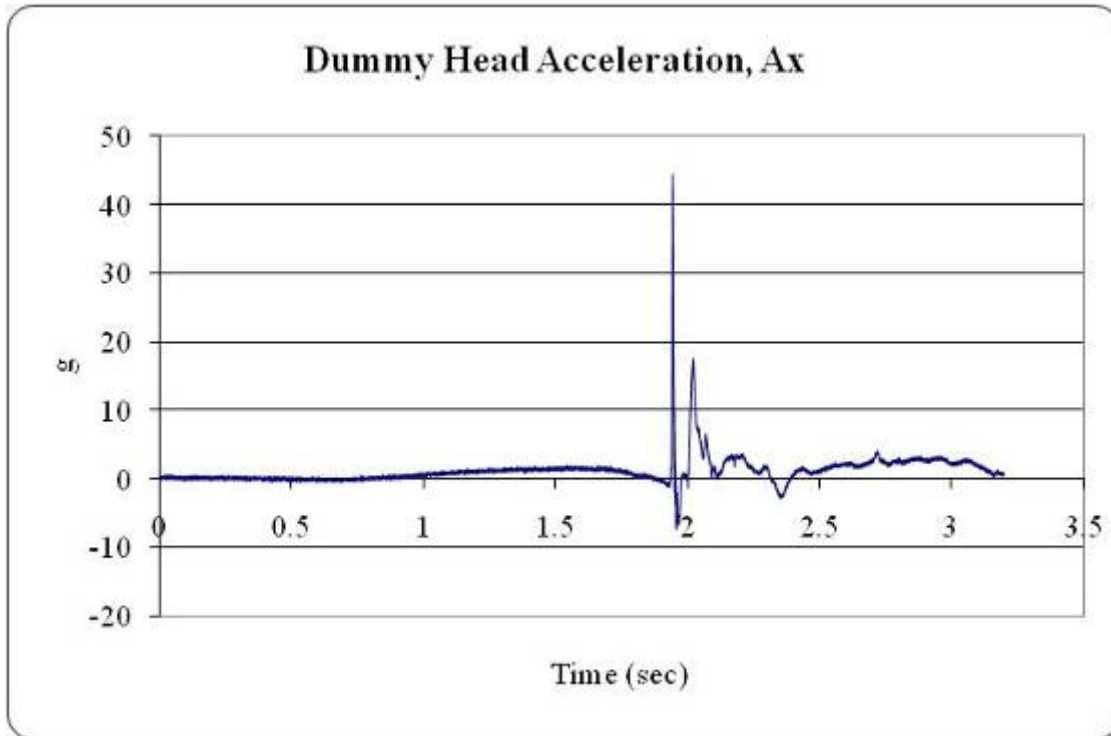
Plot 11: Head Acceleration, Ax, vs. Time

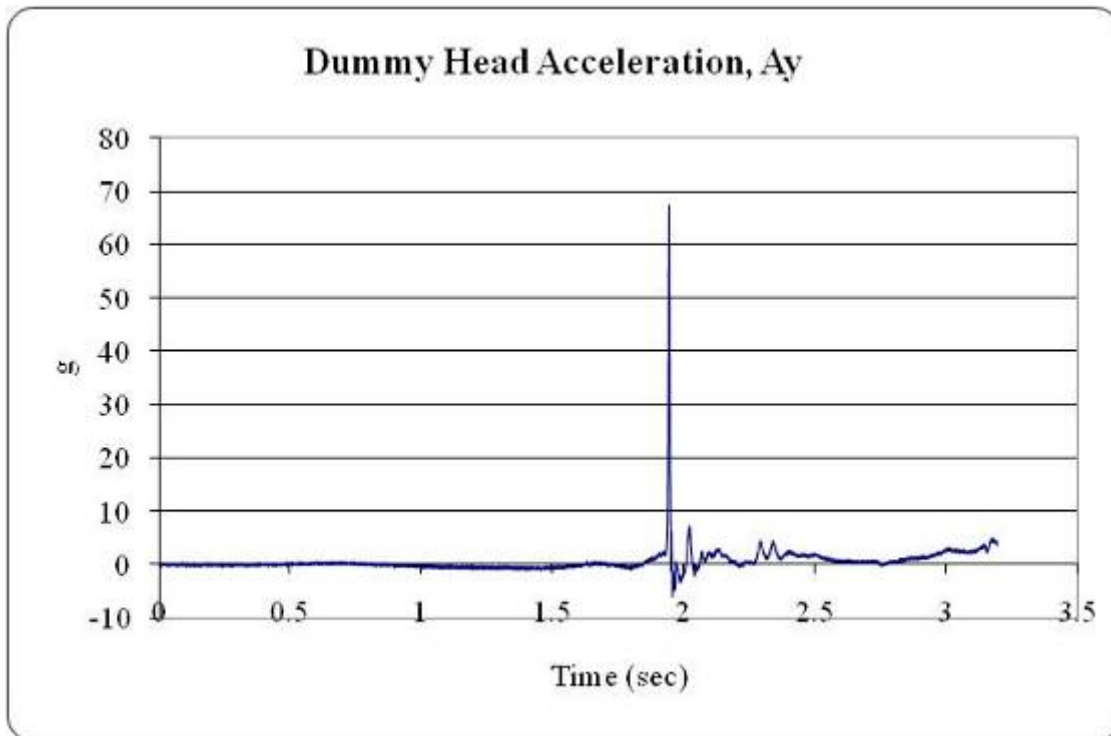
Plot 12: Head Acceleration, Ay, vs. Time

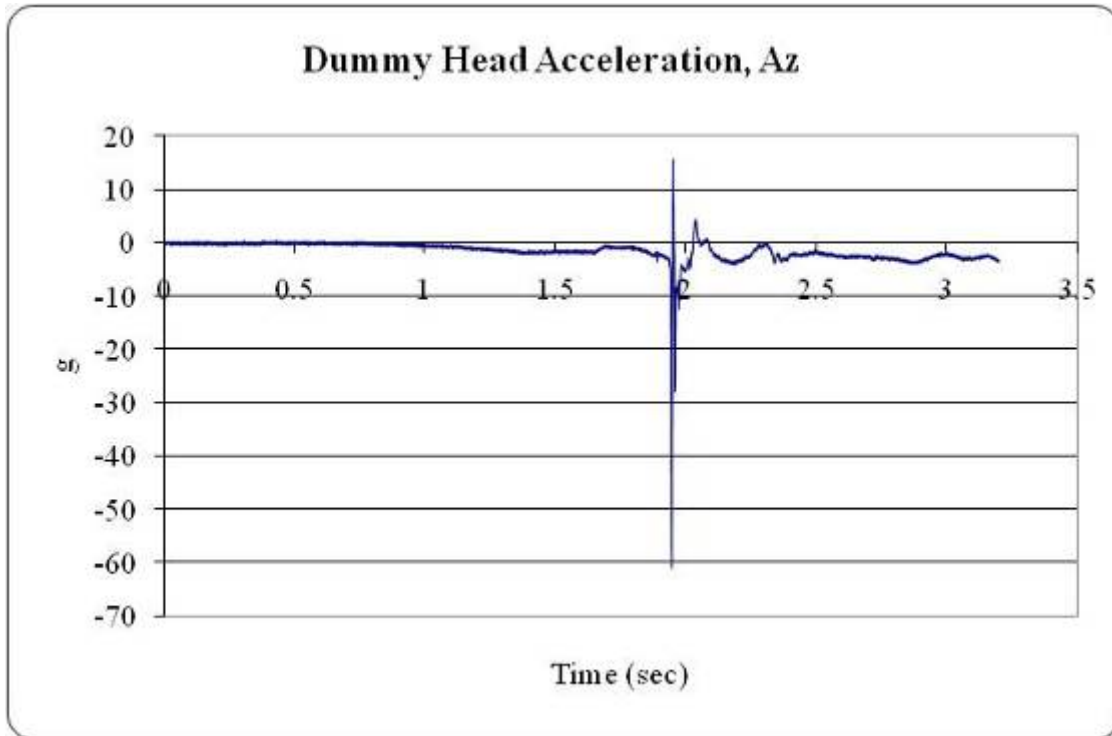
Plot 13: Head Acceleration, Az, vs. Time

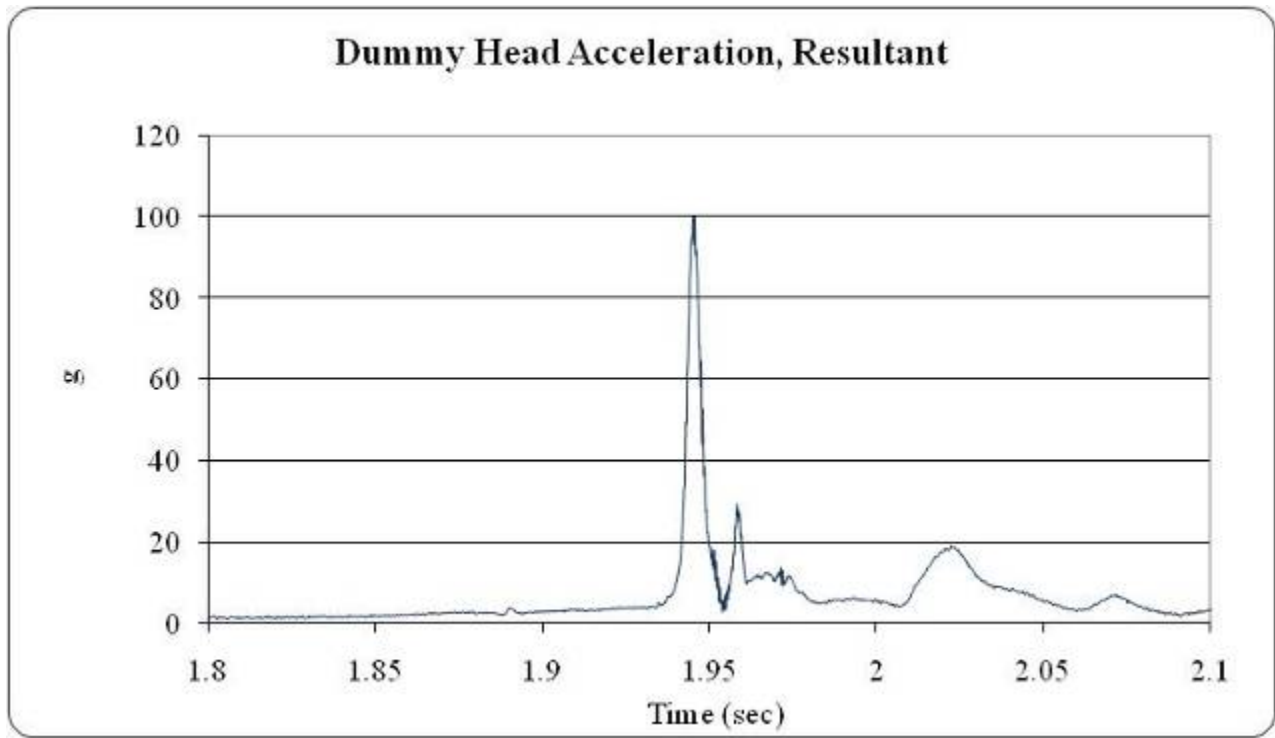
Plot 14: Resultant Head Acceleration vs. Time

HIC = 268

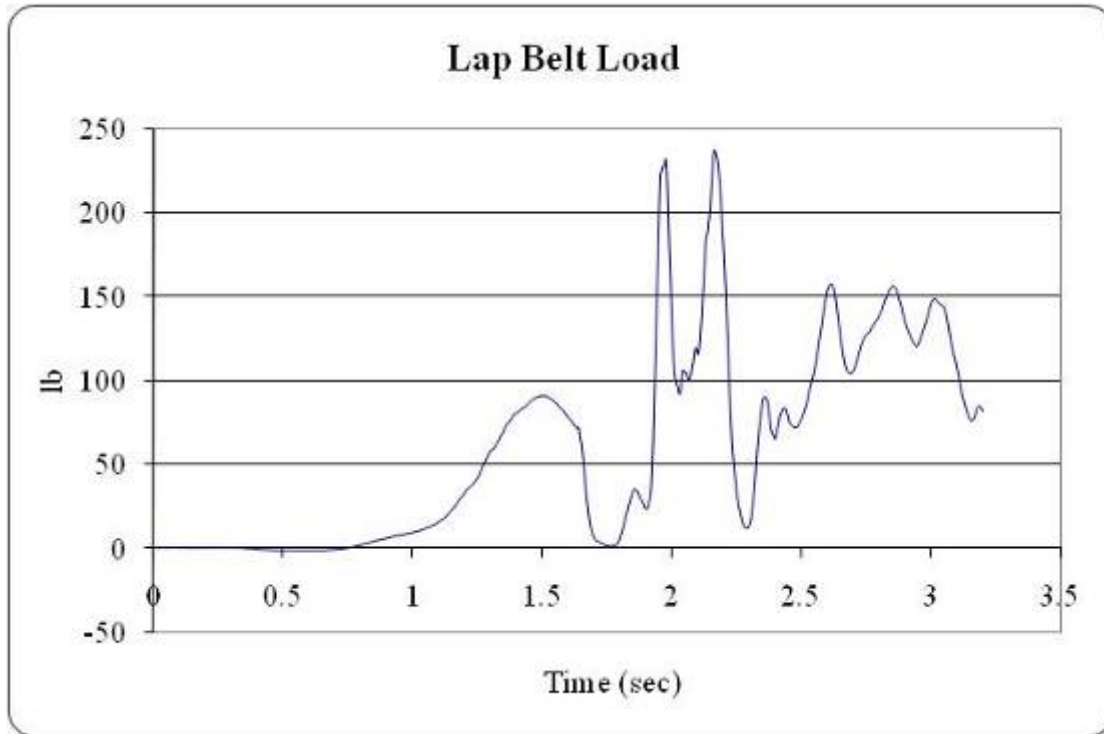
Plot 15: Lap Belt Load\* vs. Time

\*Measured on one side of the belt

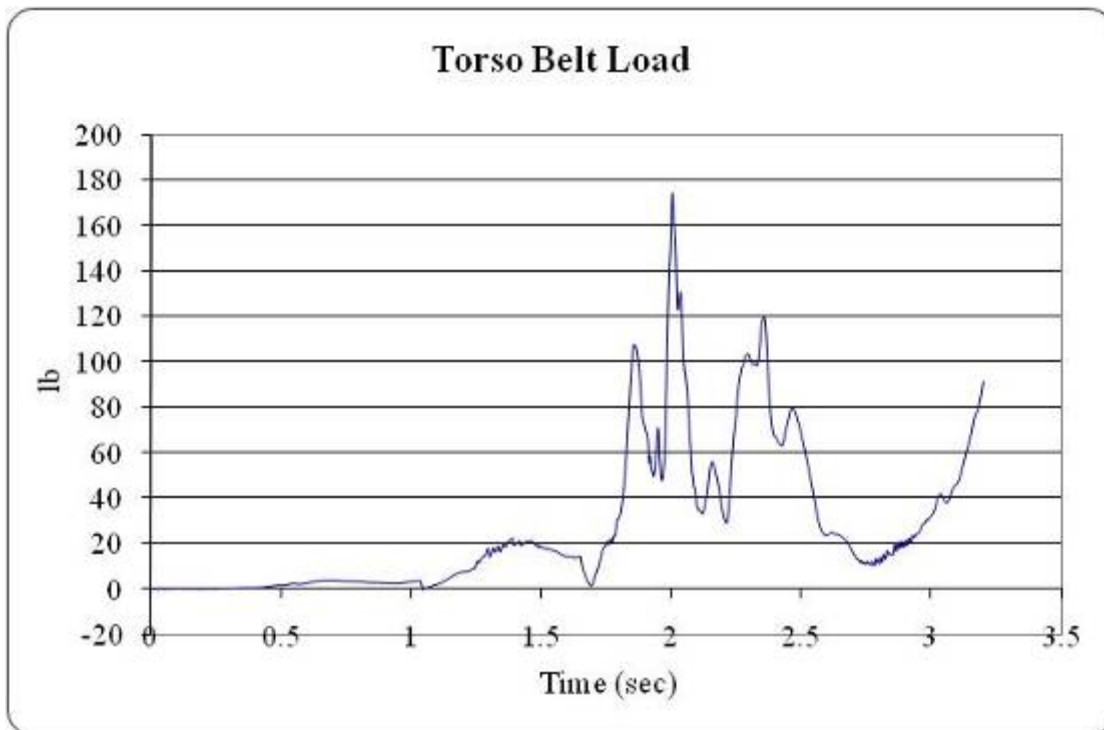
Plot 16: Torso Belt Load\* vs. Time

\*Measured on one side of the belt

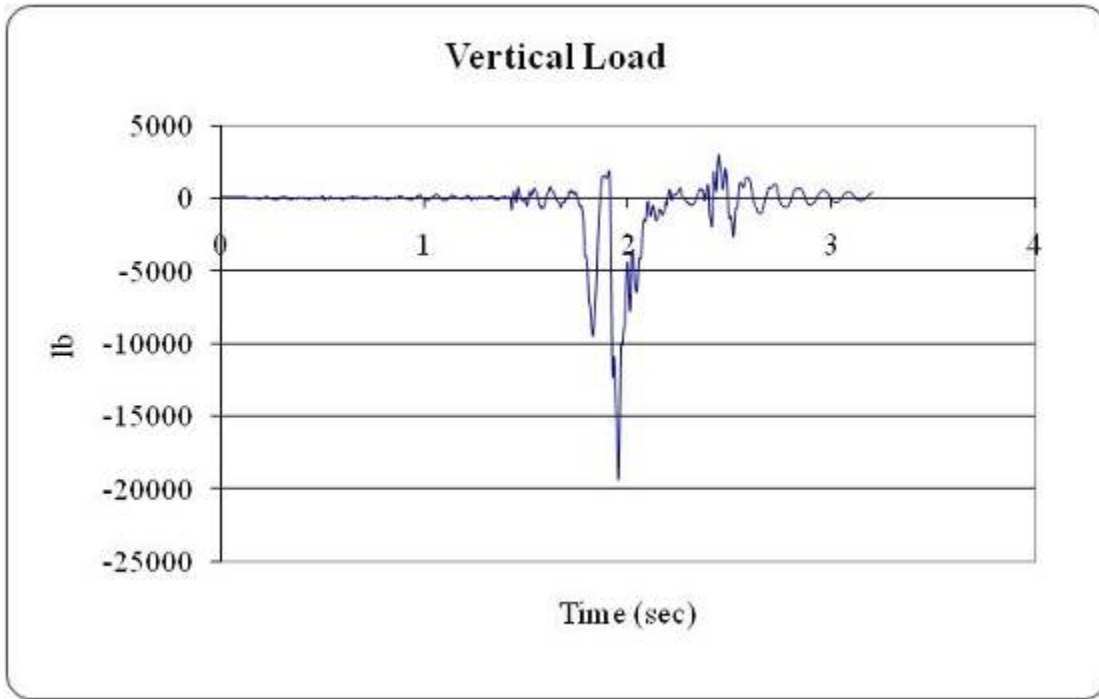
Plot 17: Total Vertical Load v. Time

The vertical load cells mounted on the roadway platform show the near and far side impacts. The vehicle struck the roadway on the near side at approximately 1.77 seconds. The entire roll sequence was completed by approximately 2.10 seconds.

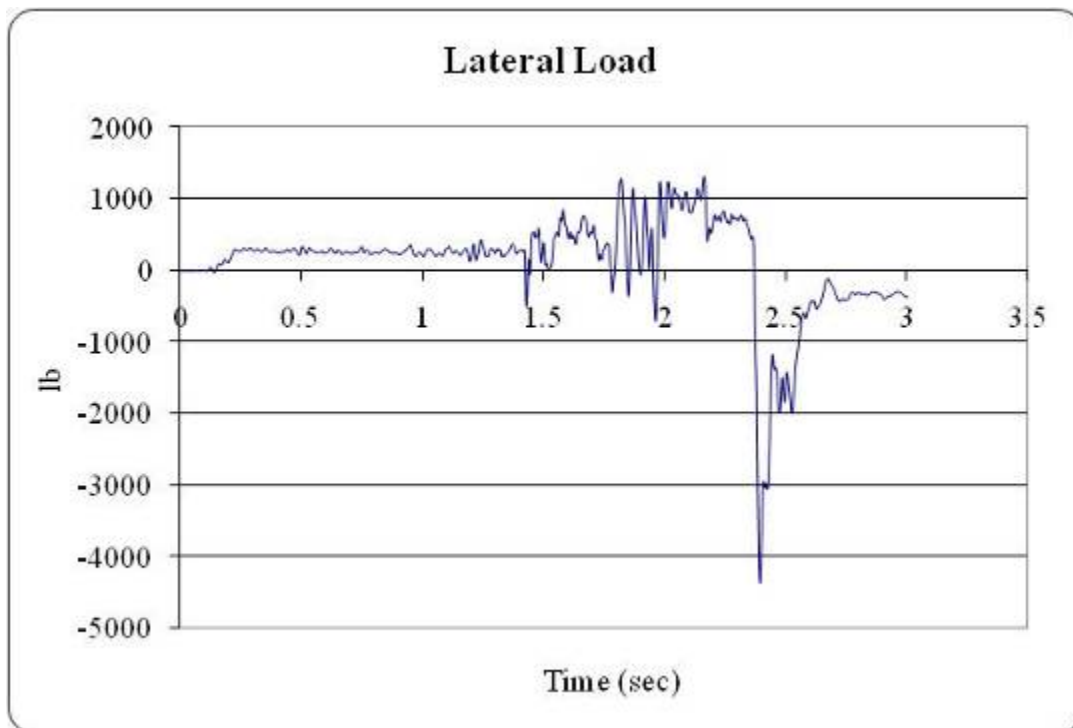
Plot 18: Total Lateral Load v. Time

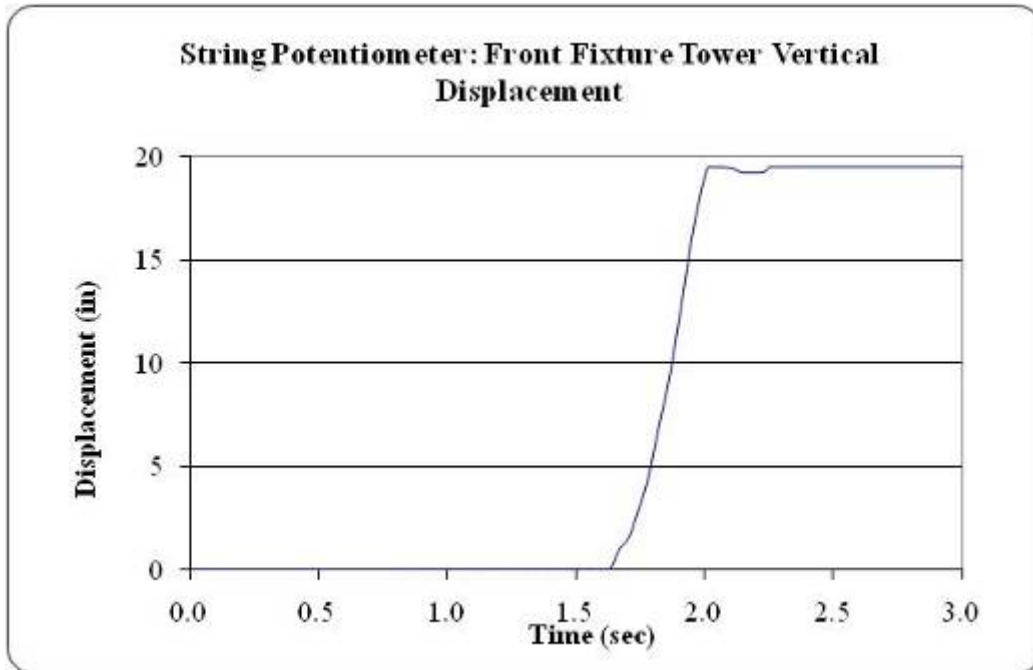
Plot 19: String Potentiometer Front Fixture Support Tower Displacement vs. Time

The string potentiometers located on the fixture support towers show the vertical vehicle motion throughout the test. The front of the vehicle dropped 3.96 inches and the rear dropped 4.38 inches prior to initial touch down. The vehicle was pitched at 4.9 degrees at contact.

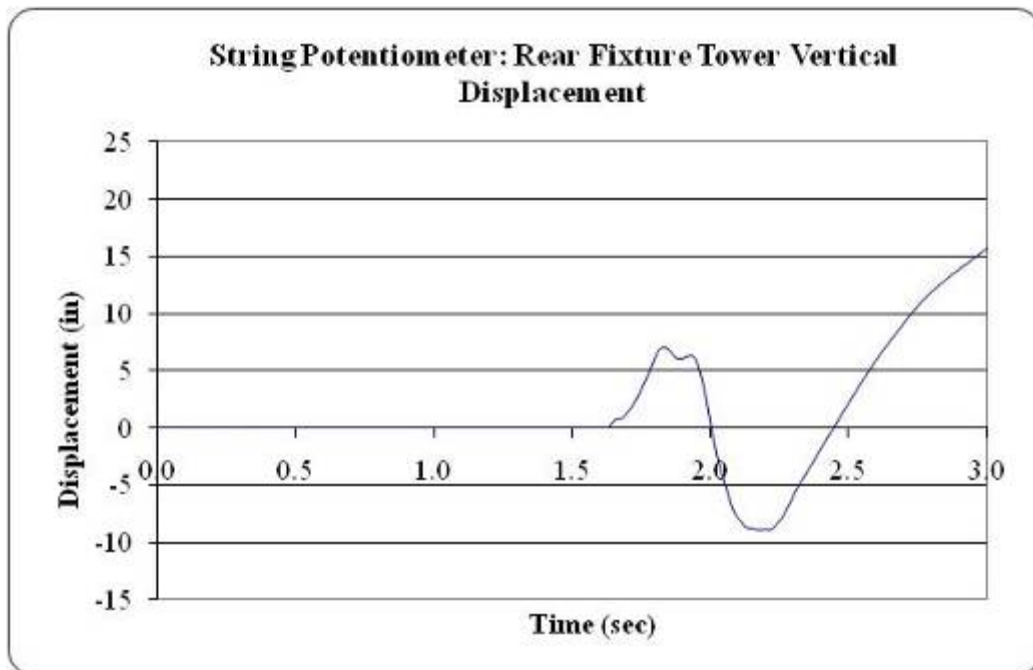
Plot 20: String Potentiometer Rear Fixture Support Tower Displacement vs. Time

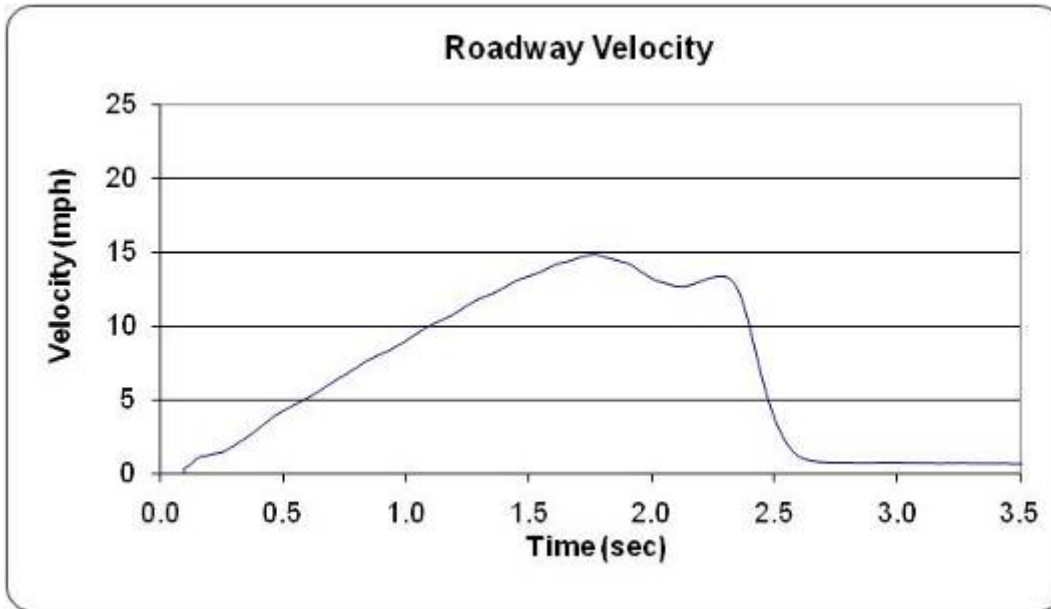
Plot 21: Roll Encoder on Roadway Velocity vs. Time

The roll encoder located on the cable pulley shows the roadway velocity throughout the roll. The roadway was traveling at 14.9 mph at contact. A roll rate sensor in the vehicle was used to determine the roll angle and rate at impact. The roll angle of the vehicle was 144 degrees and the roll rate was 187 degrees per second at the roadway impact.

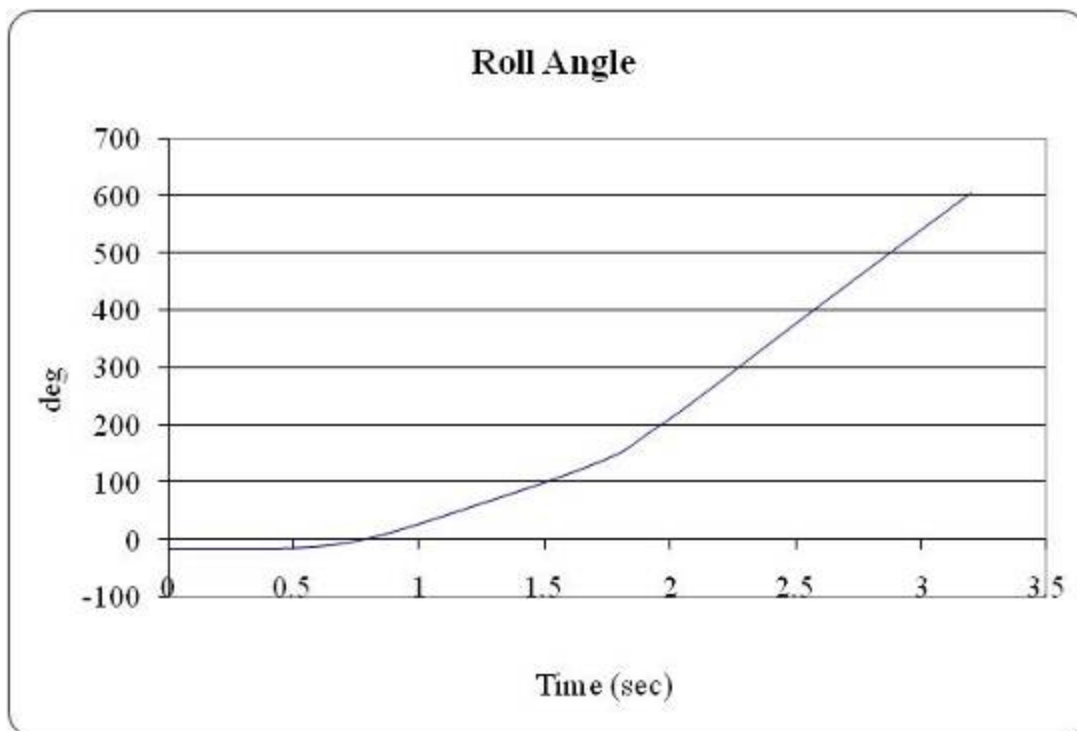
Plot 22: Roll Angle vs. Time

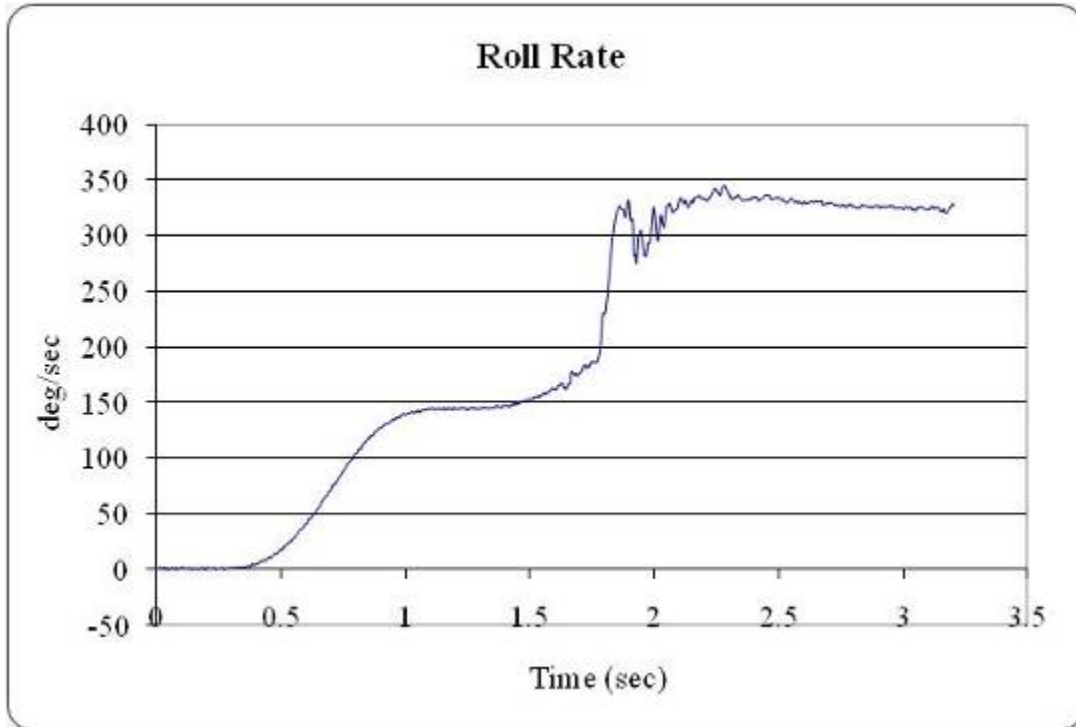
Plot 23: Roll Rate vs. Time

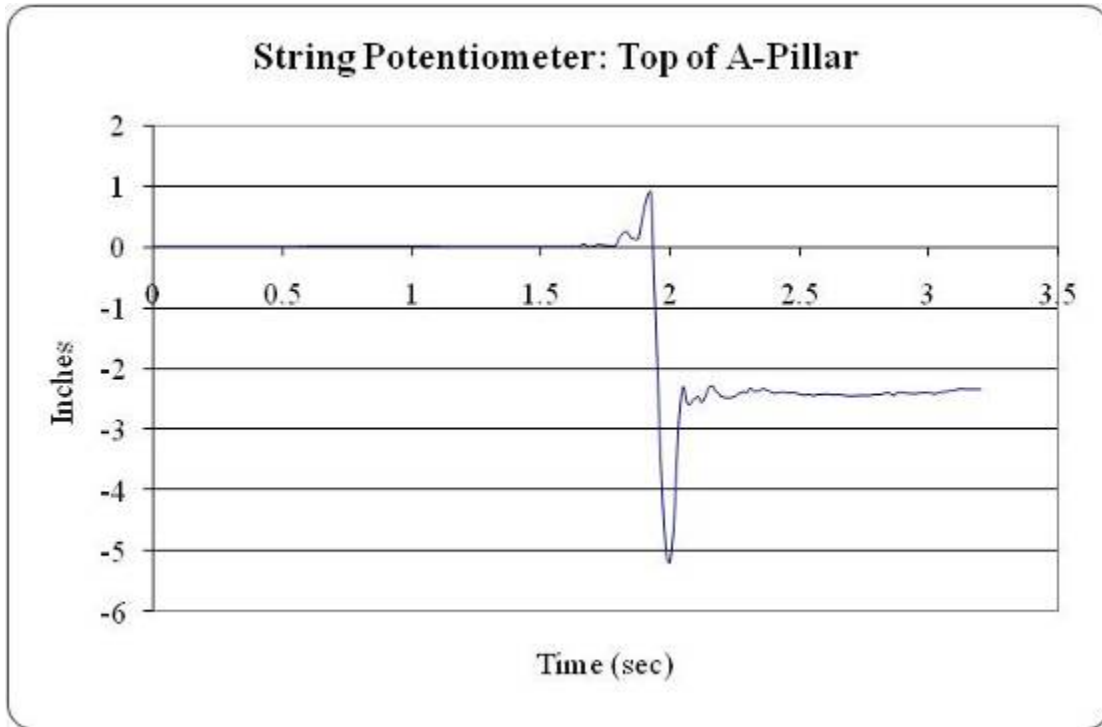
Plot 24: String Potentiometer Driver's Side A-Pillar Displacement v. Time

In Roll 2, the peak lower neck compressive load was 590 N and the peak lower neck moment was 49 Nm in flexion and 43 Nm in extension. The peak intrusion speed at the top of the A-Pillar was 8.1 mph with a peak crush of 5.2 inches.

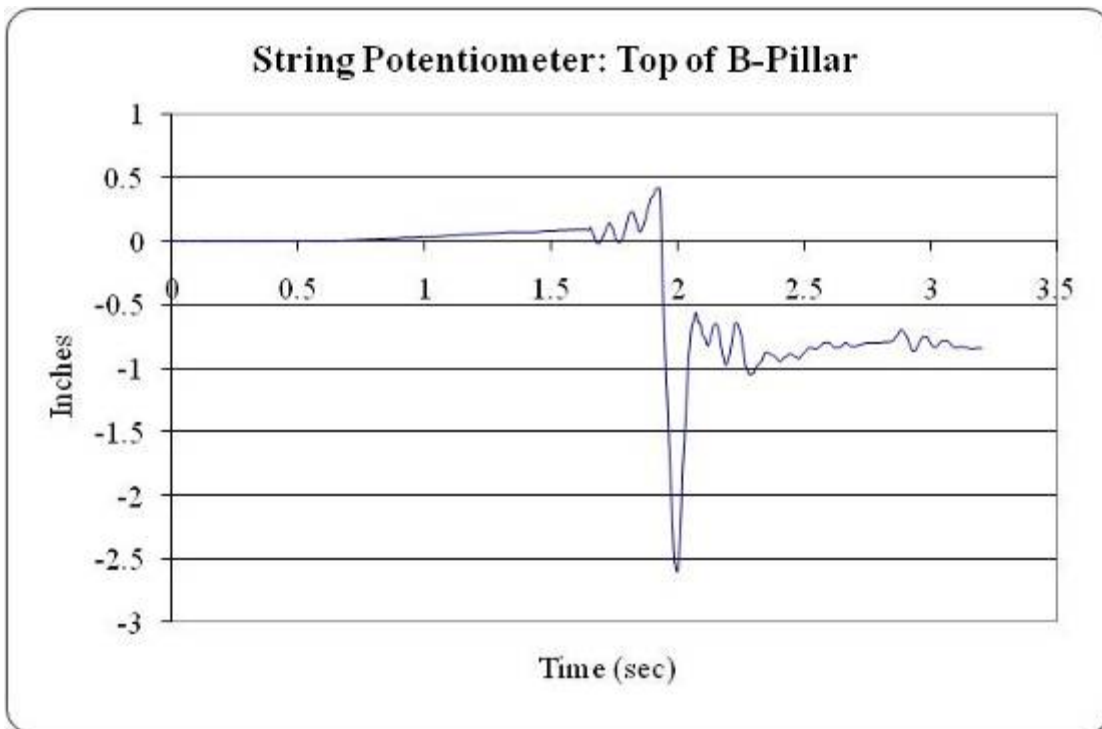
Plot 25: String Potentiometer Driver's Side B-Pillar Displacement v. Time

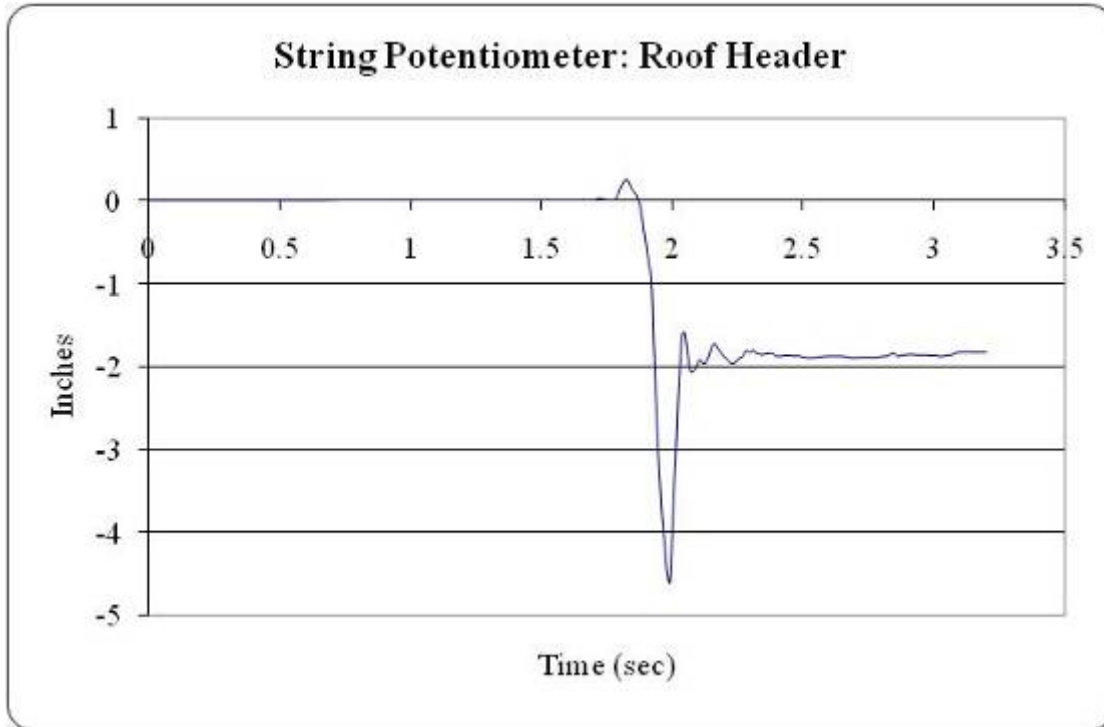
Plot 26: String Potentiometer Driver's Side Roof Header Displacement v. Time  
 Data Sampling Rate: 10 kHz

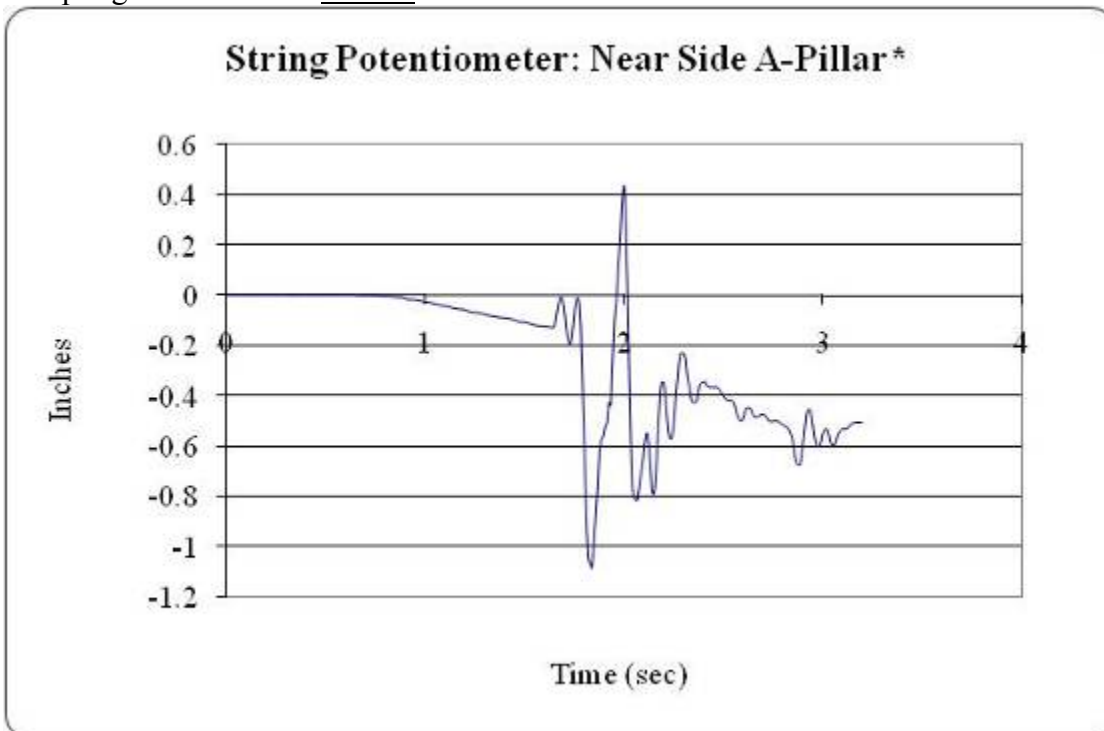
Plot 27: String Potentiometer Passenger's Side A-Pillar Displacement v. Time  
 \*Peak values estimated based on video analysis.  
 Data Sampling Rate: 10 kHz
