# JRS Dynamic Rollover Test

## 2009 Nissan Versa

**Automotive Safety Research Institute  
Charlottesville, VA.**

Center for Injury Research conducted a JRS dynamic rollover test consisting of two rolls of a 2009 Nissan Versa on April 27 and 28, 2010. This test report is organized in sections containing test information, data tables and photographs as follows:

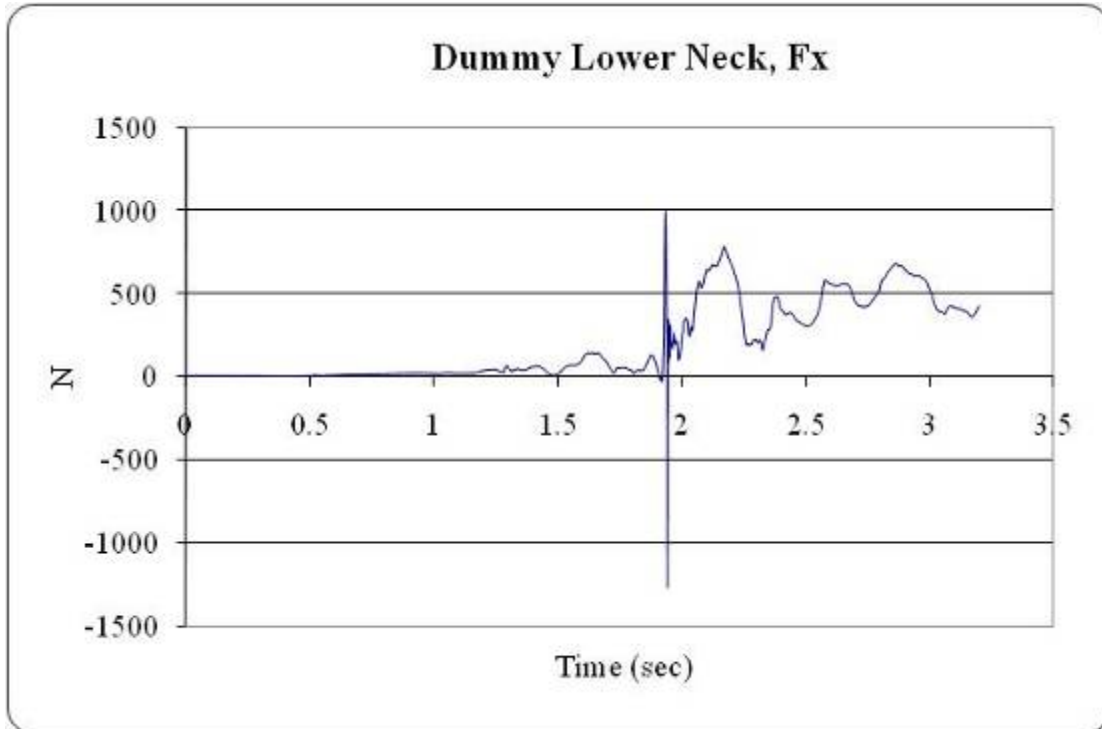
Plot 28: Lower Neck Load, Fx, v. Time

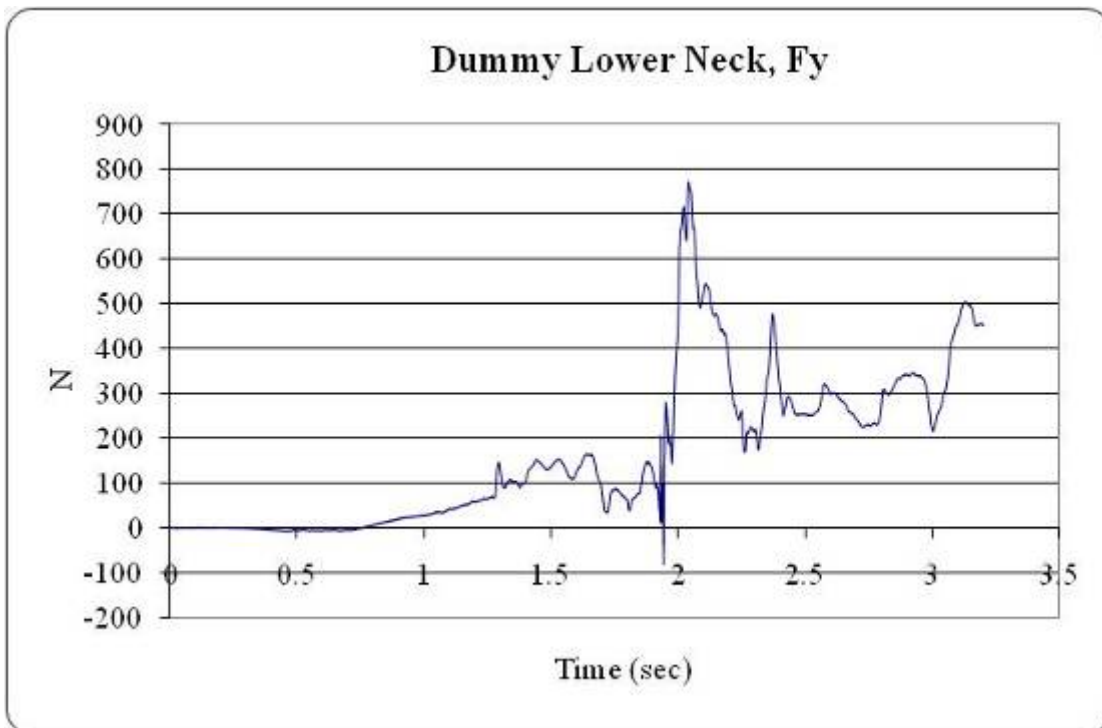
Plot 29: Lower Neck Load, Fy, v. Time

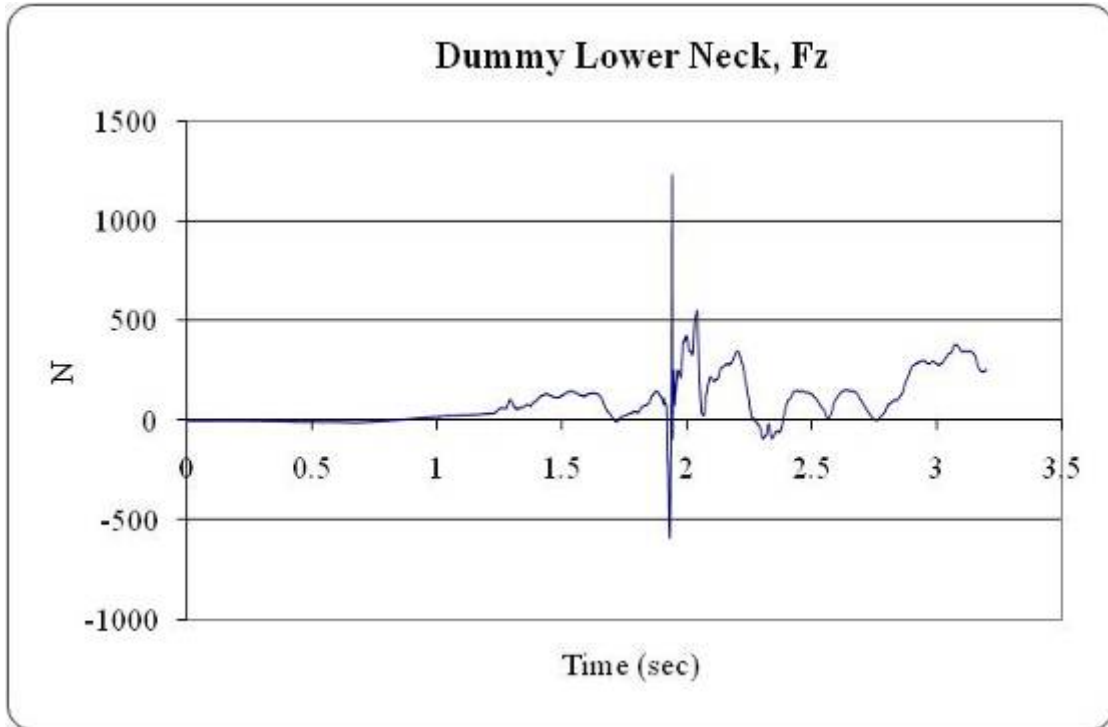
Plot 30: Lower Neck Load, Fz, v. Time

In Roll 2, the peak lower neck compressive load was 590 N and the peak lower neck moment was 49 Nm in flexion and 43 Nm in extension. The peak intrusion speed at the top of the A-Pillar was 8.1 mph with a peak crush of 5.2 inches.

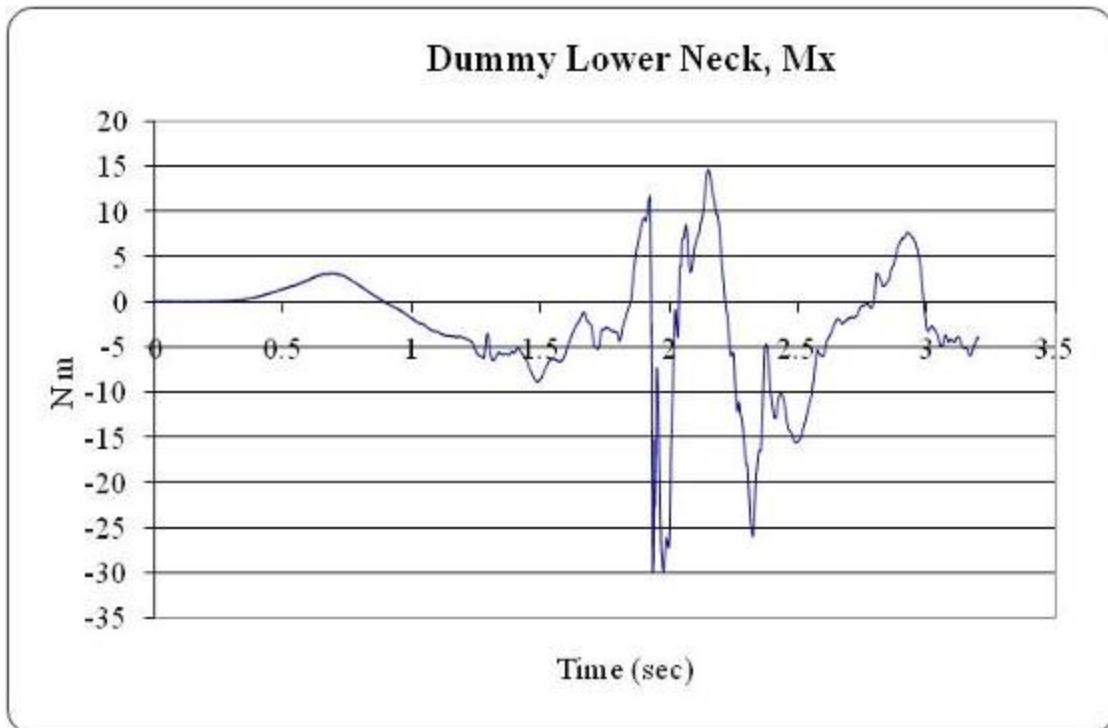
Plot 31: Lower Neck Load, Mx, v. Time

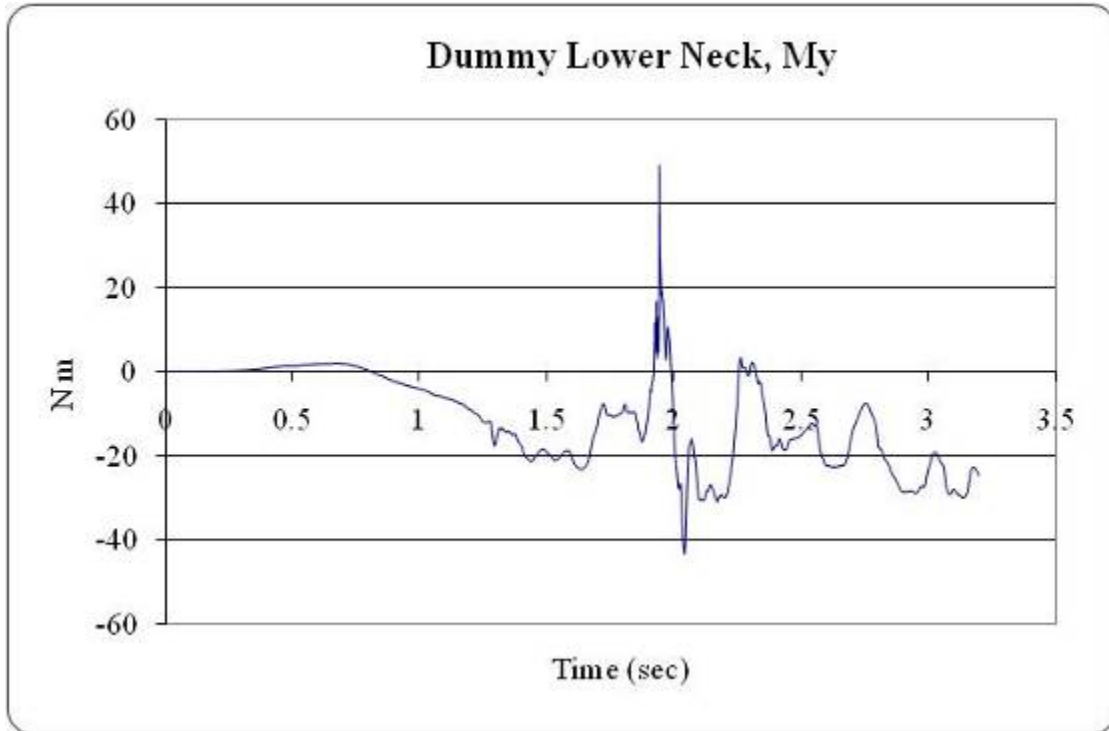
Plot 32: Lower Neck Load, My, v. Time

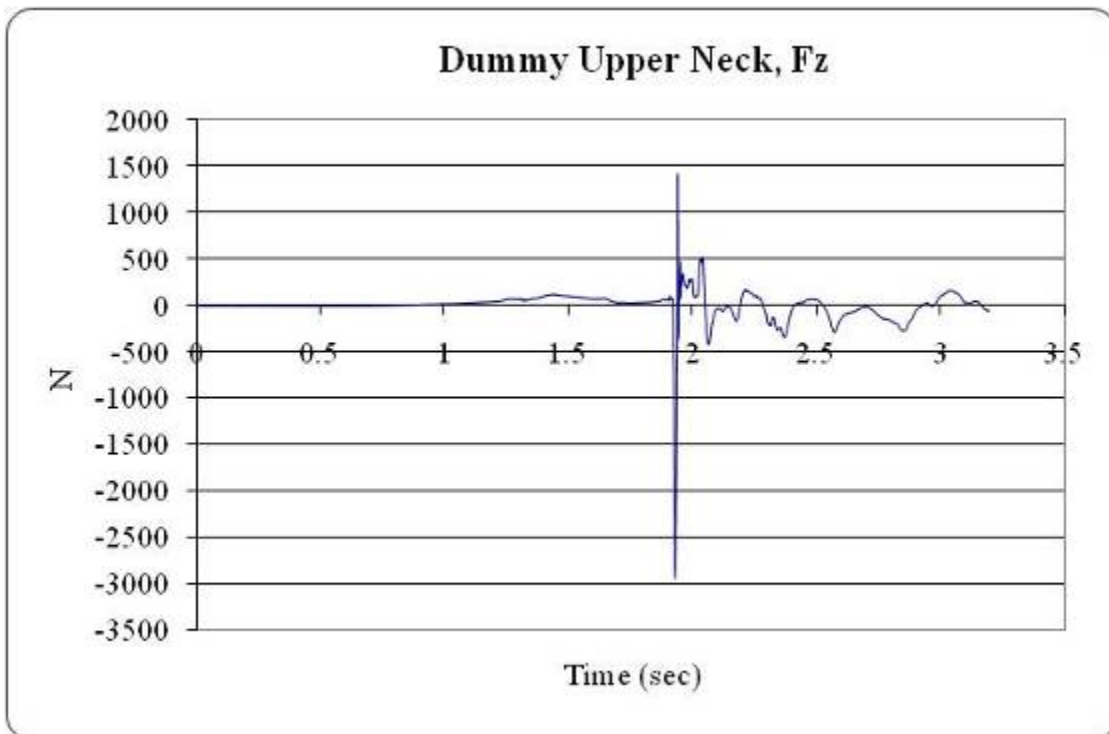
Plot 33: Upper Neck Load, Fz, v. Time

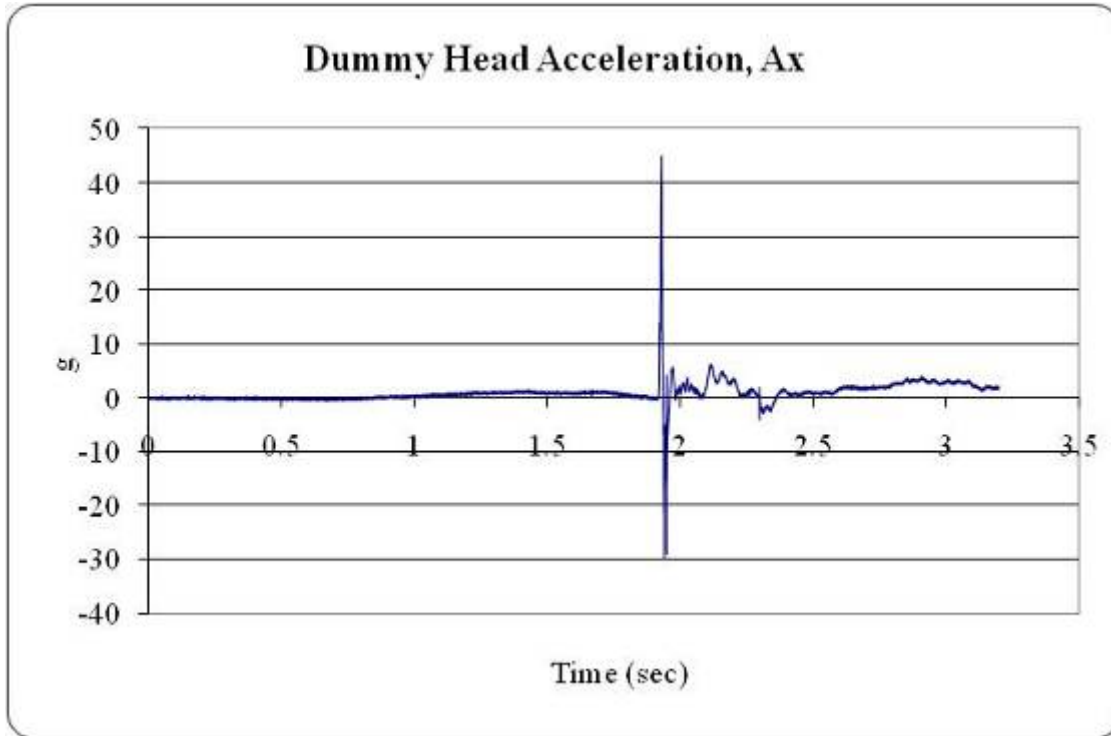
Plot 34: Head Acceleration, Ax, vs. Time

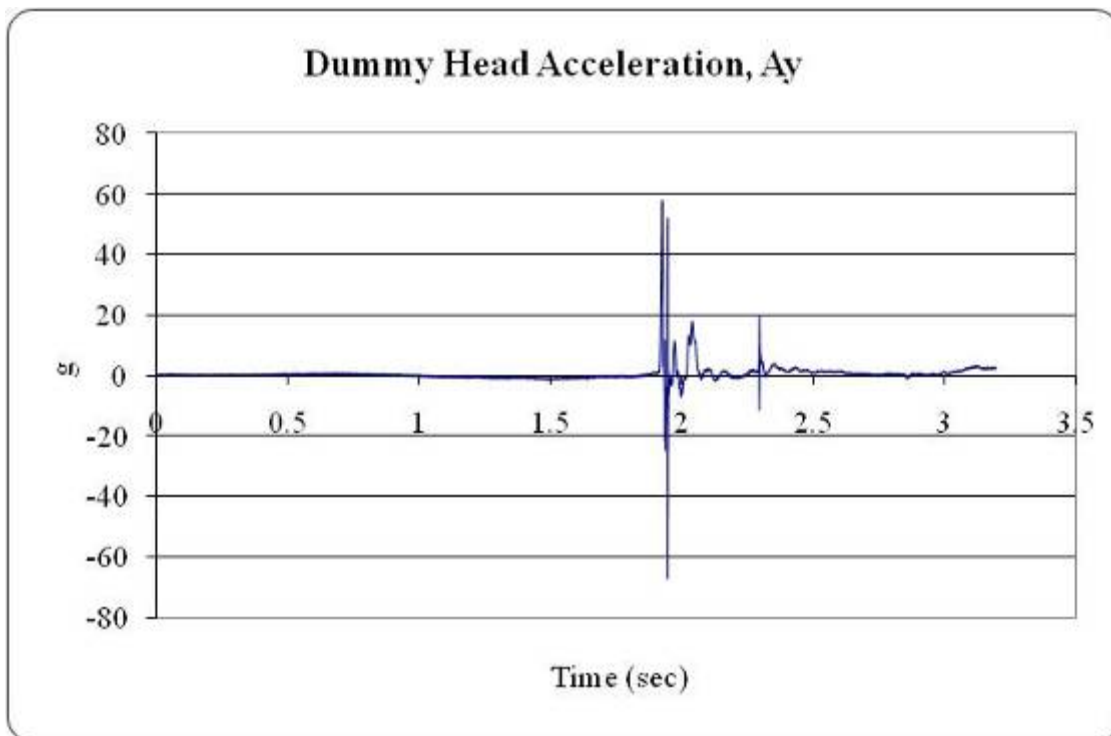
Plot 35: Head Acceleration, Ay, vs. Time

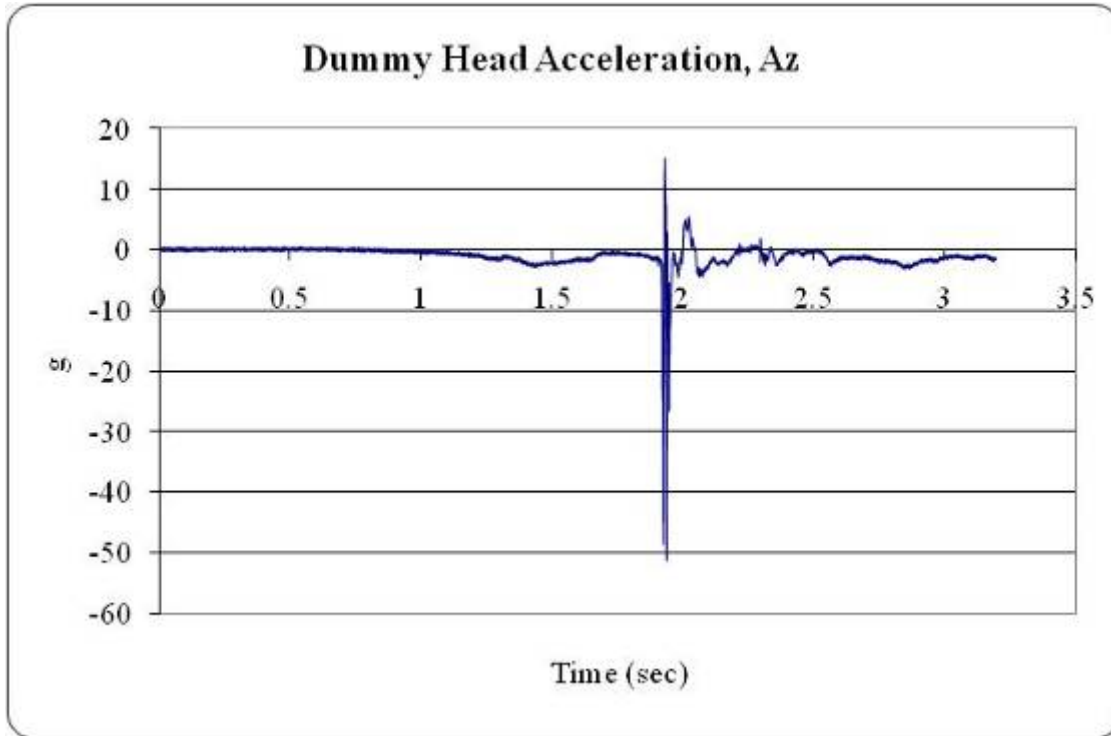
Plot 36: Head Acceleration, Az, vs. Time

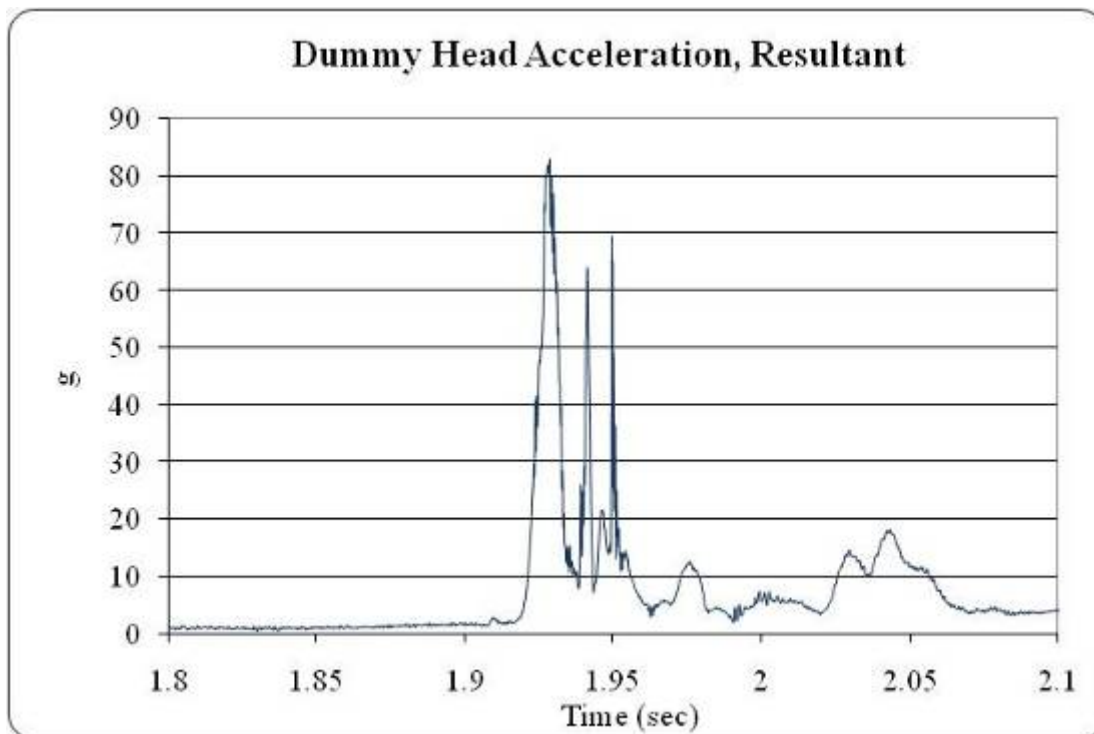
Plot 37: Resultant Head Acceleration vs. Time

HIC = 245

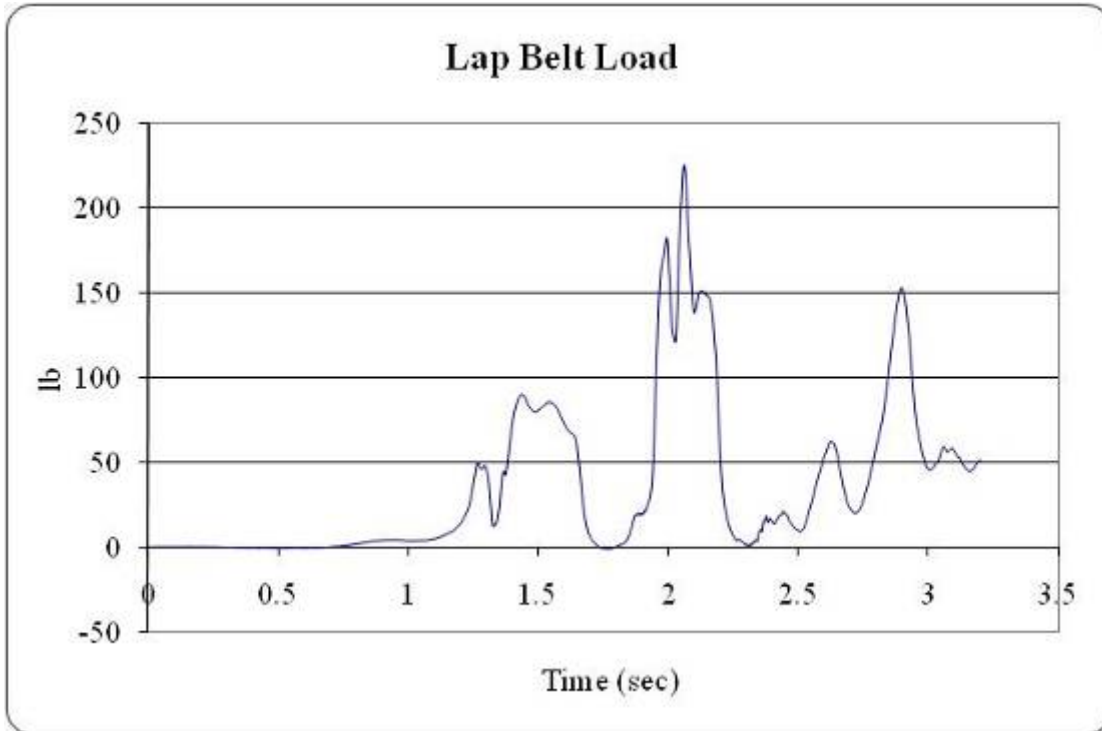
Plot 38: Lap Belt Load\* vs. Time

\*Measured on one side of the belt

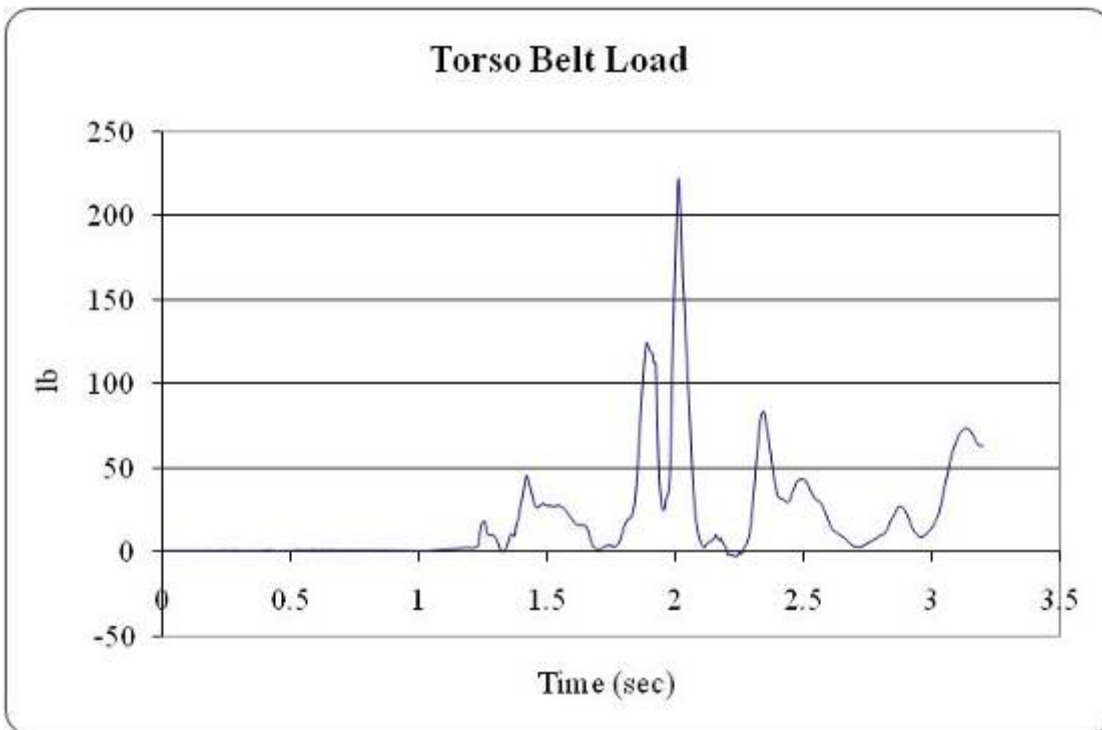
Plot 39: Torso Belt Load\* vs. Time

\*Measured on one side of the belt

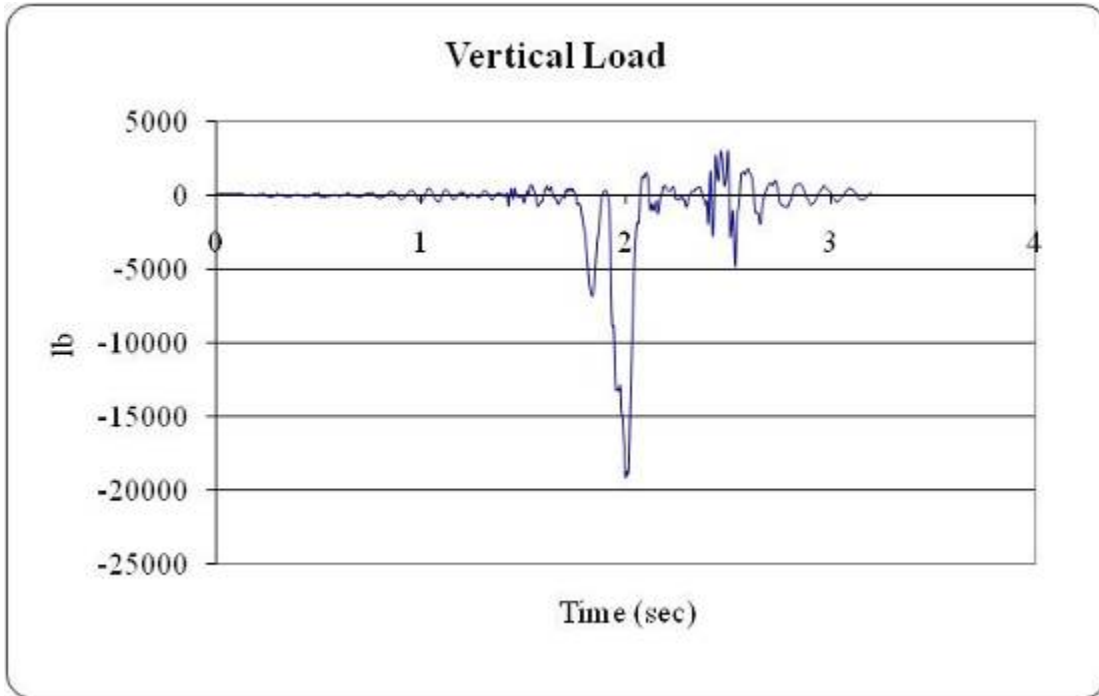
Plot 40: Total Vertical Load v. Time

The vertical load cells mounted on the roadway platform show the near and far side impacts. The vehicle struck the roadway on the near side at approximately 1.77 seconds. The entire roll sequence was completed by approximately 2.07 seconds.

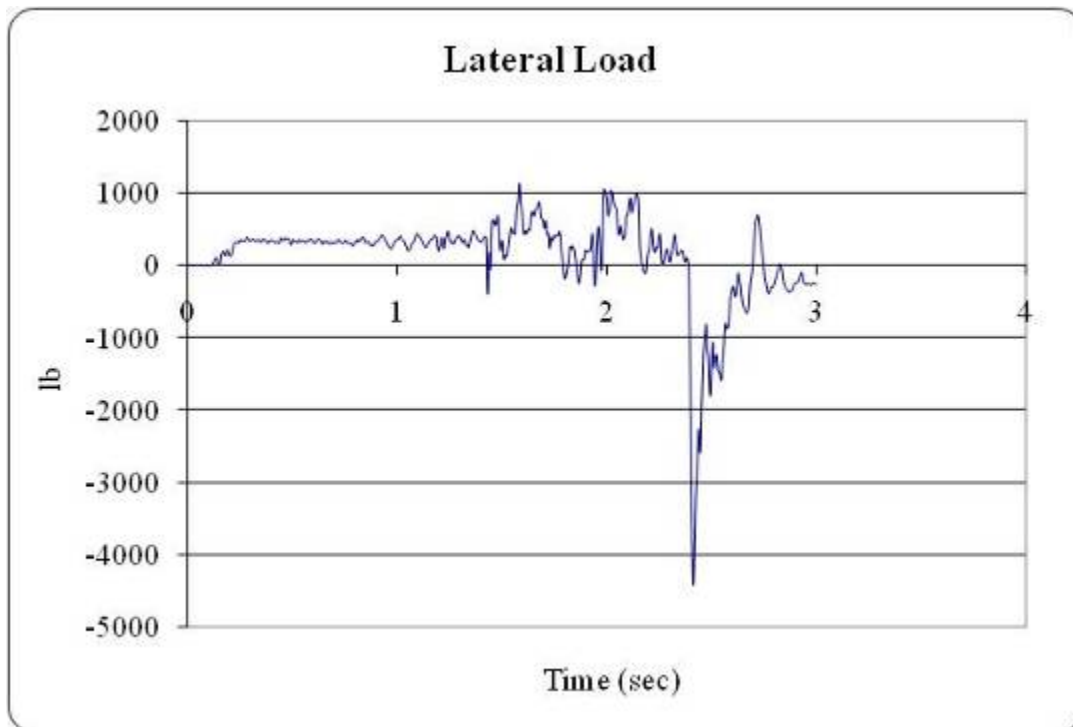
Plot 41: Total Lateral Load v. Time

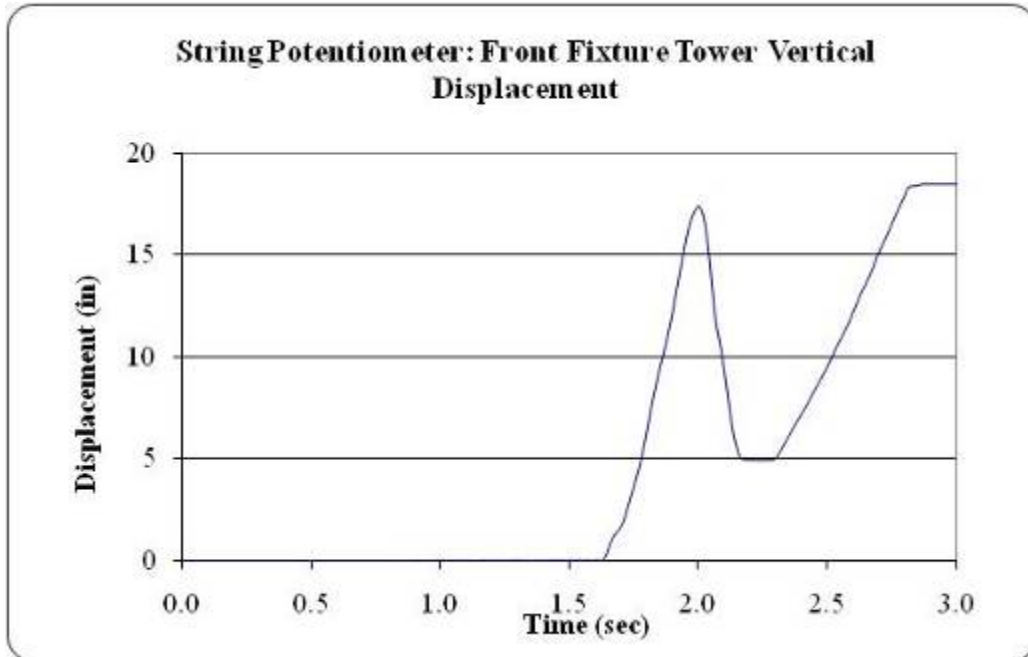
Plot 42: String Potentiometer Front Fixture Support Tower Displacement vs. Time

The string potentiometers located on the fixture support towers show the vertical vehicle motion throughout the test. The front of the vehicle dropped 4.44 inches and the rear dropped 3.84 inches prior to initial touch down. The vehicle was pitched at 10.2 degrees at contact.

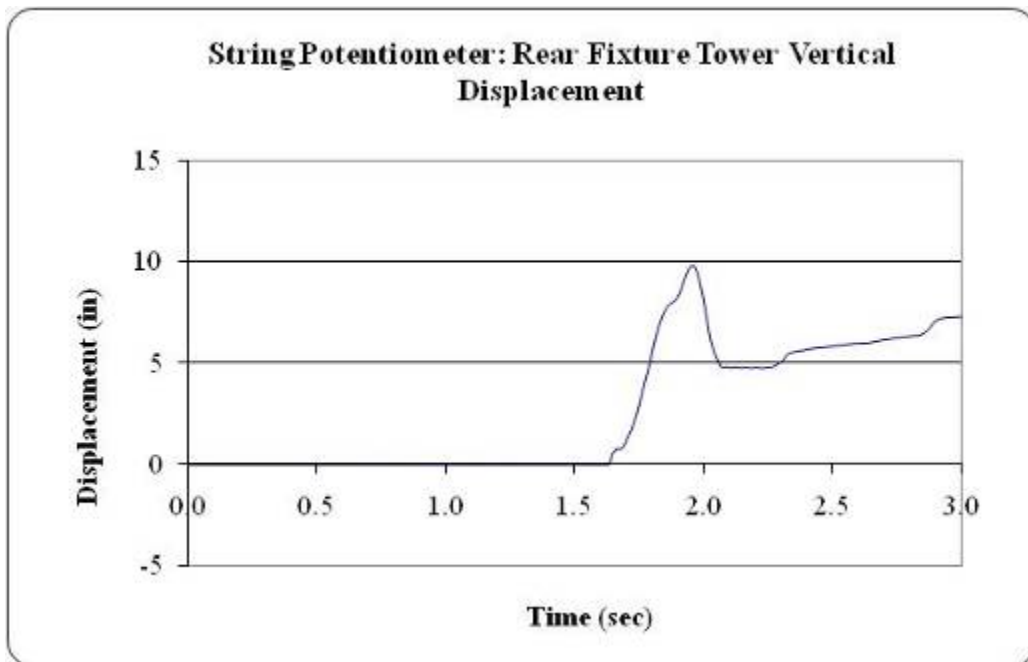
Plot 43: String Potentiometer Rear Fixture Support Tower Displacement vs. Time

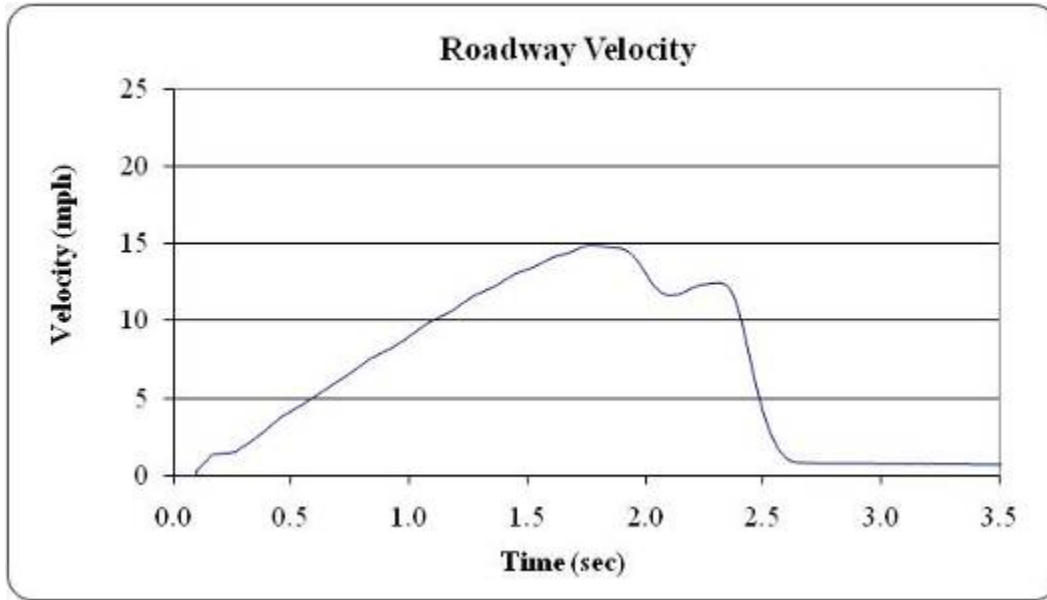
Plot 44: Roll Encoder on Roadway Velocity vs. Time

The roll encoder located on the cable pulley shows the roadway velocity throughout the roll. The roadway was traveling at 14.9 mph at contact. A roll rate sensor in the vehicle was used to determine the roll angle and roll rate at impact. The roll angle of the vehicle was 145 degrees and the roll rate was 194 degrees per second at the roadway impact.

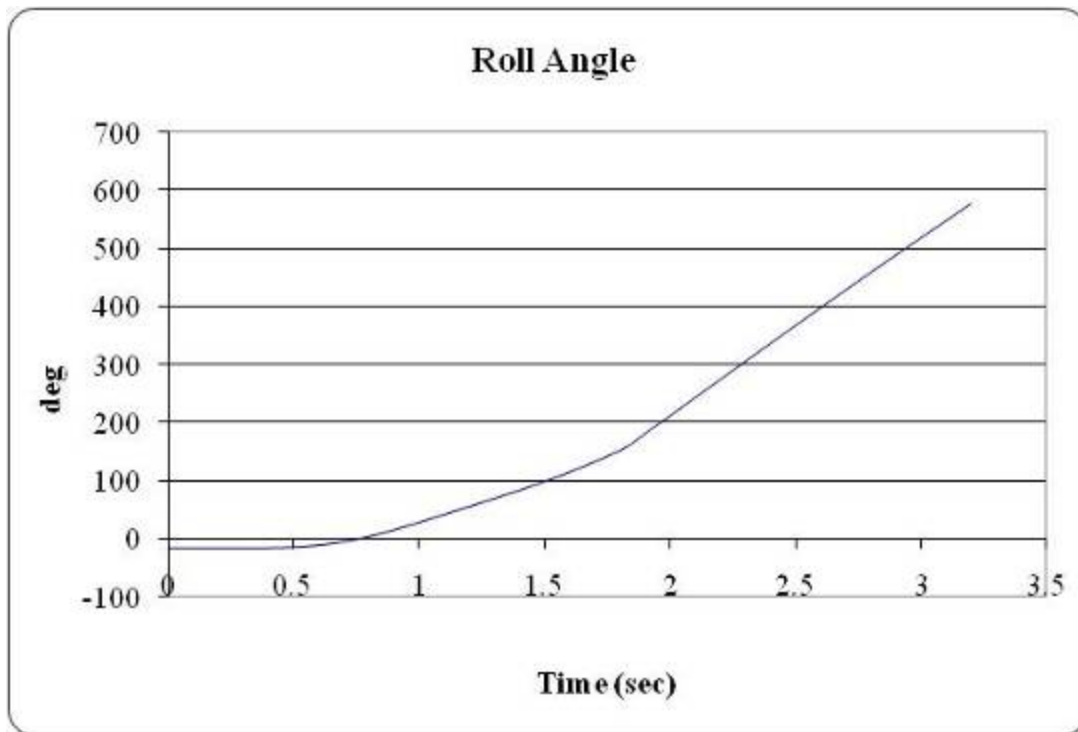
Plot 45: Roll Angle vs. Time

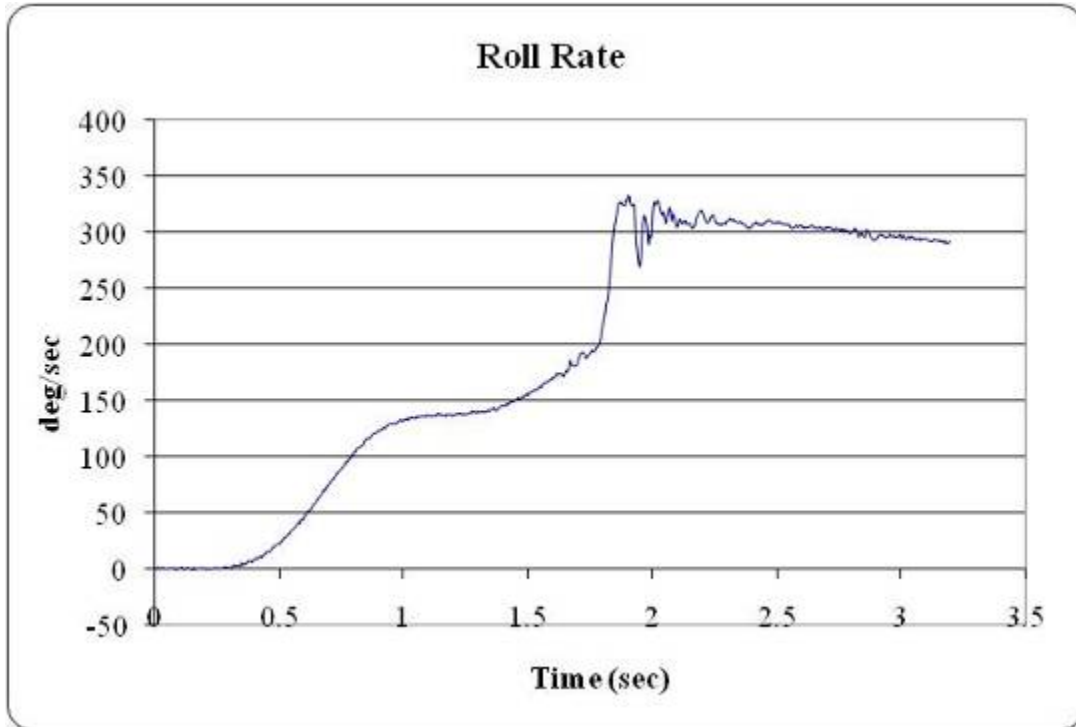
Plot 46: Roll Rate vs. Time
