# Crash Reports

Prepared by Ken Digges

1 Case 2002-4-70

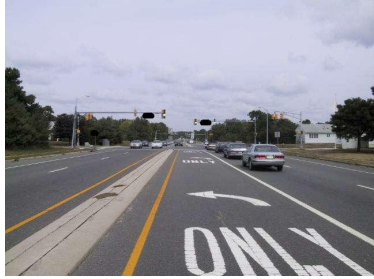
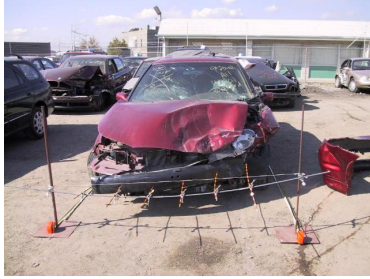
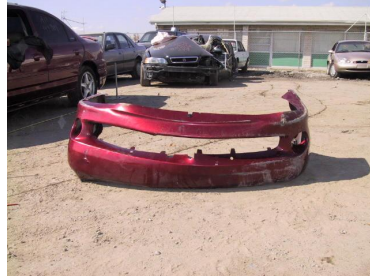
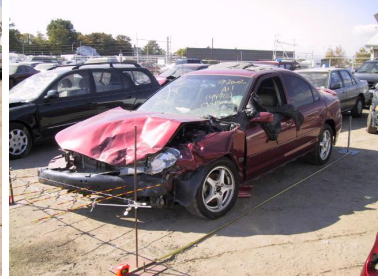
**Occupant: 2002-4-70-1-1**

Fire Occurrence	No fire
Fire Origin	No fire
Location of Fuel Leakage	No fuel leakage
Type of Fuel Tank	Metallic
Fuel Tank Location	Forward of rear axle, centered
Fuel Cap Location	Right side, behind rear axle
Fuel Tank Damage	No damage
Fuel Type	Gasoline

Make-Model	Ford Contour
Year	2000
Class	PASSENGER CAR
Body Type	4-DR SEDAN/HDTOP
Weight	126

Nr. Quarter Turns	No rollover
Impact Speed	998
Total, Longitudal, and Lateral $\delta V$	21 -20 7
Est. $\delta V$ with sequence number	DELTA V CODED 1
CDC	11 F Y E W 2
Damage (C1-C6)	39 28 15 7 0 0
Crush (L and D)	150 -37
Object Contacted 1	VEHICLE NO. 2
Object Contacted 2	CURB

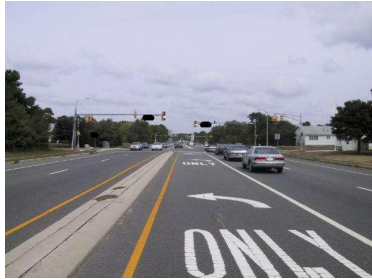
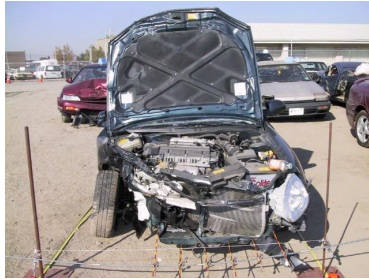
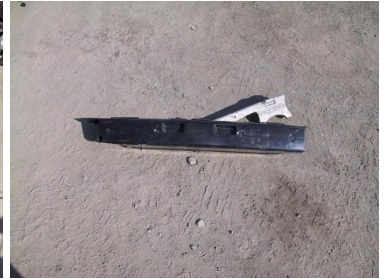
Occupant: 2002-4-70-2-1

Fire Occurrence	No fire
Fire Origin	No fire
Location of Fuel Leakage	No fuel leakage
Type of Fuel Tank	Metallic
Fuel Tank Location	Forward of rear axle, centered
Fuel Cap Location	Left side, behind rear axle
Fuel Tank Damage	No damage
Fuel Type	Gasoline

Nr. Quarter Turns	No rollover
Impact Speed	998
Total, Longitudal, and Lateral $\delta V$	21 -14 -16
Est. $\delta V$ with sequence number	DELTA V CODED 1
CDC	2 R F E W 3
Damage (C1-C6)	0 0 1 2 17 32
Crush (L and D)	184 128
Object Contacted 1	VEHICLE NO. 1
Object Contacted 2	VEHICLE NO. 1

AIS Level	Injury Description	Contacts
2=Moderate	Lumbar fracture of transverse process without cord injury	Left hardware
2=Moderate	Radial fracture, closed	Steering rim
3=Serious	Ulnar fracture, open/displaced/comminuted	Steering rim
1=Minor	Leg skin abrasion	Knee bolster
1=Minor	Thoracic skin contusion	Belt webb/buckle
1=Minor	Leg skin contusion (hematoma)	Belt webb/buckle
1=Minor	Abdominal skin contusion	Belt webb/buckle
2=Moderate	Pelvic fracture, closed	Transmiss lever
2=Moderate	Sternal fracture	Belt webb/buckle
1=Minor	Leg skin laceration, minor	Knee bolster

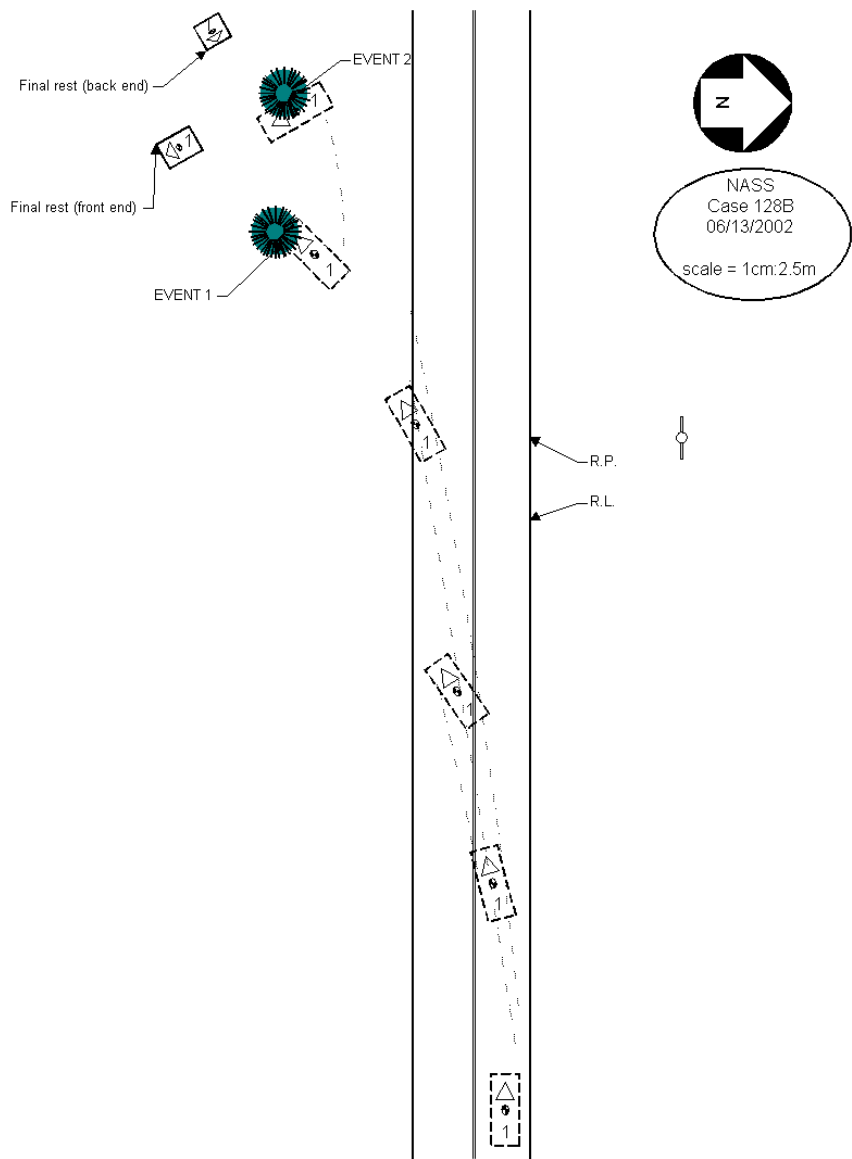
Vehicle 1, a 1993 Honda Civic was traveling west on a two-lane two-way roadway when control was lost. V1 departed the roadway to the left and it's front plane struck a 50cm diameter tree. V1 continued west while rotating counter clockwise and struck a second tree (43cm diameter) with it's right side. The car was severed into two pieces rear of the B-pillars from event two and each part came to a rest shortly thereafter. Vehicle 1 was towed from the scene and sustained severe damage to the front and right planes. It was equipped with driver side airbag which deployed. Vehicle 1 contained only a driver, no other occupants. The driver was ejected from the vehicle while wearing his seatbelt. It is believed that this is not a failure but an effect from the severe damage to the passenger compartment. There was significant intrusion from the right side which compressed and reclined the drivers seat, creating slack in the restraint system, allowing the driver to slip out during rotation. The driver sustained fatal injuries and was not transported to the hospital. )

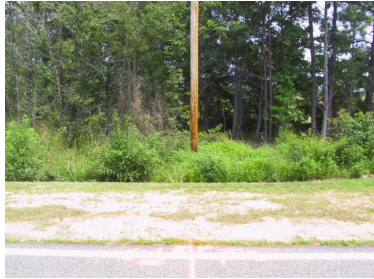
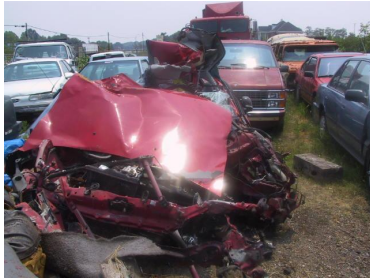
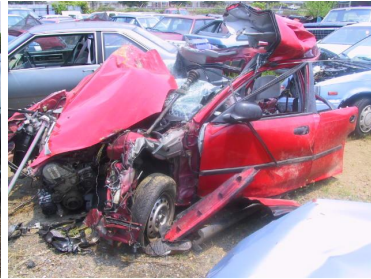
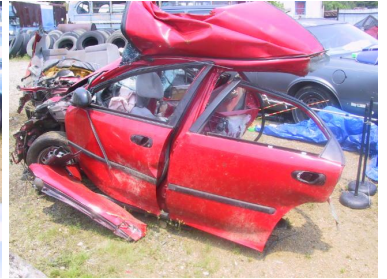
Occupant: 2002-9-128-1-1

Nr. Quarter Turns	No rollover
Impact Speed	999
Total, Longitudal, and Lateral $\delta V$	999 999 999
Est. $\delta V$ with sequence number	SEVERE 2
CDC	63 R P A W 9
Damage (C1-C6)	0 0 0 0 0 0
Crush (L and D)	0 0
Object Contacted 1	LARGE TREE
Object Contacted 2	LARGE TREE

AIS Level	Injury Description	Contacts
1=Minor	Facial skin laceration, minor	Unknown SOURCE
1=Minor	Facial skin laceration, minor	Unknown SOURCE
1=Minor	Facial skin abrasion	Unknown SOURCE
1=Minor	Facial skin contusion	Unknown SOURCE
3=Serious	Basilar skull fracture, NFS	Unknown SOURCE
4=Severe	Cerebellar laceration	Unknown SOURCE
6=Maximum	Brain stem laceration	Unknown SOURCE
3=Serious	Cerebral subarachnoid hemorrhage	Unknown SOURCE
1=Minor	Thoracic skin contusion	Unknown SOURCE
4=Severe	Thoracic aortic laceration, minor (incomplete, EBL<205=Critical	Massive hepatic injury (>502=Moderate
	Pelvic fracture NFS	Unknown SOURCE
1=Minor	Abdominal skin laceration, minor	Belt webb/buckle
1=Minor	Upper extremity skin laceration, minor	Unknown SOURCE
1=Minor	Upper extremity skin abrasion	Unknown SOURCE
1=Minor	Upper extremity skin contusion	Unknown SOURCE
1=Minor	Leg skin contusion (hematoma)	Unknown SOURCE
1=Minor	Leg skin abrasion	Seat, back

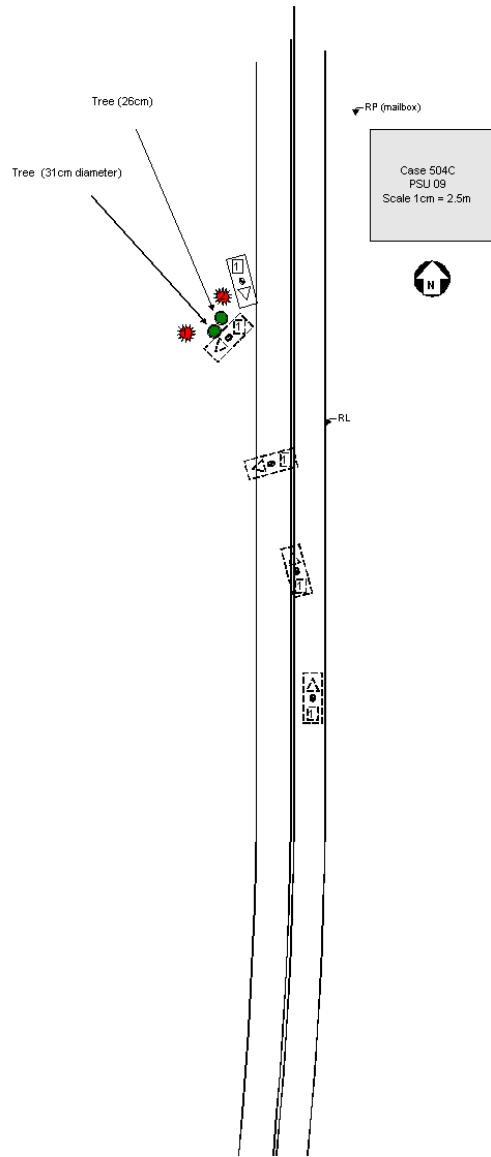
V1, a 1999 Saturn SL was traveling northbound on a two-lane, two-way roadway that curved left. The driver of V1 lost control due to icy roadway conditions. V1 began to rotate counterclockwise and departed the roadway to the left. V1 contacted two trees with its right plane. At some point after impact, a fire began, which then engulfed the entire vehicle. V1 was towed due to damage. The driver was transported due to incapacitating injuries, and admitted overnight. A 2 year old right rear occupant was secured in a 5-point, forward facing child safety seat. The child was transported, treated and released. A child seat interview was obtained; however, a seat inspection was not possible as the safety seat was destroyed in the fire. )

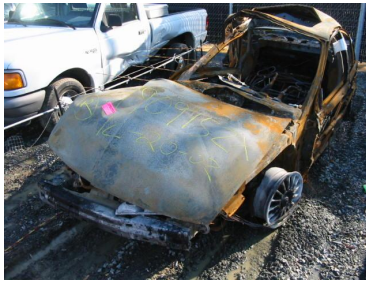
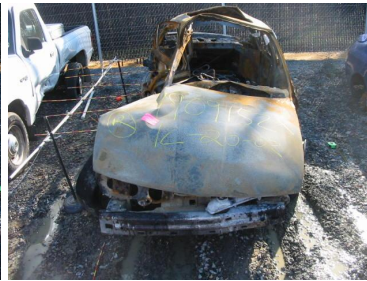
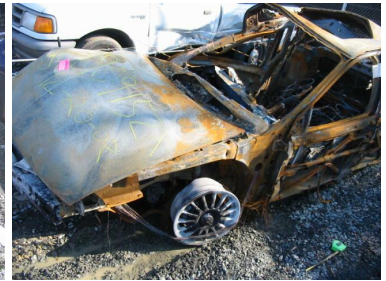
Occupant: 2002-9-504-1-1

Fire Occurrence	Major fire
Fire Origin	9
Location of Fuel Leakage	No fuel leakage
Type of Fuel Tank	Non-metallic
Fuel Tank Location	Forward of rear axle, centered
Fuel Cap Location	Left side, behind rear axle
Fuel Tank Damage	No damage
Fuel Type	Gasoline

Nr. Quarter Turns	No rollover
Impact Speed	999
Total, Longitudal, and Lateral $\delta V$	999 999 999
Est. $\delta V$ with sequence number	SEVERE 2
CDC	2 R 9 A 9 3
Damage (C1-C6)	0 0 0 0 0 0
Crush (L and D)	0 0
Object Contacted 1	LARGE TREE
Object Contacted 2	LARGE TREE

AIS Level	Injury Description	Contacts
3=Serious	Radial fracture, open/displaced/comminuted	Unknown SOURCE
1=Minor	Teeth fracture	Unknown SOURCE

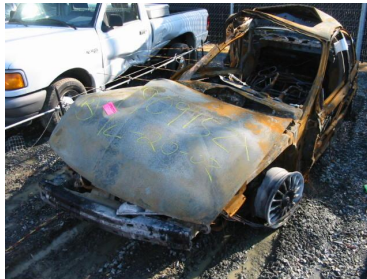
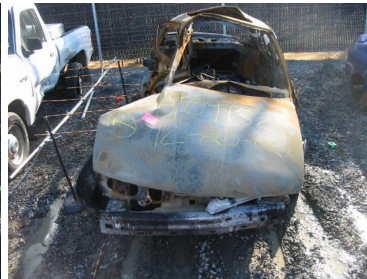
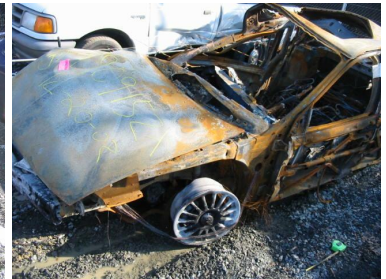
Occupant: 2002-9-504-1-2

Fire Occurrence	Major fire
Fire Origin	9
Location of Fuel Leakage	No fuel leakage
Type of Fuel Tank	Non-metallic
Fuel Tank Location	Forward of rear axle, centered
Fuel Cap Location	Left side, behind rear axle
Fuel Tank Damage	No damage
Fuel Type	Gasoline

Nr. Quarter Turns	No rollover
Impact Speed	999
Total, Longitudal, and Lateral $\delta V$	999 999 999
Est. $\delta V$ with sequence number	SEVERE 2
CDC	2 R 9 A 9 3
Damage (C1-C6)	0 0 0 0 0 0
Crush (L and D)	0 0
Object Contacted 1	LARGE TREE
Object Contacted 2	LARGE TREE

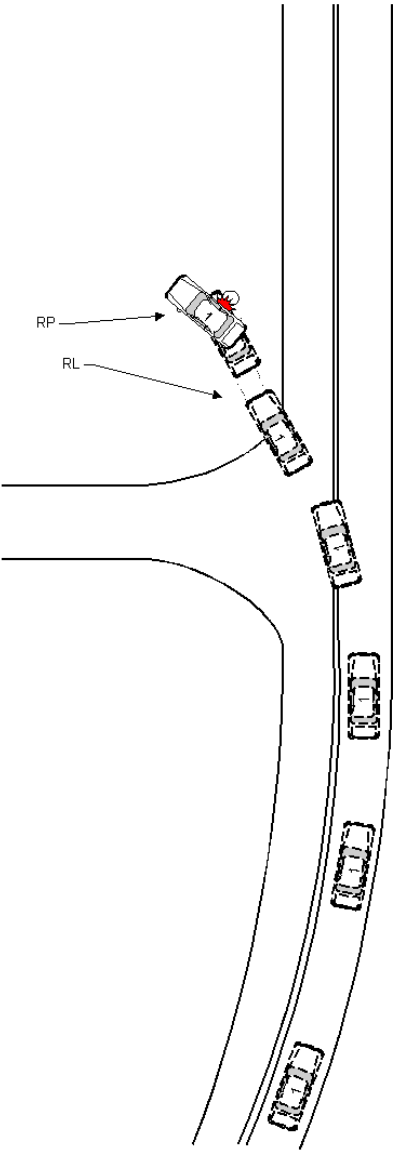
CASE 053E  
PSU 11  
50mph  
1cm=2.5m

V1, a 2002 Pontiac Grand Prix was traveling east on a two lane, non-physically divided two way, bituminous, highly traveled rural roadway. V1 went off road to the left and contacted a tree with its right side. V1 ran over two smaller trees before coming to final rest. V1 was towed due to disabling damage. The lone occupant of V1 was transported and hospitalized due to injuries received during crash. )

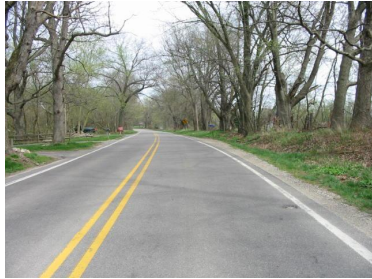
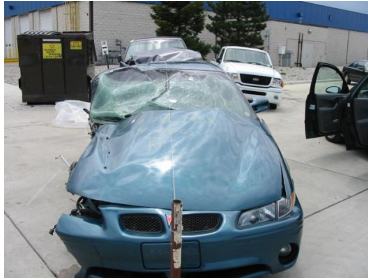
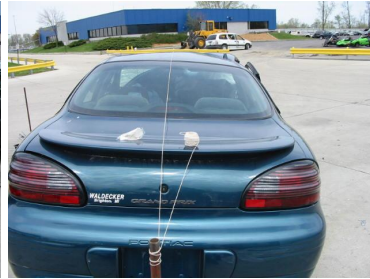
**Occupant: 2002-11-53-1-1**

Nr. Quarter Turns	No rollover
Impact Speed	998
Total, Longitudal, and Lateral $\delta V$	25 -24 -9
Est. $\delta V$ with sequence number	DELTA V CODED 1
CDC	1 R Y A W 3
Damage (C1-C6)	2 21 29 17 16 0
Crush (L and D)	230 94
Object Contacted 1	LARGE TREE
Object Contacted 2	LARGE TREE

AIS Level	Injury Description	Contacts
1=Minor	Upper extremity skin abrasion	Belt webb/buckle
1=Minor	Upper extremity skin contusion	Belt webb/buckle
1=Minor	Leg skin contusion (hematoma)	Knee bolster
1=Minor	Abdominal skin contusion	Belt webb/buckle
1=Minor	Abdominal skin abrasion	Belt webb/buckle
1=Minor	Leg skin abrasion	Knee bolster
4=Severe	Intracerebral hematoma, small (<30ccs)	Other noncontact
2=Moderate	Cervical transverse process fracture, no cord injury	Other noncontact
3=Serious	Cerebral contusion, single, small (<30ccs)	Other noncontact
3=Serious	Thoracic cavity injury NFS, with hemo-/pneumothorax	Belt webb/buckle
2=Moderate	Splenic contusion, minor (<501=Minor	Facial skin abrasion
Air bag-DR side		
1=Minor	Facial skin contusion	Air bag-DR side

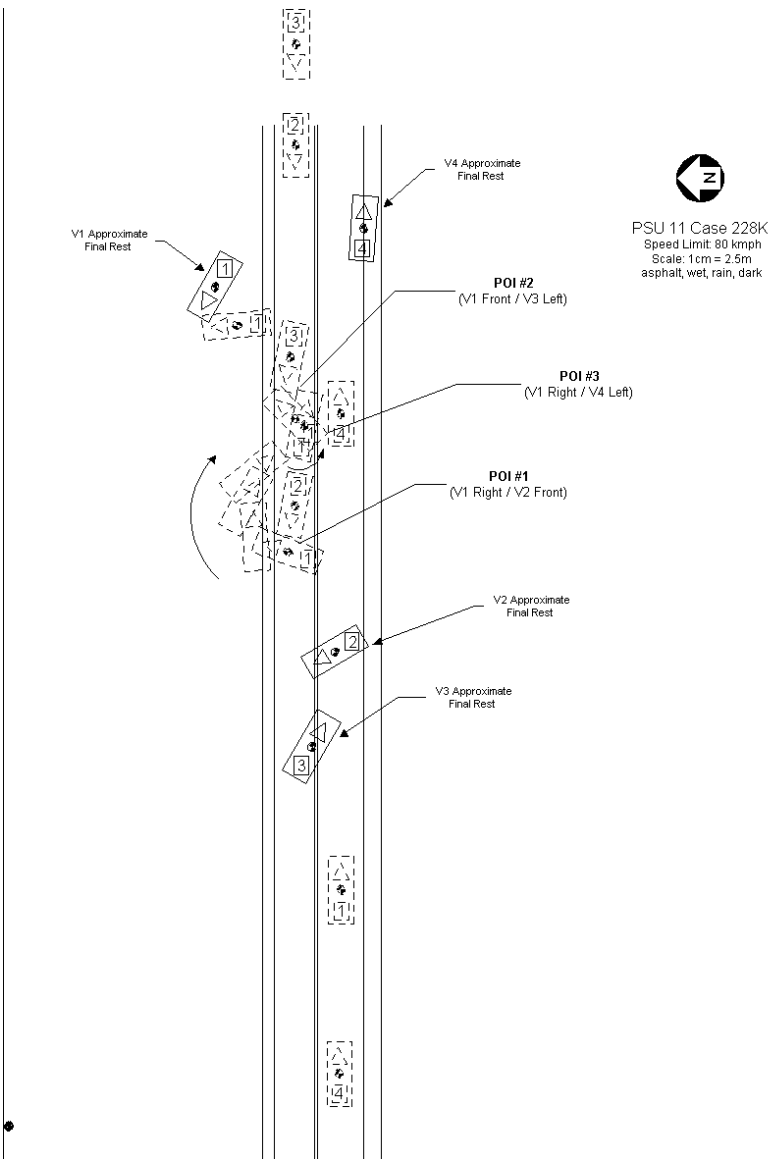
V1 and V4 were traveling eastbound on a two lane, two way, undivided roadway. V2 and V3 were traveling westbound on the same roadway. V1 began to rotate CCW and entered the westbound lane, across the path of V2. As V1 entered the westbound lane, the right side surface was impacted by the frontal area of V2, which resulted in severe damage to both vehicles. As a result of the initial impact, V1 was re-directed in a CW rotation, and subsequently across the path of V3. As V1 continued into the westbound lane, the front left area impacted the left side surface of V3, which resulted in moderate damage to both vehicles. At this point, V1 was (again) re-directed in a CCW rotation as the right rear side surface impacted the left side surface of V4, resulting in minor damage to both vehicles. Vehicle 1 came to rest off the north pavement edge facing northwest. Vehicle 2 and vehicle 3 came to rest in the roadway facing northwest and southeast, respectively. Vehicle 4 came to rest off the south pavement edge facing east. Vehicles 1, 2 and 3 were towed due to damage. The occupants of vehicles 1, 2 and 3 were transported due to injuries. V4 was not towed and the driver was not transported. )

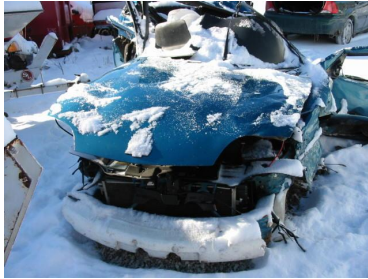
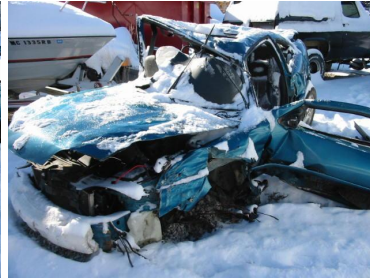
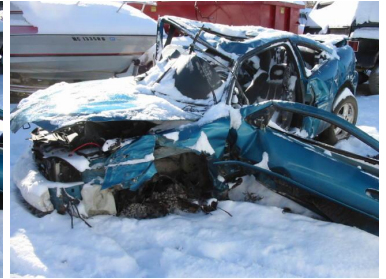
Occupant: 2002-11-228-1-1

Fire Occurrence	No fire
Fire Origin	No fire
Location of Fuel Leakage	No fuel leakage
Type of Fuel Tank	Metallic
Fuel Tank Location	Forward of rear axle, centered
Fuel Cap Location	Right side, behind rear axle
Fuel Tank Damage	Deformed
Fuel Type	Gasoline

AIS Level	Injury Description	Contacts
1=Minor	Scalp abrasion	Head restraint
1=Minor	Upper extremity skin abrasion	Air bag-DR side
1=Minor	Upper extremity skin laceration NFS	Left apnel
1=Minor	Leg skin abrasion	Knee bolster
1=Minor	Upper extremity skin abrasion	Left apnel
4=Severe	Splenic laceration, major (segmental injury, no hilar injury)	Belt webb/buckle
2=Moderate	Humeral fracture NFS	Left interior
3=Serious	450211	Seat, back
4=Severe	Lung contusion, bilateral	Belt webb/buckle

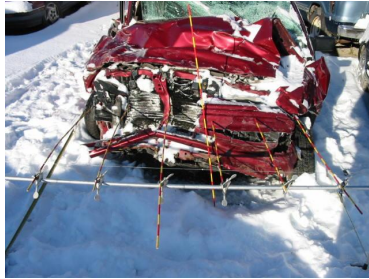
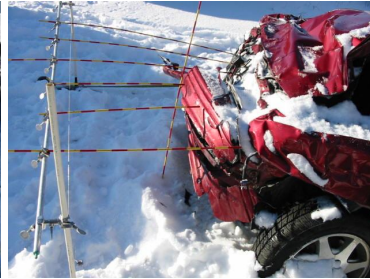
Occupant: 2002-11-228-2-1

Fire Occurrence	No fire
Fire Origin	No fire
Location of Fuel Leakage	No fuel leakage
Type of Fuel Tank	Metallic
Fuel Tank Location	Forward of rear axle, centered
Fuel Cap Location	Left side, behind rear axle
Fuel Tank Damage	No damage
Fuel Type	Gasoline

AIS Level	Injury Description	Contacts
1=Minor	Thoracic skin contusion	Belt webb/buckle
1=Minor	Thoracic skin abrasion	Belt webb/buckle
1=Minor	Leg skin laceration NFS	Center panel
2=Moderate	Fibular head, neck, or shaft fracture	Center panel
2=Moderate	Tibial fracture medial malleolus, open/displaced/comminuted	Floor
2=Moderate	Ankle joint dislocation NFS	Floor
2=Moderate	Pelvic fracture, closed	Left apnel
2=Moderate	Sternal fracture	Belt webb/buckle
2=Moderate	Rib cage fracture NFS	Belt webb/buckle
2=Moderate	Splenic laceration, minor (tear<3cms deep, no major vessel)	Belt webb/buckle
5=Critical	Massive hepatic injury (>50

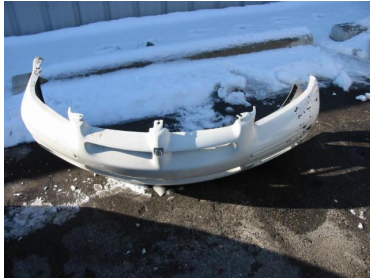
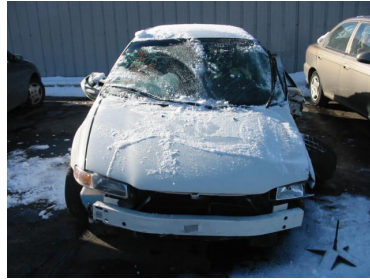
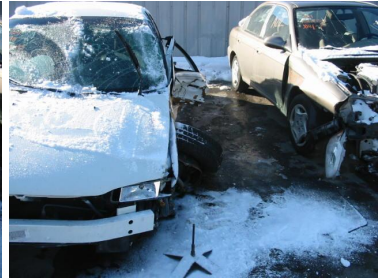
Occupant: 2002-11-228-3-1

Fire Occurrence	No fire
Fire Origin	No fire
Location of Fuel Leakage	No fuel leakage
Type of Fuel Tank	Non-metallic
Fuel Tank Location	Forward of rear axle, centered
Fuel Cap Location	Left side, behind rear axle
Fuel Tank Damage	No damage
Fuel Type	Gasoline

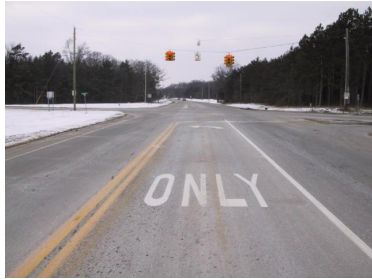
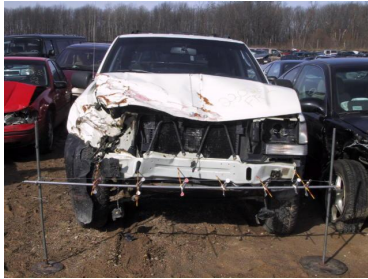
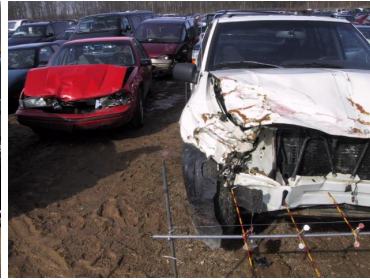
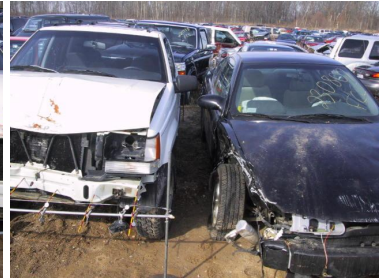
**Occupant: 2002-13-14-1-1**

Fire Occurrence	No fire
Fire Origin	No fire
Location of Fuel Leakage	No fuel leakage
Type of Fuel Tank	Metallic
Fuel Tank Location	Behind rear axle, centered
Fuel Cap Location	Left side, behind rear axle
Fuel Tank Damage	No damage
Fuel Type	Gasoline

AIS Level	Injury Description	Contacts
1=Minor	Upper extremity skin contusion	Belt webb/buckle
1=Minor	Thoracic skin contusion	Belt webb/buckle

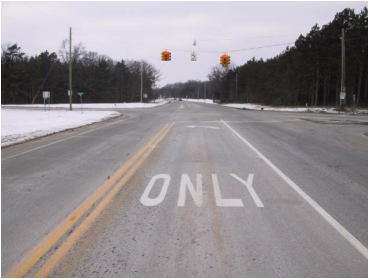
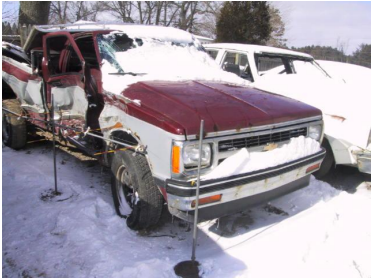
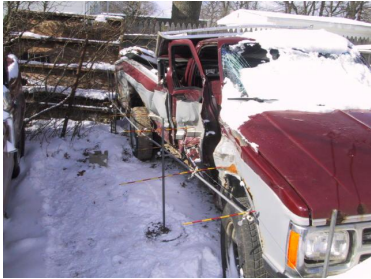
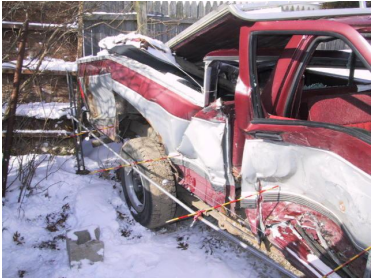
Occupant: 2002-13-14-2-1

Fire Occurence	No fire
Fire Origin	No fire
Location of Fuel Leakage	No fuel leakage
Type of Fuel Tank	Metallic
Fuel Tank Location	Forward of rear axle, left side
Fuel Cap Location	Left side, forward rear axle
Fuel Tank Damage	No damage
Fuel Type	Gasoline

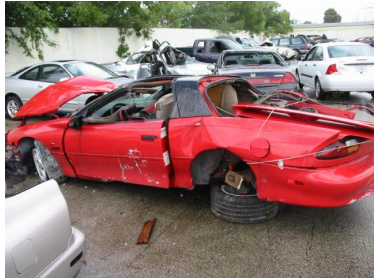
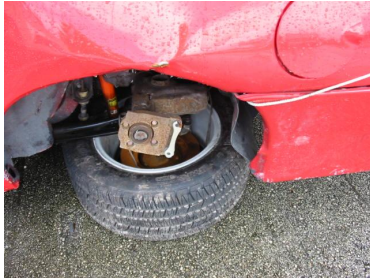
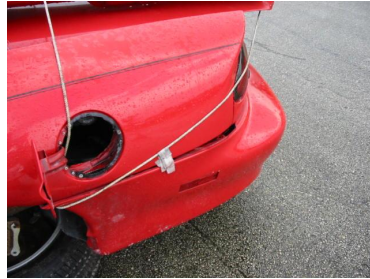
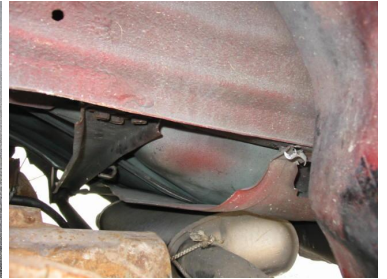
**Occupant: 2002-41-52-1-1**

Fire Occurrence	No fire
Fire Origin	No fire
Location of Fuel Leakage	No fuel leakage
Type of Fuel Tank	Metallic
Fuel Tank Location	Behind rear axle, centered
Fuel Cap Location	Left side, behind rear axle
Fuel Tank Damage	No damage
Fuel Type	Gasoline

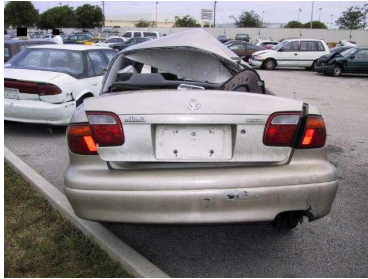
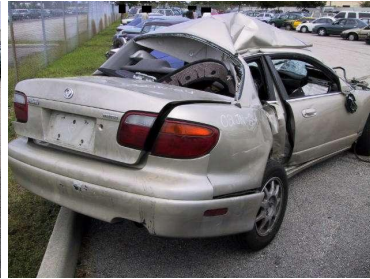
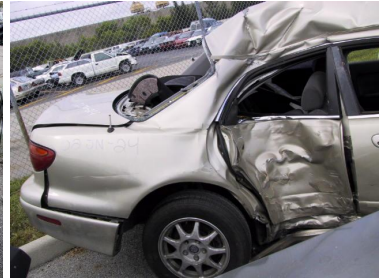
Occupant: 2002-41-55-1-1

Fire Occurrence	No fire
Fire Origin	No fire
Location of Fuel Leakage	No fuel leakage
Type of Fuel Tank	Non-metallic
Fuel Tank Location	Forward of rear axle, centered
Fuel Cap Location	Left side, behind rear axle
Fuel Tank Damage	No damage
Fuel Type	Gasoline

Nr. Quarter Turns	No rollover
Impact Speed	999
Total, Longitudal, and Lateral $\delta V$	999 999 999
Est. $\delta V$ with sequence number	SEVERE 3
CDC	2 R P A W 3
Damage (C1-C6)	0 0 0 0 0 0
Crush (L and D)	0 0
Object Contacted 1	LARGE TREE
Object Contacted 2	VEHICLE NO. 2

AIS Level	Injury Description	Contacts
1=Minor	251090	Air bag-DR side
1=Minor	Thoracic skin abrasion	Belt webb/buckle
1=Minor	Facial skin laceration, minor	Flying glass
1=Minor	Upper extremity skin contusion	Seat, back
3=Serious	Thoracic cord contusion, transient neuro signs&fx&dislocatio	Seat, back
3=Serious	Thoracic facet fracture without cord injury	Seat, back
3=Serious	Thoracic lamina fracture without cord injury	Seat, back

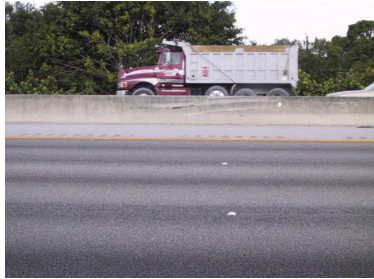
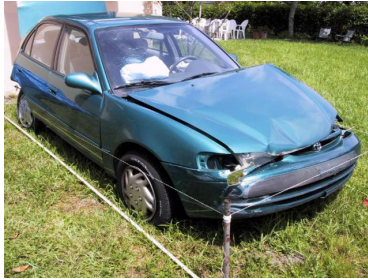
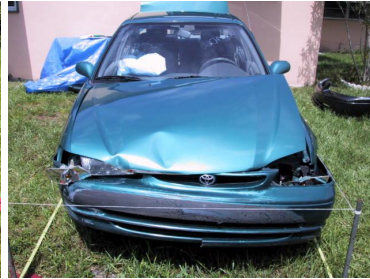
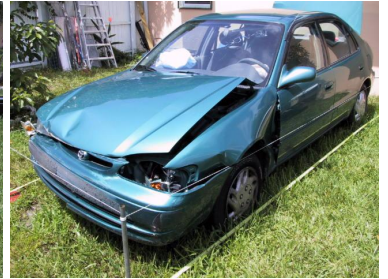
**Occupant: 2002-41-55-2-1**

Fire Occurrence	No fire
Fire Origin	No fire
Location of Fuel Leakage	No fuel leakage
Type of Fuel Tank	Non-metallic
Fuel Tank Location	Forward of rear axle, left side
Fuel Cap Location	Left side, behind rear axle
Fuel Tank Damage	No damage
Fuel Type	Gasoline

Nr. Quarter Turns	No rollover
Impact Speed	998
Total, Longitudal, and Lateral $\delta V$	25 25 4
Est. $\delta V$ with sequence number	DELTA V CODED 1
CDC	6 B Z E W 5
Damage (C1-C6)	0 4 16 29 46 66
Crush (L and D)	140 34
Object Contacted 1	VEHICLE NO. 1
Object Contacted 2	WALL

AIS Level	Injury Description	Contacts
-----------	--------------------	----------

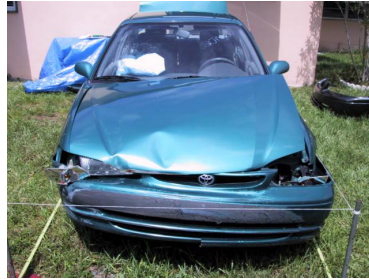
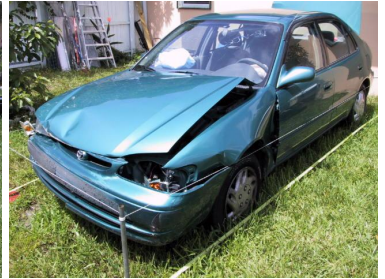
**Occupant: 2002-41-55-2-2**

Fire Occurrence	No fire
Fire Origin	No fire
Location of Fuel Leakage	No fuel leakage
Type of Fuel Tank	Non-metallic
Fuel Tank Location	Forward of rear axle, left side
Fuel Cap Location	Left side, behind rear axle
Fuel Tank Damage	No damage
Fuel Type	Gasoline

Nr. Quarter Turns	No rollover
Impact Speed	998
Total, Longitudal, and Lateral $\delta V$	25 25 4
Est. $\delta V$ with sequence number	DELTA V CODED 1
CDC	6 B Z E W 5
Damage (C1-C6)	0 4 16 29 46 66
Crush (L and D)	140 34
Object Contacted 1	VEHICLE NO. 1
Object Contacted 2	WALL

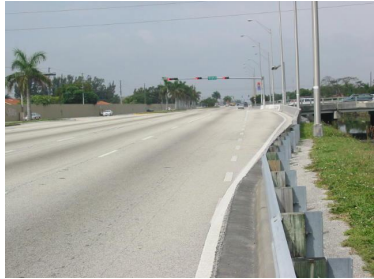
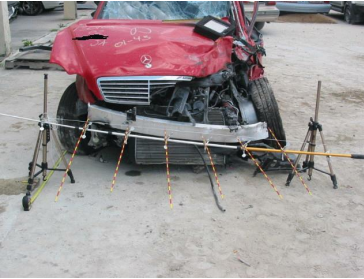
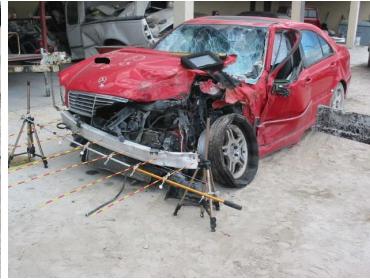
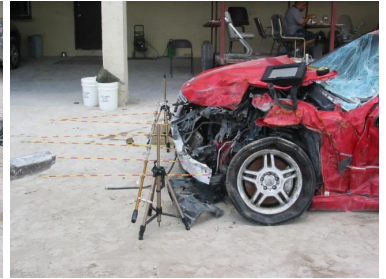
Occupant: 2002-42-22-1-1

Fire Occurrence	No fire
Fire Origin	No fire
Location of Fuel Leakage	No fuel leakage
Type of Fuel Tank	Non-metallic
Fuel Tank Location	Behind rear axle, right side
Fuel Cap Location	Right side, behind rear axle
Fuel Tank Damage	No damage
Fuel Type	Gasoline

Nr. Quarter Turns	No rollover
Impact Speed	998
Total, Longitudal, and Lateral $\delta V$	24 -19 16
Est. $\delta V$ with sequence number	DELTA V CODED 1
CDC	11 F L E W 2
Damage (C1-C6)	36 17 11 8 7 10
Crush (L and D)	160 -30
Object Contacted 1	VEHICLE NO. 2
Object Contacted 2	CONCRETE BARRIER

AIS Level	Injury Description	Contacts
1=Minor	Neck skin contusion (hematoma)	Belt webb/buckle
1=Minor	Upper extremity skin contusion	Belt webb/buckle
1=Minor	Neck skin abrasion	Belt webb/buckle
1=Minor	Upper extremity skin abrasion	Belt webb/buckle
1=Minor	Upper extremity skin laceration, minor	Left interior
1=Minor	Upper extremity skin laceration, minor	Windshield
1=Minor	Leg skin laceration, minor	Left hardware
1=Minor	Leg skin avulsion, superficial (<100cms2)	Center panel
1=Minor	Leg skin contusion (hematoma)	Knee bolster
1=Minor	Leg skin contusion (hematoma)	Left hardware

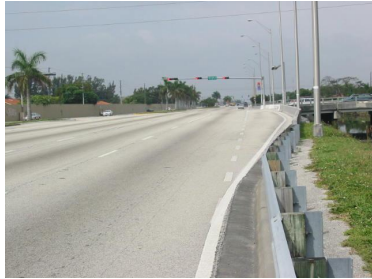
**Occupant: 2002-42-22-2-1**

Fire Occurrence	No fire
Fire Origin	No fire
Location of Fuel Leakage	No fuel leakage
Type of Fuel Tank	Non-metallic
Fuel Tank Location	Forward of rear axle, left side
Fuel Cap Location	Left side, behind rear axle
Fuel Tank Damage	No damage
Fuel Type	Gasoline

Nr. Quarter Turns	No rollover
Impact Speed	998
Total, Longitudal, and Lateral $\delta V$	14 -11 -9
Est. $\delta V$ with sequence number	DELTA V CODED 1
CDC	1 R F E W 4
Damage (C1-C6)	7 7 21 36 62 63
Crush (L and D)	94 128
Object Contacted 1	VEHICLE NO. 1
Object Contacted 2	0

AIS Level	Injury Description	Contacts
1=Minor	Facial skin abrasion	Air bag-DR side
1=Minor	Abdominal skin abrasion	Transmiss lever
1=Minor	Thoracic skin abrasion	Belt webb/buckle
3=Serious	Radial fracture, open/displaced/comminuted	Steering rim
2=Moderate	Ulnar fracture, closed	Steering rim
2=Moderate	Fibular head, neck, or shaft fracture	Knee bolster
2=Moderate	Tibial fracture of the posterior malleolus	Floor
3=Serious	Tibial shaft fracture, open/displaced/comminuted	Floor

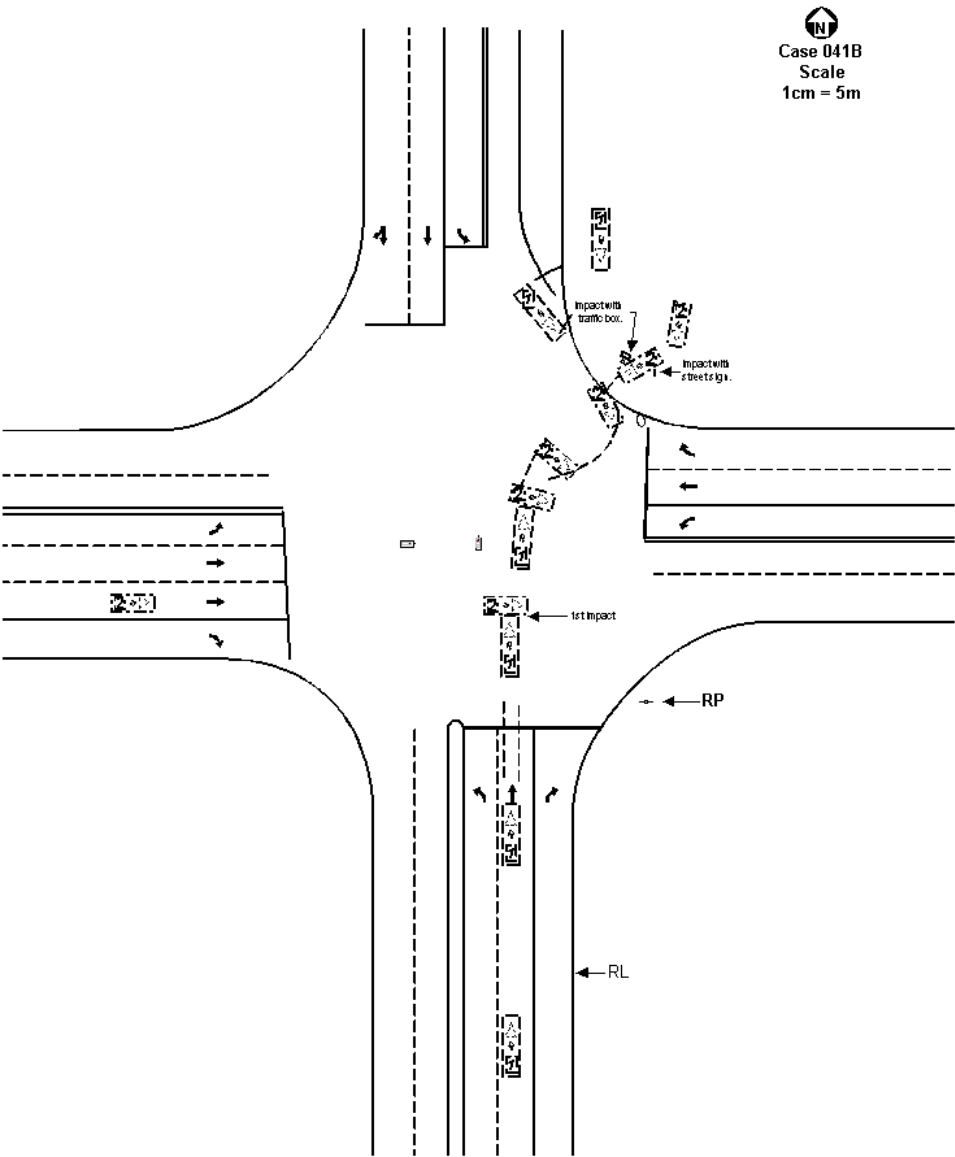
Vehicle one, a 2001 Ford F-250, was traveling north on a five lane, divided, roadway entering a four-leg intersection. Vehicle two, 1996 Saturn SC2, was traveling east on a 6-lane, undivided road way entering the same intersection. The front plane of V1 impacted the right plane of V2. After the initial impact, V2 struck a sign post with its right plane and a traffic box with its back plane, coming to rest at the NE shoulder facing south. V1 came to rest at the north east shoulder facing south after striking a curb with its left wheels. Both vehicles were towed due to damage. The driver of vehicle one was not injured. The front right occupant of V1 sustained a moderate injury and received treatment later at the ER. The driver of vehicle two sustained an incapacitating injury and was hospitalized for eleven days. The front right passenger of vehicle two sustained fatal injuries. The 8 month old left rear occupant was seated in an unknown model of infant child restraint and sustained an incapacitating injury and was transported and hospitalized for twelve days prior to transfer to another facility for treatment. EMS on scene cut the vehicles safety belt securing the car seat to the vehicle, indicated the seat had incurred no obvious deformation, and transported the child to the hospital in the seat. The seat was not available for inspection. )

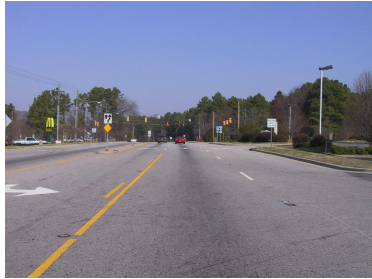
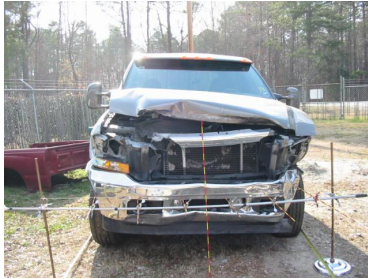
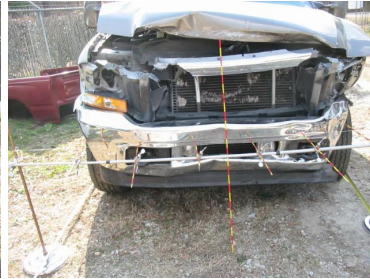
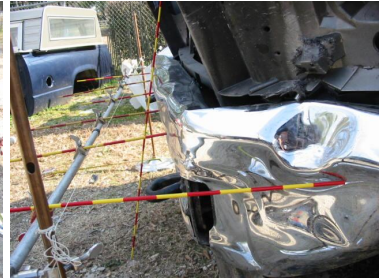
**Occupant: 2002-43-41-1-1**

Fire Occurrence	No fire
Fire Origin	No fire
Location of Fuel Leakage	No fuel leakage
Type of Fuel Tank	Metallic
Fuel Tank Location	Forward of rear axle, left side
Fuel Cap Location	Left side, forward rear axle
Fuel Tank Damage	No damage
Fuel Type	Gasoline

Nr. Quarter Turns	No rollover
Impact Speed	998
Total, Longitudal, and Lateral $\delta V$	17 -13 11
Est. $\delta V$ with sequence number	DELTA V CODED 1
CDC	11 F D E W 2
Damage (C1-C6)	29 11 10 9 7 14
Crush (L and D)	164 0
Object Contacted 1	VEHICLE NO. 2
Object Contacted 2	CURB

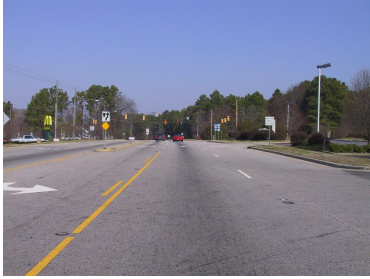
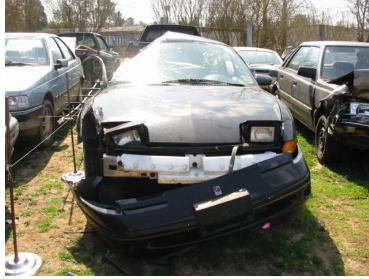
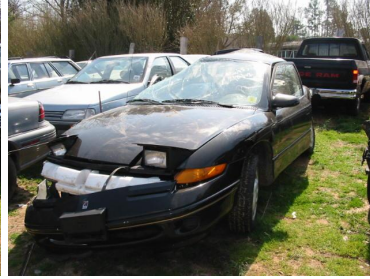
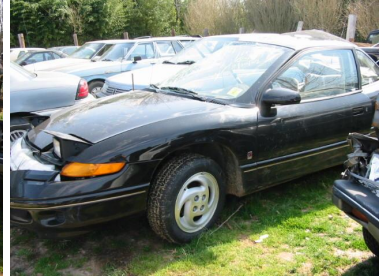
**Occupant: 2002-43-41-2-1**

Fire Occurrence	No fire
Fire Origin	No fire
Location of Fuel Leakage	No fuel leakage
Type of Fuel Tank	Non-metallic
Fuel Tank Location	Forward of rear axle, left side
Fuel Cap Location	Left side, behind rear axle
Fuel Tank Damage	No damage
Fuel Type	Gasoline

Nr. Quarter Turns	No rollover
Impact Speed	998
Total, Longitudal, and Lateral $\delta V$	39 -25 -30
Est. $\delta V$ with sequence number	DELTA V CODED 1
CDC	2 R Z A W 4
Damage (C1-C6)	0 45 60 13 22 0
Crush (L and D)	253 -53
Object Contacted 1	VEHICLE NO. 1
Object Contacted 2	Oth FIXED OBJECT

AIS Level	Injury Description	De-	Contacts
2=Moderate	Hepatic laceration, minor (<3cms deep, EBL<202=	Moderate	Hepatic contusion, minor (subcapsular, at 503=
Lung contusion, unilateral	Other occupants		
4=Severe	>3 rib fx on one side & <3 other side & hemo-/pneumothorax		Other occupants
1=Minor	Leg skin contusion (hematoma)		Steering column
1=Minor	Upper extremity skin contusion		Left A pillar

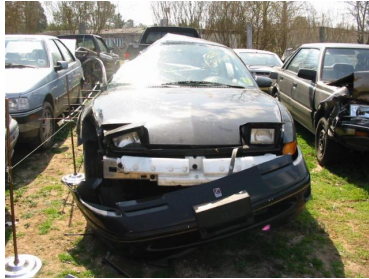
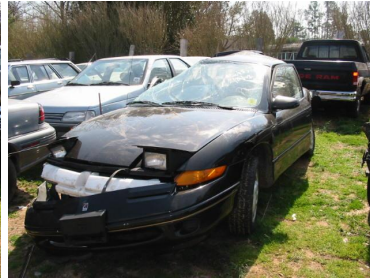
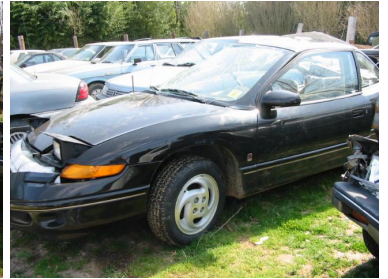
## Occupant: 2002-43-41-2-2

Fire Occurrence	No fire
Fire Origin	No fire
Location of Fuel Leakage	No fuel leakage
Type of Fuel Tank	Non-metallic
Fuel Tank Location	Forward of rear axle, left side
Fuel Cap Location	Left side, behind rear axle
Fuel Tank Damage	No damage
Fuel Type	Gasoline

Nr. Quarter Turns	No rollover
Impact Speed	998
Total, Longitudal, and Lateral $\delta V$	39 -25 -30
Est. $\delta V$ with sequence number	DELTA V CODED 1
CDC	2 R Z A W 4
Damage (C1-C6)	0 45 60 13 22 0
Crush (L and D)	253 -53
Object Contacted 1	VEHICLE NO. 1
Object Contacted 2	Oth FIXED OBJECT

AIS Level	Injury Description	Contacts
1=Minor	Mandible fracture NFS	OMV other front
7=Unk. sev.	Head injury, closed, NFS	OMV other front
2=Moderate	Cervical fracture without cord injury +/- dislocation NFS	Other noncontact
2=Moderate	Humeral fracture NFS	Right windowsill
1=Minor	Teeth fracture	OMV other front
1=Minor	Neck skin abrasion	Belt webb/buckle
1=Minor	Upper extremity skin abrasion	Right interior
1=Minor	Upper extremity skin abrasion	Belt webb/buckle
1=Minor	Upper extremity skin laceration, minor	Right interior
1=Minor	Thoracic skin abrasion	Belt webb/buckle
1=Minor	Upper extremity skin abrasion	Belt webb/buckle
1=Minor	Leg skin abrasion	Transmiss lever
1=Minor	Upper extremity skin abrasion	Transmiss lever
1=Minor	Upper extremity skin contusion	Transmiss lever
1=Minor	Abdominal skin abrasion	Belt webb/buckle

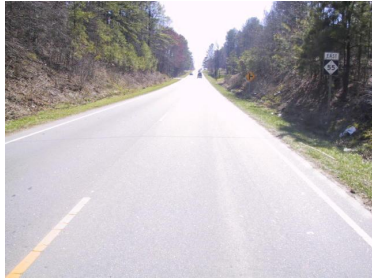
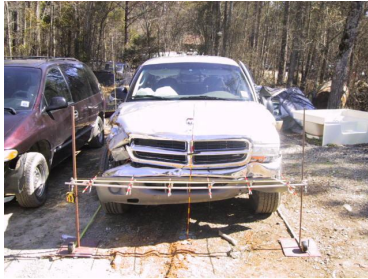
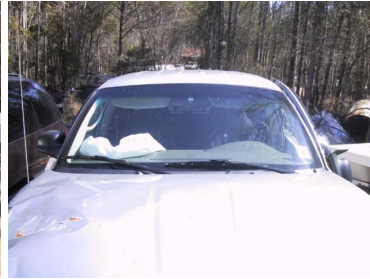
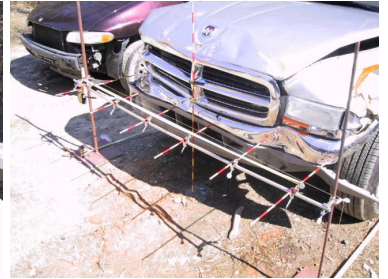
**Occupant: 2002-43-47-1-1**

Fire Occurrence	No fire
Fire Origin	No fire
Location of Fuel Leakage	No fuel leakage
Type of Fuel Tank	Metallic
Fuel Tank Location	Forward of rear axle, left side
Fuel Cap Location	Left side, forward rear axle
Fuel Tank Damage	No damage
Fuel Type	Gasoline

AIS Level	Injury Description	Contacts
3=Serious	Humeral fracture, open/displaced/comminuted	Steering comb
2=Moderate	Shoulder dislocation (glenohumeral joint)	Steering comb

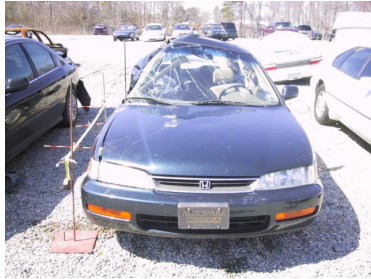
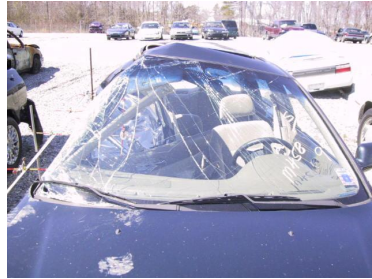
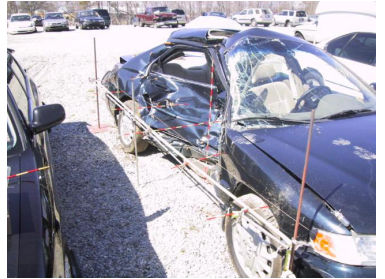
**Occupant: 2002-43-47-2-1**

Fire Occurrence	No fire
Fire Origin	No fire
Location of Fuel Leakage	No fuel leakage
Type of Fuel Tank	Metallic
Fuel Tank Location	Forward of rear axle, left side
Fuel Cap Location	Left side, behind rear axle
Fuel Tank Damage	No damage
Fuel Type	Gasoline

Nr. Quarter Turns	No rollover
Impact Speed	998
Total, Longitudal, and Lateral $\delta V$	42 -7 -41
Est. $\delta V$ with sequence number	DELTA V CODED 2
CDC	3 R P A W 4
Damage (C1-C6)	0 2 50 67 9 0
Crush (L and D)	342 -43
Object Contacted 1	VEHICLE NO. 1
Object Contacted 2	0

AIS Level	Injury Description	Contacts
3=Serious	Hepatic laceration, moderate (>3cms deep, EBL>201=Minor	Teeth fracture
Other noncontact 1=Minor	Thoracic skin contusion	Transmiss lever
1=Minor	Leg skin contusion (hematoma)	Transmiss lever

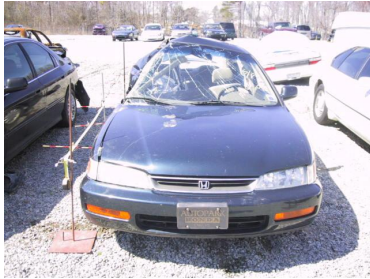
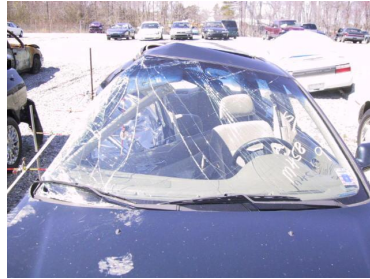
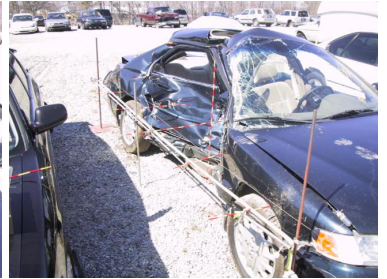
**Occupant: 2002-43-47-2-2**

Fire Occurrence	No fire
Fire Origin	No fire
Location of Fuel Leakage	No fuel leakage
Type of Fuel Tank	Metallic
Fuel Tank Location	Forward of rear axle, left side
Fuel Cap Location	Left side, behind rear axle
Fuel Tank Damage	No damage
Fuel Type	Gasoline

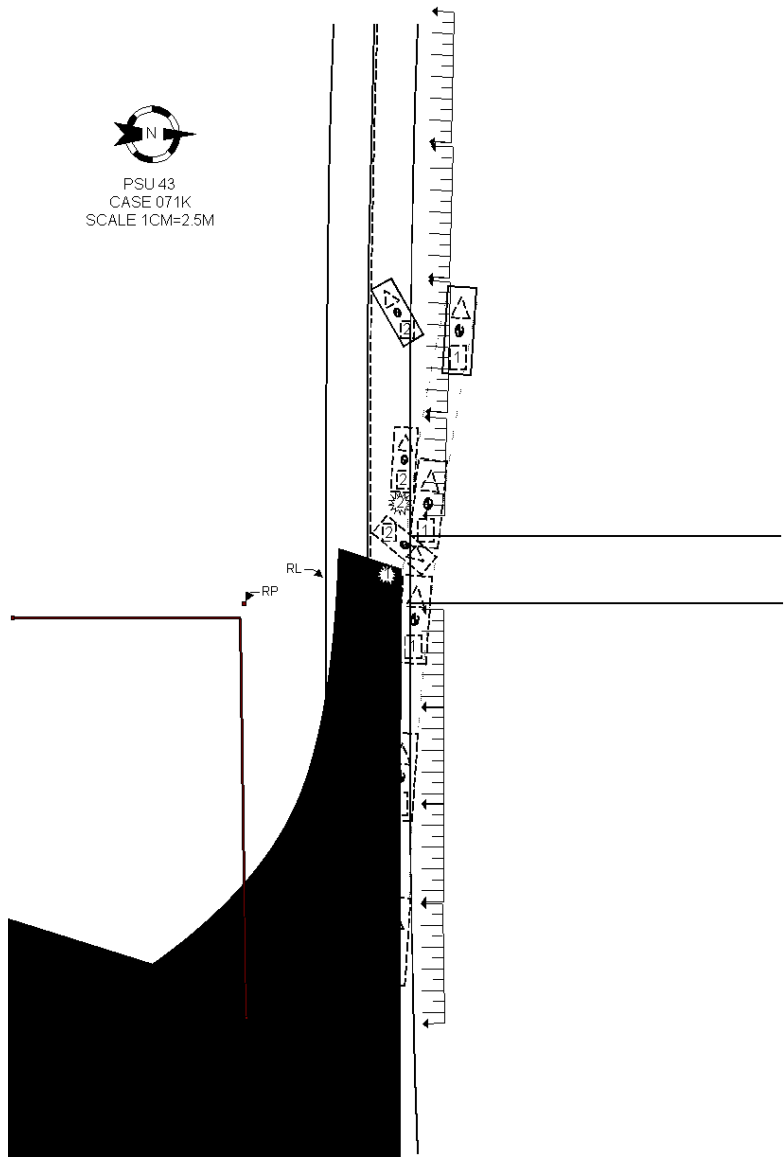
Vehicle 1, a 1999 Ford F250 Crew Cap, was traveling west in lane one of a two-lane, bituminous, level roadway. Vehicle 2, a 1988 Pontiac Sunfire, was traveling east in lane one of the same bituminous roadway. There were no adverse weather conditions and it was dark. V2 turned left onto a private drive. The front of V1 contacted the right side of V2. V2 then side slapped V1 on the left side. V1 came to rest in a ditch off the right side of the road. V2 came to rest in the roadway facing west. The driver of V1 was reported to have sustained "C" injuries but was not transported. The driver of V2 was reported to have "A" injuries and was transported and admitted. The occupant of V2 was reported to have "A" injuries and was transported and admitted. )

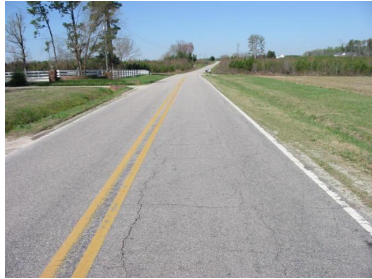
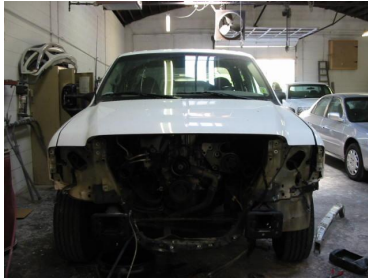
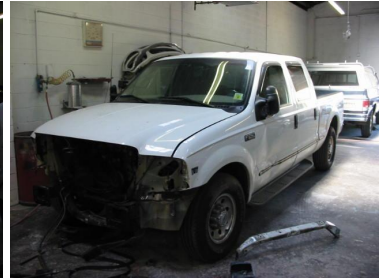
**Occupant: 2002-43-71-1-1**

Fire Occurrence	No fire
Fire Origin	No fire
Location of Fuel Leakage	No fuel leakage
Type of Fuel Tank	Non-metallic
Fuel Tank Location	Forward of rear axle, left side
Fuel Cap Location	Left side, forward rear axle
Fuel Tank Damage	No damage
Fuel Type	Diesel

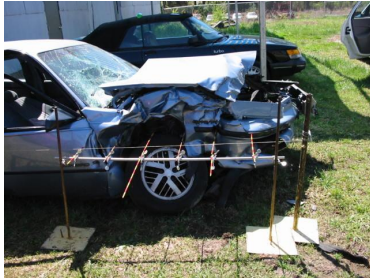
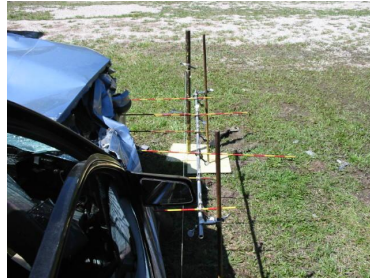
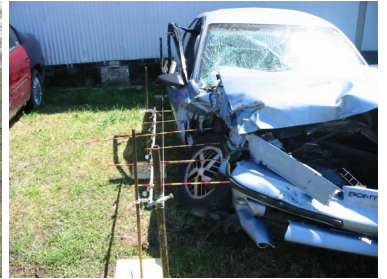
**Occupant: 2002-43-71-2-1**

Nr. Quarter Turns	No rollover
Impact Speed	998
Total, Longitudal, and Lateral $\delta V$	23 -15 -18
Est. $\delta V$ with sequence number	DELTA V CODED 1
CDC	2 R F E W 3
Damage (C1-C6)	0 18 24 26 20 10
Crush (L and D)	114 129
Object Contacted 1	VEHICLE NO. 1
Object Contacted 2	VEHICLE NO. 1

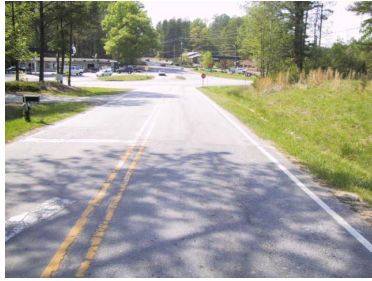
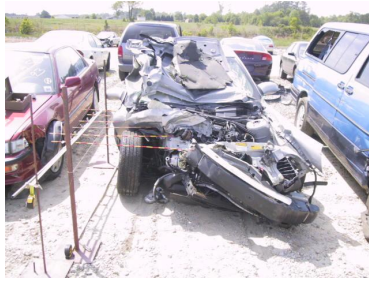
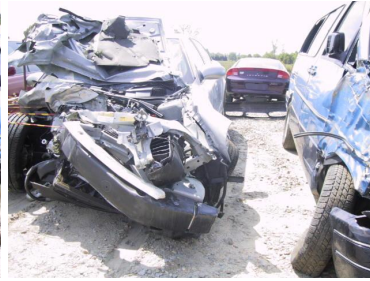
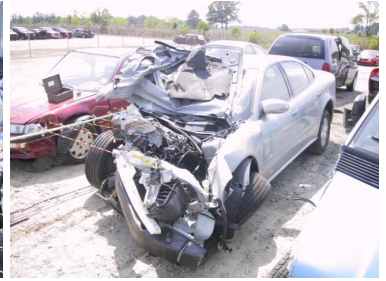
**Occupant: 2002-43-83-1-1**

Nr. Quarter Turns	No rollover
Impact Speed	998
Total, Longitudal, and Lateral $\delta V$	25 -9 -24
Est. $\delta V$ with sequence number	DELTA V CODED 1
CDC	2 R F E W 4
Damage (C1-C6)	0 0 7 44 58 69
Crush (L and D)	112 151
Object Contacted 1	VEHICLE NO. 2
Object Contacted 2	0

AIS Level	Injury Description	Contacts
3=Serious	>3 rib fractures one side & <3 other side, with stable chest	Belt webb/buckle
2=Moderate	752500	Center panel
2=Moderate	Patellar fracture	Knee bolster
1=Minor	Leg skin laceration, minor	Left apnel
1=Minor	Abdominal skin contusion	Belt webb/buckle
1=Minor	Thoracic skin contusion	Belt webb/buckle
1=Minor	Scalp contusion	Mirror
2=Moderate	Small bowel injury NFS	Belt webb/buckle
3=Serious	Lung contusion, uni-lateral	Belt webb/buckle
1=Minor	Neck skin abrasion	Belt webb/buckle
1=Minor	Thoracic skin abrasion	Belt webb/buckle
1=Minor	Leg skin abrasion	Left apnel
1=Minor	Leg skin contusion (hematoma)	Left apnel
1=Minor	Upper extremity skin abrasion	Roof

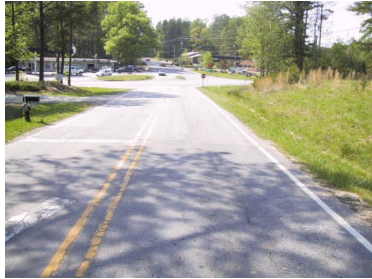
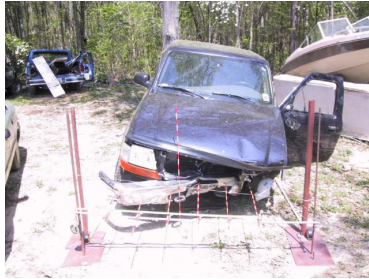
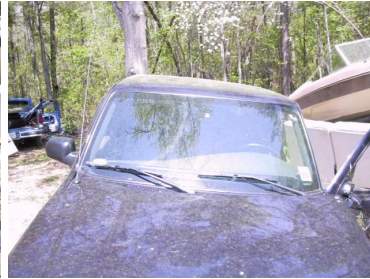
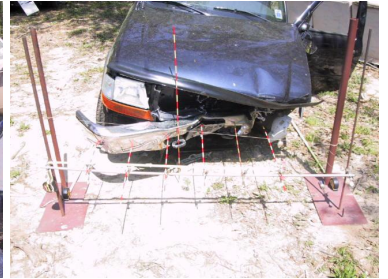
**Occupant: 2002-43-83-2-1**

Nr. Quarter Turns	1 QUARTER TURN
Impact Speed	998
Total, Longitudal, and Lateral $\delta V$	22 -19 11
Est. $\delta V$ with sequence number	DELTA V CODED 1
CDC	11 F L E E 3
Damage (C1-C6)	43 27 22 4 0 0
Crush (L and D)	119 -51
Object Contacted 1	VEHICLE NO. 1
Object Contacted 2	ROLLOVER-OVERTURN

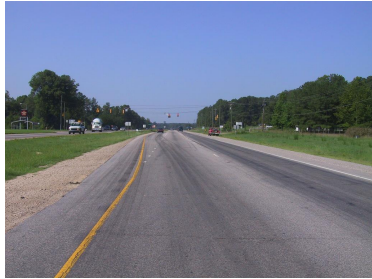
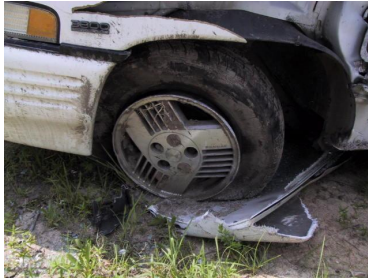
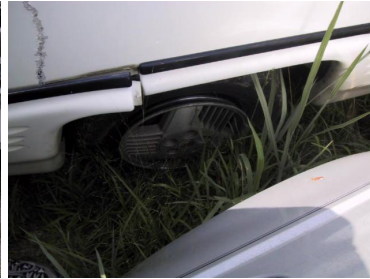
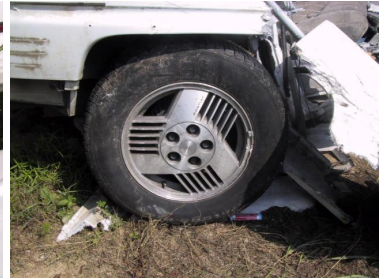
**Occupant: 2002-43-174-1-1**

Nr. Quarter Turns	No rollover
Impact Speed	999
Total, Longitudal, and Lateral $\delta V$	999 999 999
Est. $\delta V$ with sequence number	SEVERE 1
CDC	82 R D A W 6
Damage (C1-C6)	0 24 127 127 24 0
Crush (L and D)	377 3
Object Contacted 1	VEHICLE NO. 2
Object Contacted 2	0

AIS Level	Injury Description	Contacts
1=Minor	Facial skin laceration NFS	Right windowsill
1=Minor	Leg skin laceration NFS	Right interior
1=Minor	Scalp laceration, NFS	Right windowsill
3=Serious	Pelvic fracture, open/displaced/comminuted	Right interior
3=Serious	Sacroiliac fracture	Right interior
2=Moderate	Pelvic fracture, closed	Right interior
2=Moderate	Lumbar fracture of transverse process without cord injury	Right interior
2=Moderate	Fibular head, neck, or shaft fracture	Right interior
3=Serious	853405	Right interior

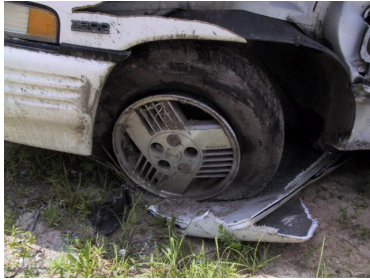
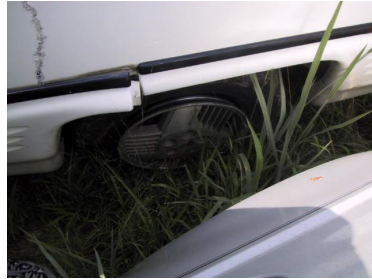
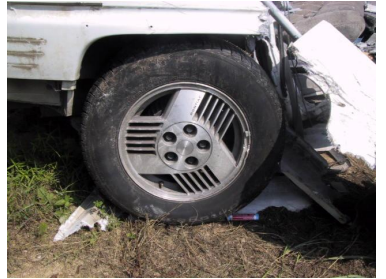
Occupant: 2002-43-174-1-2

Nr. Quarter Turns	No rollover
Impact Speed	999
Total, Longitudal, and Lateral $\delta V$	999 999 999
Est. $\delta V$ with sequence number	SEVERE 1
CDC	82 R D A W 6
Damage (C1-C6)	0 24 127 127 24 0
Crush (L and D)	377 3
Object Contacted 1	VEHICLE NO. 2
Object Contacted 2	0
