# Crash Reports

Prepared by Ken Digges

1 Case 2002-4-70

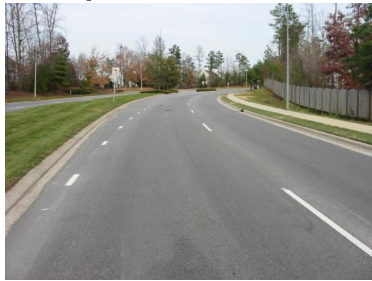
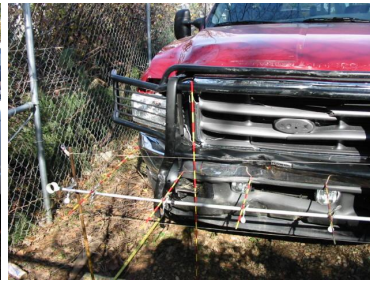
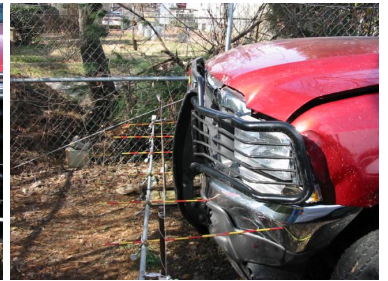
Occupant: 2002-43-287-1-1

Nr. Quarter Turns	No rollover
Impact Speed	999
Total, Longitudal, and Lateral $\delta V$	999 999 999
Est. $\delta V$ with sequence number	>24 AND <40 KMPH 1
CDC	12 F D E W 1
Damage (C1-C6)	0 0 0 0 0 0
Crush (L and D)	0 0
Object Contacted 1	VEHICLE NO. 3
Object Contacted 2	VEHICLE NO. 2

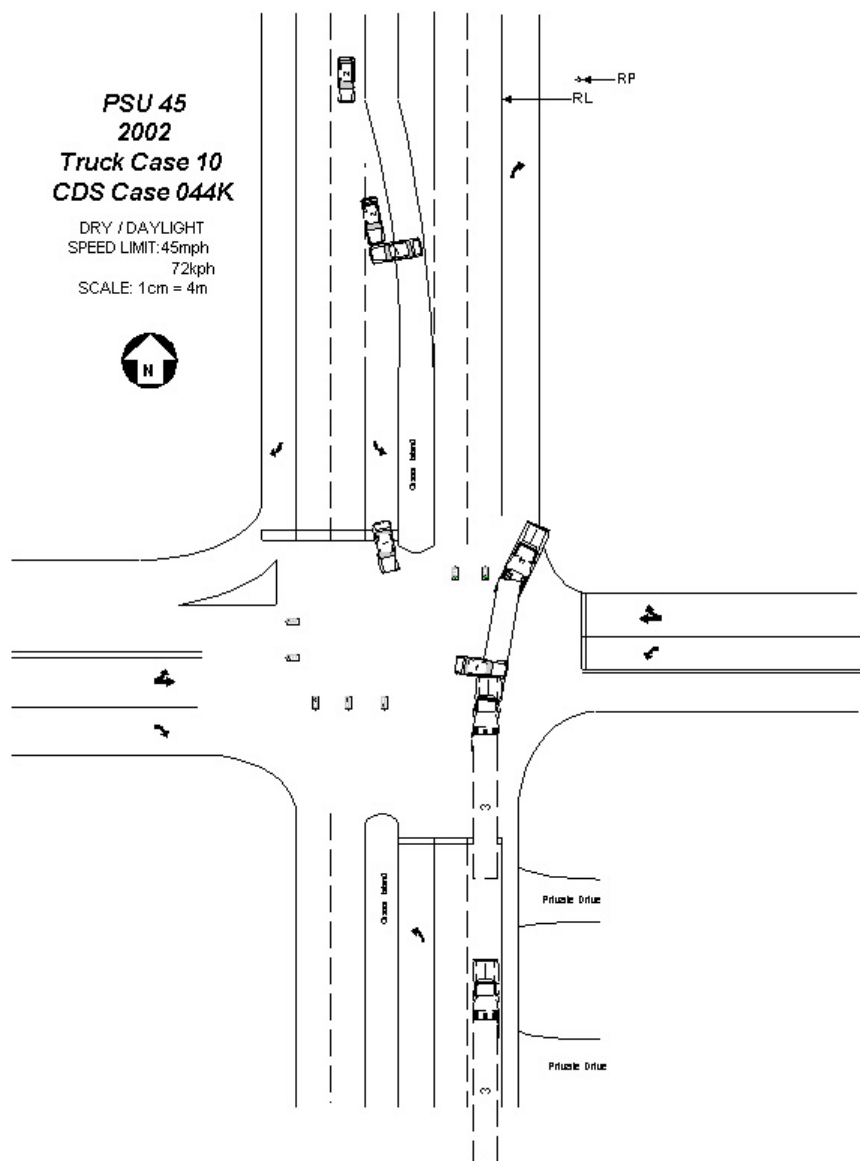
The crash site was an urban four lane north/south median divided highway with left turn lanes. The highway is intersected by a two lane road on the east side and a private drive on the west side. The intersection is controlled by traffic signals. Conditions at the time of the crash were daylight and dry at 2:05pm on a Tuesday afternoon. V1 was a 1997 Pontiac Grand Prix that was stopped southbound in the left turn lane attempting to cross the northbound lanes to go east on the two lane road. V3, a 1998 Volvo conventional tractor with a 48ft semi trailer, was northbound in the right lane. When the traffic light changed from solid green to red V1 attempted to make a left turn and was struck in the right side by V3's front. Although the driver of V1 reports no recollection of the crash it's believed that she assumed traffic traveling northbound encountered a red light at the same time as southbound traffic. The lights are sequenced at the intersection with northbound traffic receiving a green light for 15 seconds longer than southbound traffic. After impact V1 rotated counter clockwise, crossed the grass traffic island and came to final rest 44 meters north of impact in the southbound left turn lane. V1 came to rest facing west with its right side against the front of V2 which was a 1995 Dodge Neon traveling southbound. V3 came to rest facing northeast just north of impact in its original lane. The 30 year old female driver of V1 was belted with non deployed airbags and was hospitalized. She was very familiar with the area and states she has no memory of the crash. V1's driver was charged with failure to yield. Damage to V2 was extremely minor and the driver along with several other witness' agree that V1 turned left on red. V3 was driven by a 35 year old male that was belted and not injured. He reports that he applied his brakes but had minimal time to avoid the crash. The truck was empty at the time of the crash and police inspection of the truck and driver found no violations. )

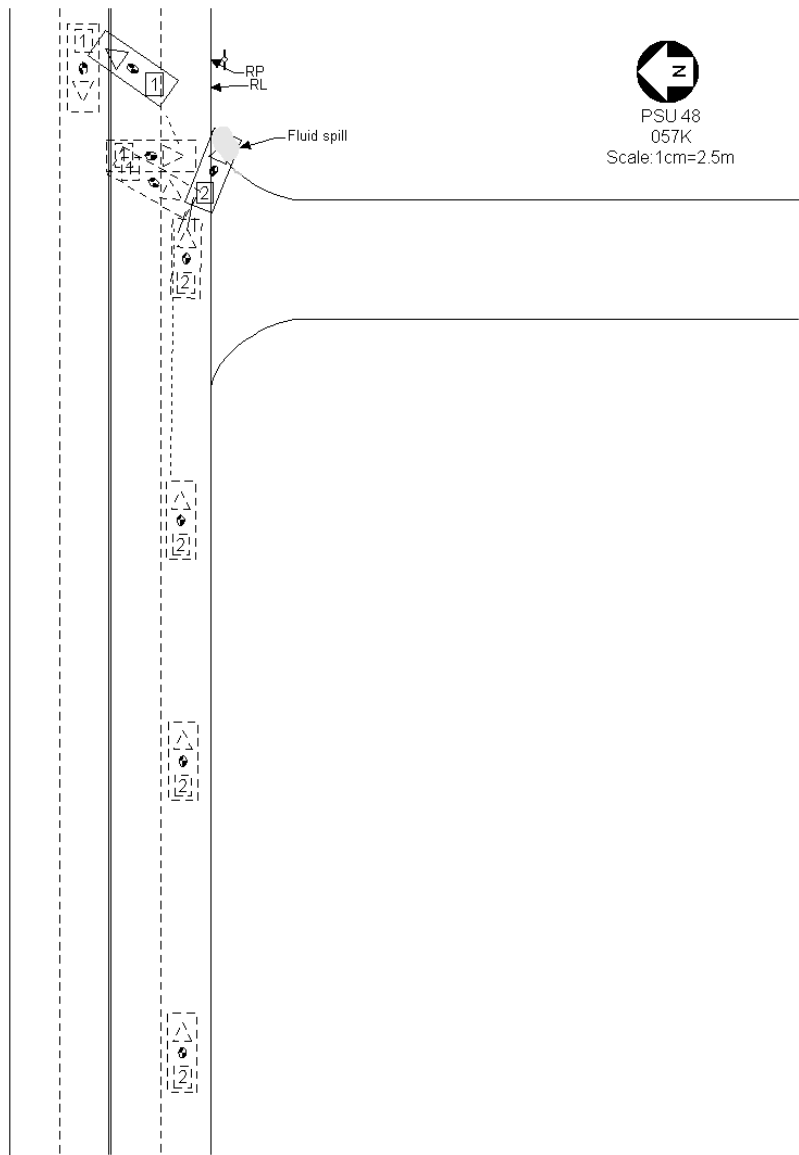
Vehicle 1 (V1) was west bound on a four lane city street turning left into a private drive. Vehicle 2 (V2) was east bound in lane one of the same city street. The roadway was dry and divided by double solid painted lines. As V1 turned, the front of V2 struck the right side of V1. V1 rotated CCW and came to final rest in lane two of the east bound lanes facing northeast. V2 veered off to the right, went over the curb and came to final rest partially off the roadway facing east. Both vehicles were towed due to disabling damage. The restrained driver of V1 was hospitalized with a fractured sternum, pneumothorax, and minor lacerations, abrasions, and bruising. The restrained passenger of V1 was hospitalized overnight for observation and released with a shoulder contusion. The restrained driver of V2 was hospitalized overnight for observation and released with chest contusion and cervical strain. Both front airbags in V2 deployed. )

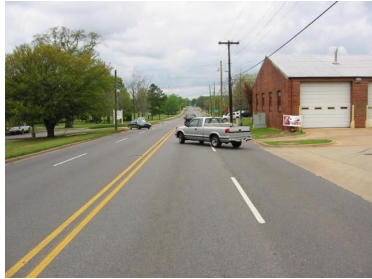
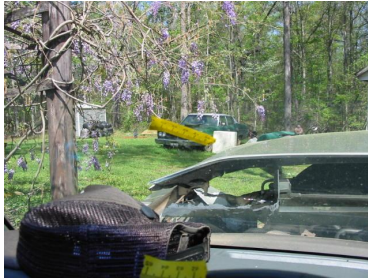
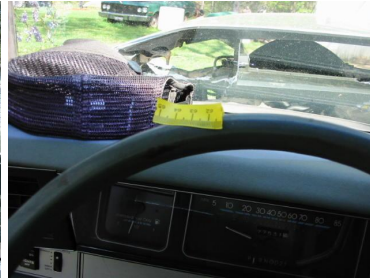
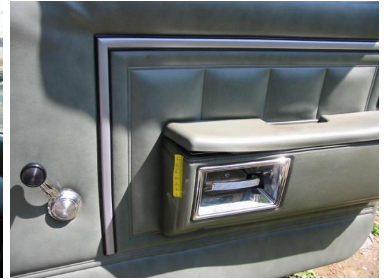
**Occupant: 2002-48-57-1-1**

AIS Level	Injury Description	Contacts
2=Moderate	Sternal fracture	Belt webb/buckle
3=Serious	Thoracic cavity injury NFS, with hemo- /pneumothorax	Belt webb/buckle
2=Moderate	Lethargic on admis- sion, never uncon- scious	Steering rim
1=Minor	Facial skin laceration, minor	Steering rim
1=Minor	Facial skin contusion	Steering rim
1=Minor	297402	Steering rim
1=Minor	297602	Steering rim
1=Minor	Thoracic skin contu- sion	Belt webb/buckle
1=Minor	Thoracic skin lacera- tion, minor	Belt webb/buckle
1=Minor	Upper extremity skin laceration, minor	Left apnel
1=Minor	Upper extremity skin contusion	Windshield
1=Minor	Upper extremity skin contusion	Left apnel
1=Minor	Upper extremity skin laceration, minor	Windshield

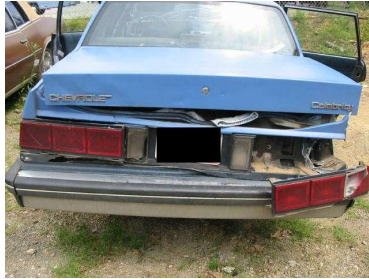
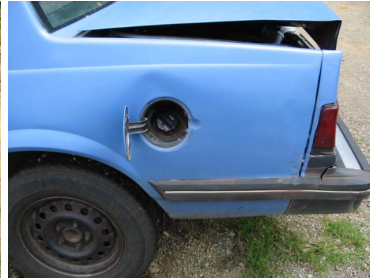
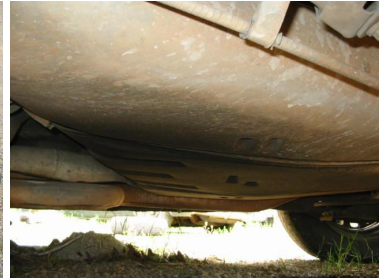
**Occupant: 2002-48-60-2-1**

AIS Level	Injury Description	Contacts
2=Moderate	Awake on admission, unconscious <1 hour	Left A pillar
1=Minor	Facial skin laceration, minor	Left A pillar
1=Minor	Upper extremity skin contusion	Steering comb

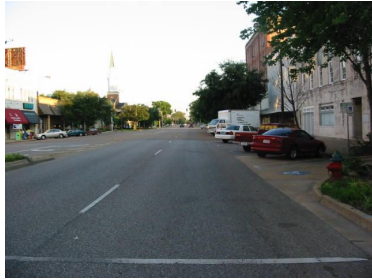
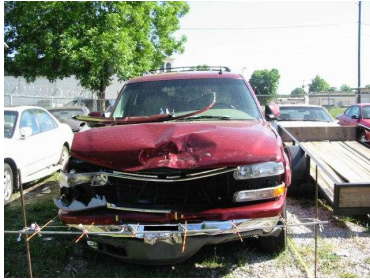
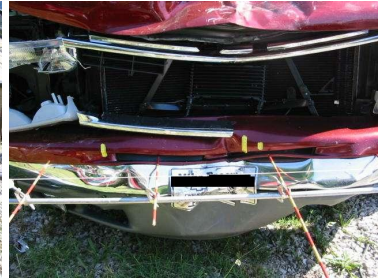
**Occupant: 2002-48-75-1-1**

Nr. Quarter Turns	No rollover
Impact Speed	998
Total, Longitudal, and Lateral $\delta V$	23 -18 15
Est. $\delta V$ with sequence number	DELTA V CODED 1
CDC	11 F D E W 1
Damage (C1-C6)	0 2 13 14 8 11
Crush (L and D)	180 0
Object Contacted 1	VEHICLE NO. 2
Object Contacted 2	VEHICLE NO. 2

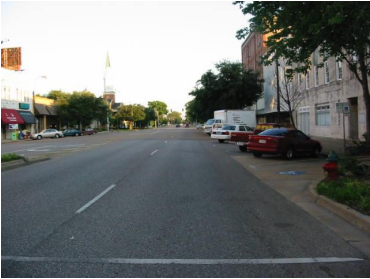
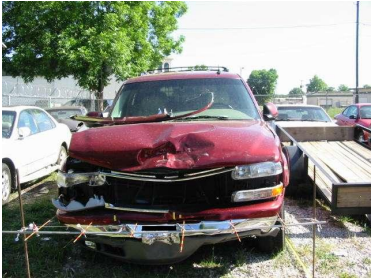
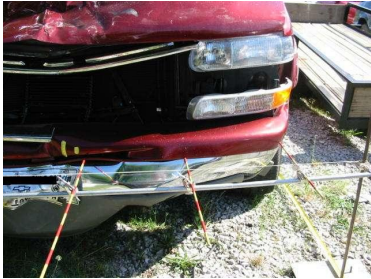
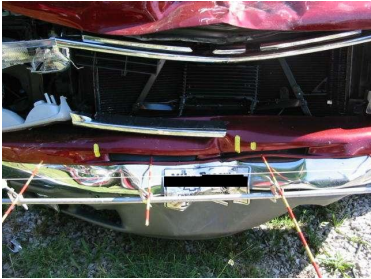
Occupant: 2002-48-75-1-2

Nr. Quarter Turns	No rollover
Impact Speed	998
Total, Longitudal, and Lateral $\delta V$	23 -18 15
Est. $\delta V$ with sequence number	DELTA V CODED 1
CDC	11 F D E W 1
Damage (C1-C6)	0 2 13 14 8 11
Crush (L and D)	180 0
Object Contacted 1	VEHICLE NO. 2
Object Contacted 2	VEHICLE NO. 2

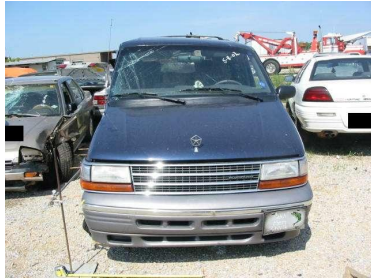
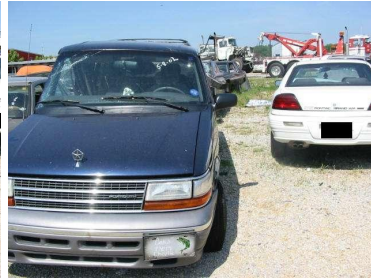
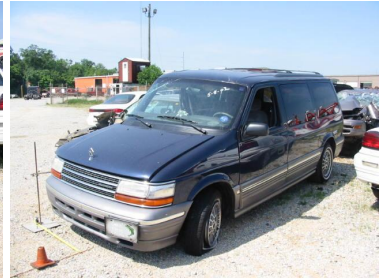
Occupant: 2002-48-75-2-1

Nr. Quarter Turns	No rollover
Impact Speed	998
Total, Longitudal, and Lateral $\delta V$	29 -19 -22
Est. $\delta V$ with sequence number	DELTA V CODED 1
CDC	2 R Y E W 3
Damage (C1-C6)	0 0 0 0 0 0
Crush (L and D)	0 0
Object Contacted 1	VEHICLE NO. 1
Object Contacted 2	VEHICLE NO. 1

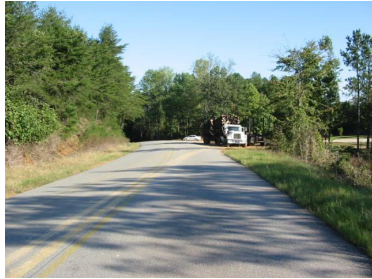
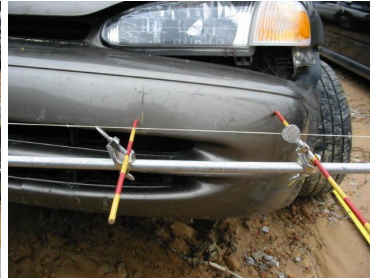
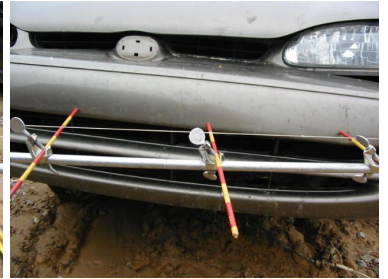
Occupant: 2002-48-164-1-1

Nr. Quarter Turns	No rollover
Impact Speed	999
Total, Longitudal, and Lateral $\delta V$	999 999 999
Est. $\delta V$ with sequence number	SEVERE 1
CDC	0 R Y A W 5
Damage (C1-C6)	9 5 13 51 20 2
Crush (L and D)	350 7
Object Contacted 1	LARGE TREE
Object Contacted 2	EMBANKMENT

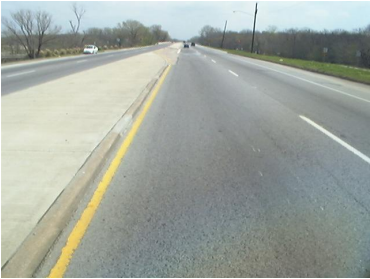
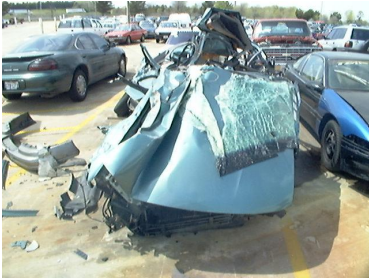
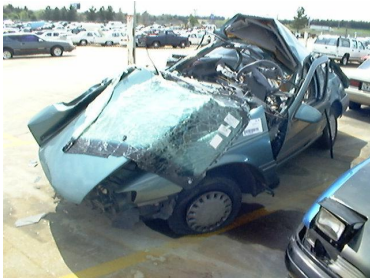
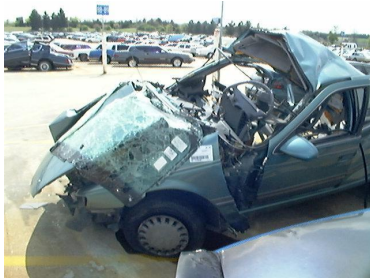
Occupant: 2002-49-51-1-1

Nr. Quarter Turns	No rollover
Impact Speed	999
Total, Longitudal, and Lateral $\delta V$	999 999 999
Est. $\delta V$ with sequence number	SEVERE 1
CDC	2 R D A W 99
Damage (C1-C6)	0 0 0 0 0 0
Crush (L and D)	0 0
Object Contacted 1	VEHICLE NO. 2
Object Contacted 2	VEHICLE NO. 2

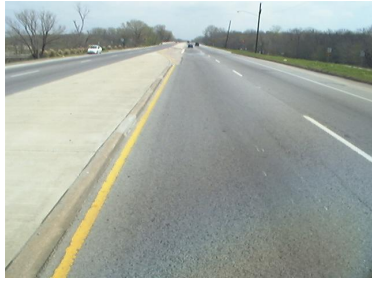
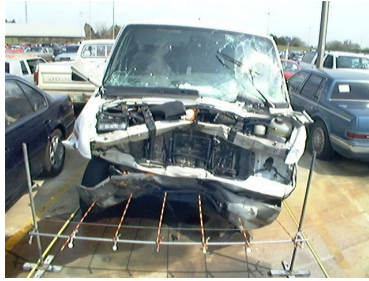
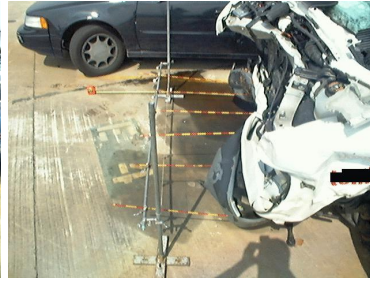
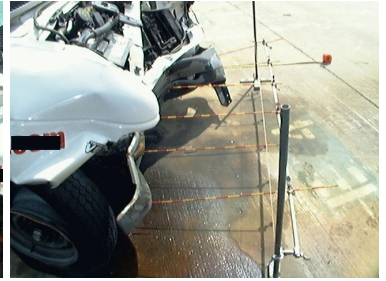
**Occupant: 2002-49-51-2-1**

Nr. Quarter Turns	No rollover
Impact Speed	998
Total, Longitudal, and Lateral $\delta V$	55 -54 10
Est. $\delta V$ with sequence number	DELTA V CODED 1
CDC	12 F D E W 5
Damage (C1-C6)	29 26 60 71 65 49
Crush (L and D)	176 0
Object Contacted 1	VEHICLE NO. 1
Object Contacted 2	VEHICLE NO. 1

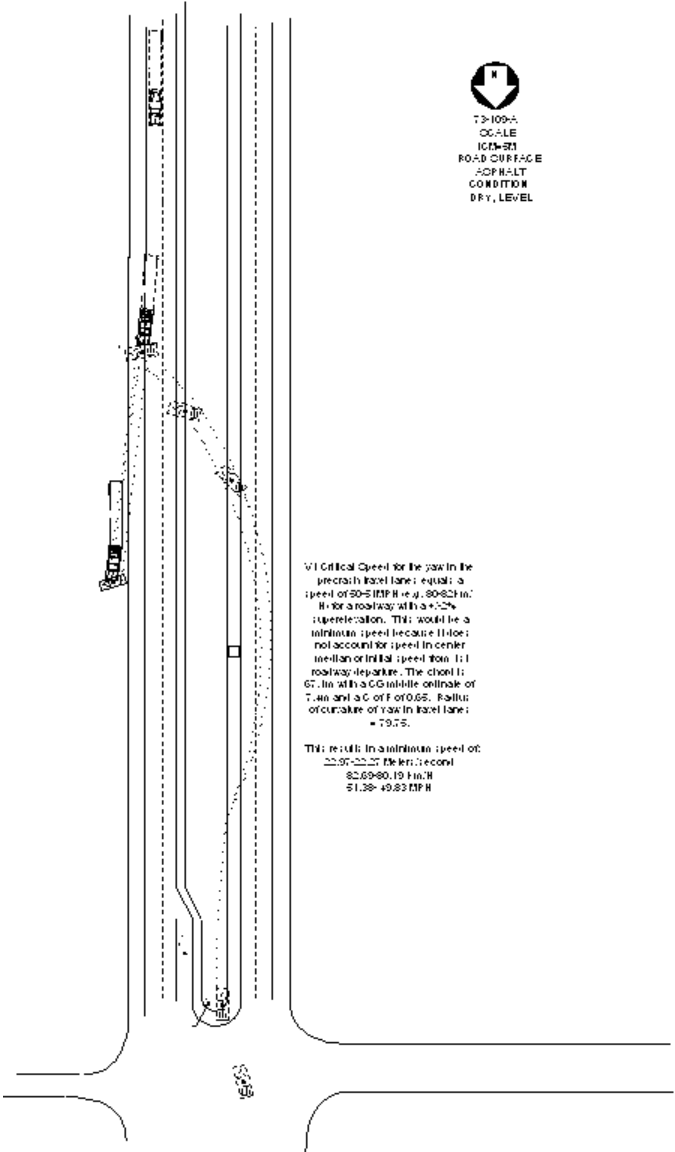
This crash occurred in the morning at 0405 hours on a four-lane, divided highway US Highway without a positive barrier with two lanes in each direction. There was a slightly depressed grass median between the two directions of travel. The posted speed limit was 89 KmPH (e.g. 55 MPH) and there were no adverse weather conditions at this time. Vehicle one is a 1999 Dodge Dakota light truck that was traveling south in the 2nd lane occupied by a driver only. After passing an intersecting roadway, vehicle one drove into center median and steered to the right to return to the travel lanes. After he returned to roadway on the southbound lanes, he then overcorrected to the left, which initiated vehicle one to spin into a counterclockwise yaw. The vehicle then re-entered and crossed over the center grass median and onto the northbound lanes at which time the right side was contacted by the front of vehicle two. Vehicle two is a 1999 Freightliner Conventional tractor with a GVWR of 23,587 kgs (e.g. 52,000 lbs.) pulling one Fruehauf van trailer. Vehicle two was traveling north on the same roadway as vehicle one in the first lane, when vehicle one came across the grass median into vehicle two's travel lane. The driver of vehicle two braked and tried to steer right before the front contacted the right side of vehicle one. A level one inspection was performed on vehicle two and a warning was issued one brake out of adjustment. The driver of vehicle one was taken to a trauma center and died a few hours later with a partial transection of the thoracic aorta and pulmonary vein as well as lung contusions and multiple fractures involving the ribs, arms and right leg. The driver of Vehicle 2 was not injured. Both vehicles were towed due to damage. )

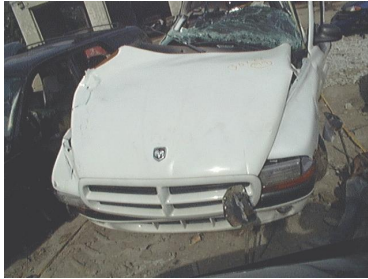
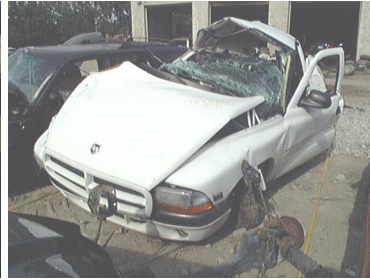
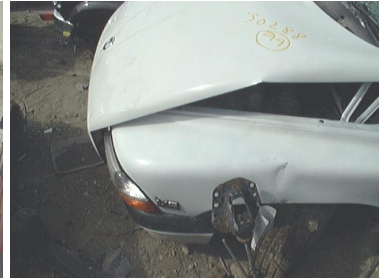
Occupant: 2002-73-109-1-1

Nr. Quarter Turns	No rollover
Impact Speed	999
Total, Longitudal, and Lateral $\delta V$	999 999 999
Est. $\delta V$ with sequence number	SEVERE 1
CDC	64 R D A W 7
Damage (C1-C6)	0 0 0 0 0 0
Crush (L and D)	0 0
Object Contacted 1	VEHICLE NO. 2
Object Contacted 2	0

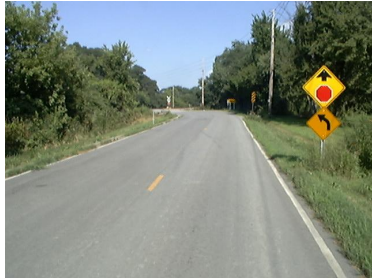
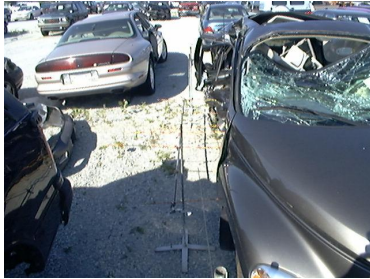
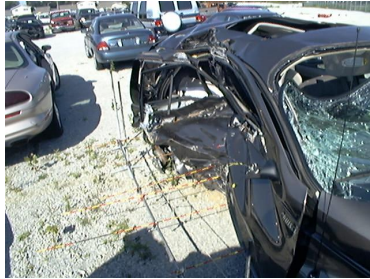
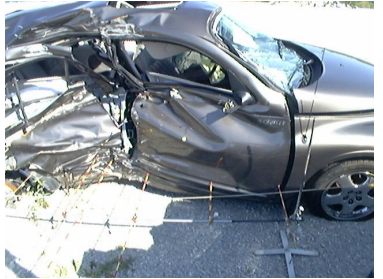
**Occupant: 2002-73-124-1-1**

Nr. Quarter Turns	No rollover
Impact Speed	999
Total, Longitudal, and Lateral $\delta V$	999 999 999
Est. $\delta V$ with sequence number	DELTA V CODED 1
CDC	3 R Z A W 4
Damage (C1-C6)	28 11 38 47 29 9
Crush (L and D)	272 -82
Object Contacted 1	TRAIN
Object Contacted 2	Unk FIXED OBJECT

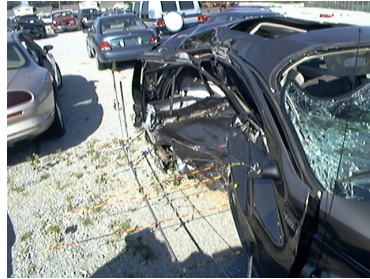
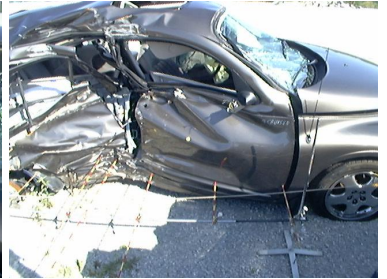
**Occupant: 2002-73-124-1-2**

Nr. Quarter Turns	No rollover
Impact Speed	999
Total, Longitudal, and Lateral $\delta V$	999 999 999
Est. $\delta V$ with sequence number	DELTA V CODED 1
CDC	3 R Z A W 4
Damage (C1-C6)	28 11 38 47 29 9
Crush (L and D)	272 -82
Object Contacted 1	TRAIN
Object Contacted 2	Unk FIXED OBJECT

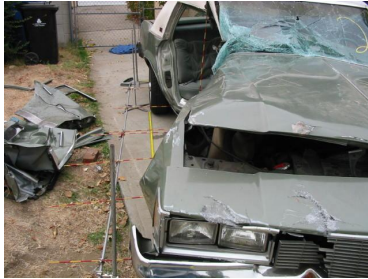
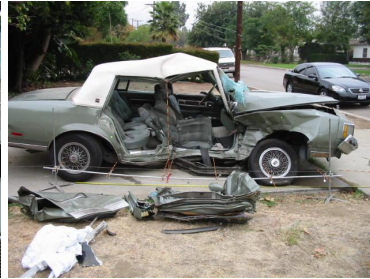
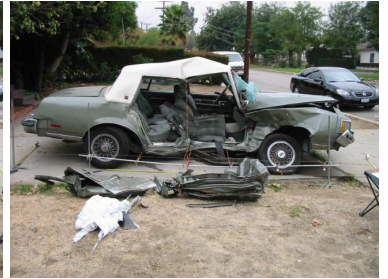
**Occupant: 2002-79-85-1-1**

Nr. Quarter Turns	No rollover
Impact Speed	998
Total, Longitudal, and Lateral $\delta V$	52 -26 -45
Est. $\delta V$ with sequence number	DELTA V CODED 1
CDC	62 R Y A W 5
Damage (C1-C6)	14 39 78 67 60 17
Crush (L and D)	302 25
Object Contacted 1	VEHICLE NO. 2
Object Contacted 2	FENCE

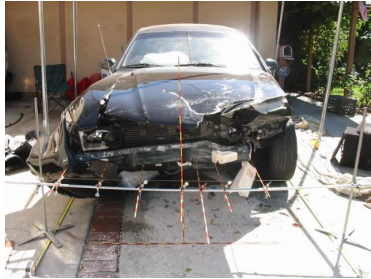
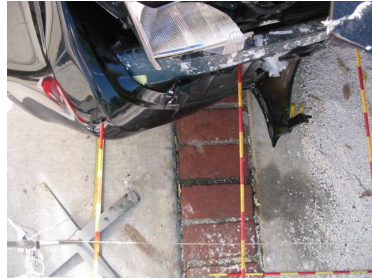
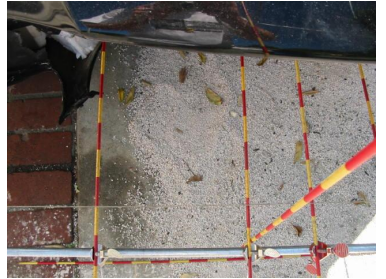
**Occupant: 2002-79-85-2-1**

Nr. Quarter Turns	No rollover
Impact Speed	998
Total, Longitudal, and Lateral $\delta V$	56 -49 28
Est. $\delta V$ with sequence number	DELTA V CODED 1
CDC	11 F D E W 2
Damage (C1-C6)	35 40 49 43 30 14
Crush (L and D)	152 0
Object Contacted 1	VEHICLE NO. 1
Object Contacted 2	FENCE

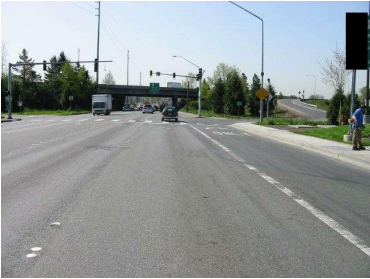
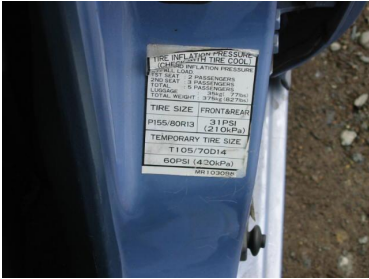
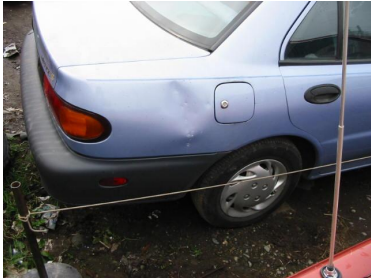
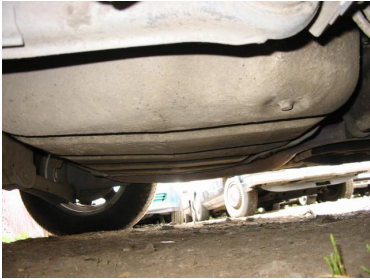
Occupant: 2002-81-36-1-1

Nr. Quarter Turns	No rollover
Impact Speed	998
Total, Longitudal, and Lateral $\delta V$	25 -19 -16
Est. $\delta V$ with sequence number	DELTA V CODED 1
CDC	1 R Y E W 2
Damage (C1-C6)	0 0 2 11 18 18
Crush (L and D)	216 123
Object Contacted 1	VEHICLE NO. 2
Object Contacted 2	0
