Crash Reports

Prepared by Ken Digges

Mon Jan 16 14:44:34 2006

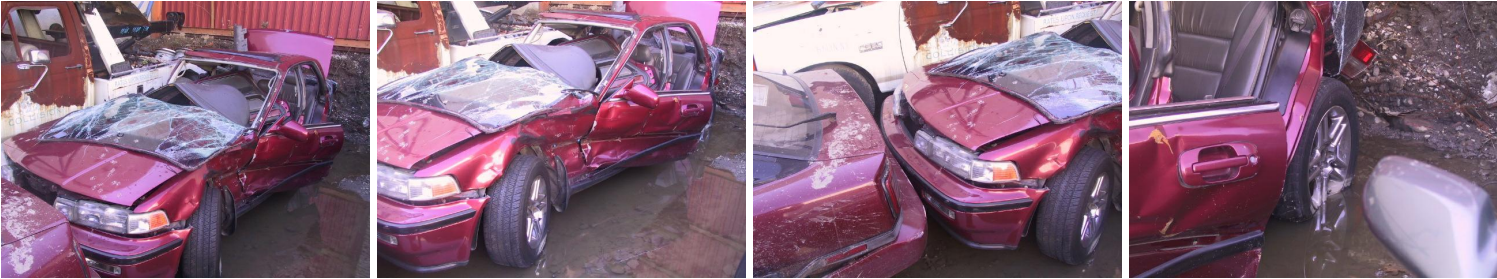
Occupant: 2003-3-73-1-1

AIS Level	Injury Description	Contacts
4=Severe	Lung contusion, bilateral	Seat, back
2=Moderate	Awake on admission, prior unconscious, length NFS	Other noncontact

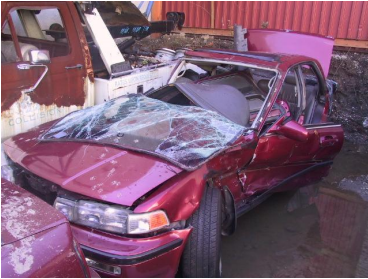
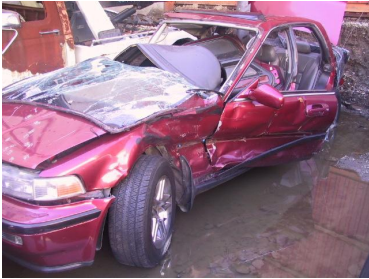
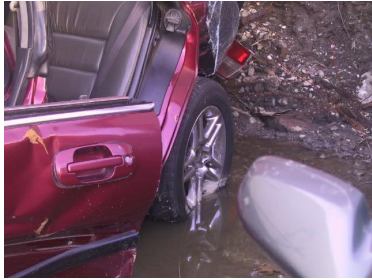
Occupant: 2003-3-73-1-2

AIS Level	Injury Description	Contacts
4=Severe	Unconscious on admission, moves appropriately only to pain	Right B pillar
2=Moderate	C-spine dislocation no bone or cord involvement NFS	Other noncontact
1=Minor	Scalp contusion	Unknown SOURCE
1=Minor	Upper extremity skin contusion	Right interior
1=Minor	Upper extremity skin laceration, minor	Right interior
1=Minor	Facial skin abrasion	Right B pillar
1=Minor	Facial skin laceration, minor	Right B pillar

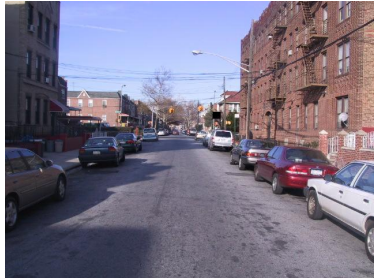
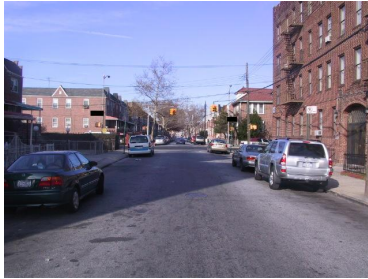
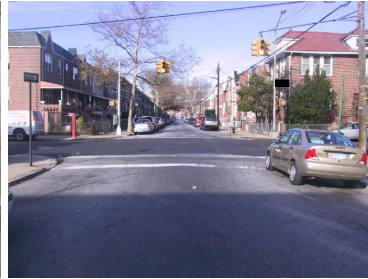
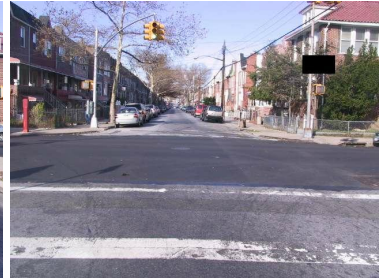
Occupant: 2003-3-73-2-1

Nr. Quarter Turns	No rollover
Impact Speed	999
Total, Longitudal, and Lateral δV	999 999 999
Est. δV with sequence number	9 99
CDC	No data No data No data No data
Damage (C1-C6)	No data No data No data No data
Crush (L and D)	No data No data
Object Contacted 1	No data
Object Contacted 2	No data

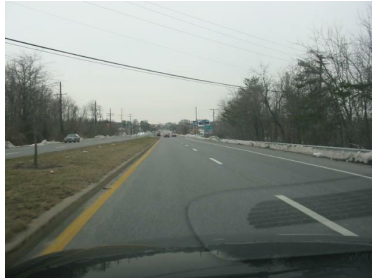
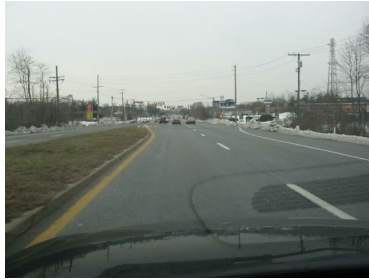
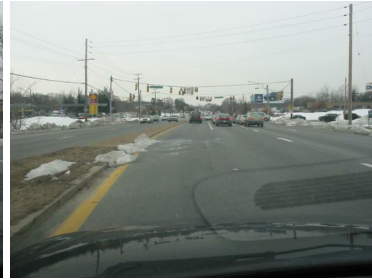
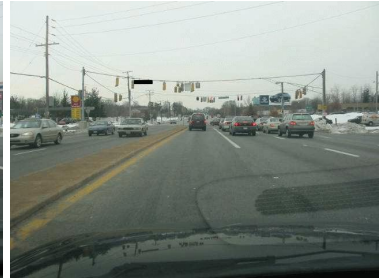
Occupant: 2003-9-35-1-1

Nr. Quarter Turns	No rollover
Impact Speed	999
Total, Longitudal, and Lateral δV	999 999 999
Est. δV with sequence number	9 99
CDC	No data No data No data No data
Damage (C1-C6)	No data No data No data No data
Crush (L and D)	No data No data
Object Contacted 1	No data
Object Contacted 2	No data

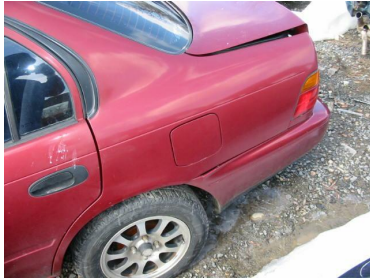
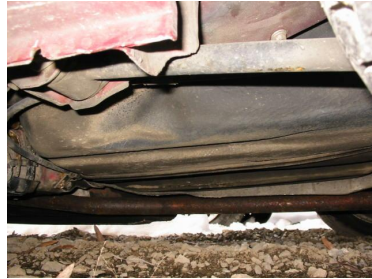
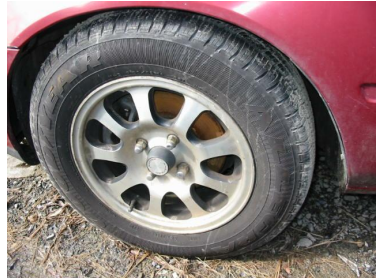
Occupant: 2003-9-35-2-1

Nr. Quarter Turns	No rollover
Impact Speed	999
Total, Longitudal, and Lateral δV	999 999 999
Est. δV with sequence number	DELTA V CODED 1
CDC	2 R Z A W 3
Damage (C1-C6)	4 8 24 44 39 0
Crush (L and D)	284 -49
Object Contacted 1	VEHICLE NO. 1
Object Contacted 2	0

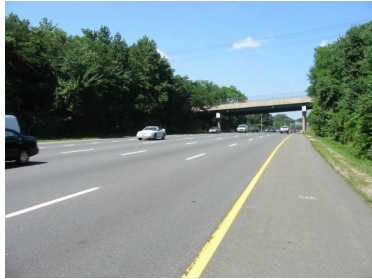
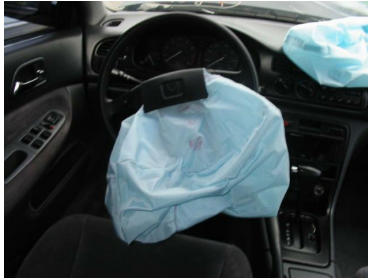
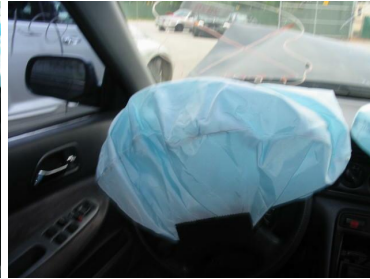
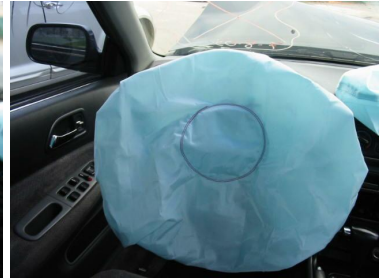
Occupant: 2003-9-154-1-1

Nr. Quarter Turns	No rollover
Impact Speed	998
Total, Longitudal, and Lateral δV	14 -14 < 0.5 KMPH
Est. δV with sequence number	DELTA V CODED 1
CDC	12 F Y E W 2
Damage (C1-C6)	5 4 0 0 0 0
Crush (L and D)	157 -46
Object Contacted 1	VEHICLE NO. 2
Object Contacted 2	VEHICLE NO. 3

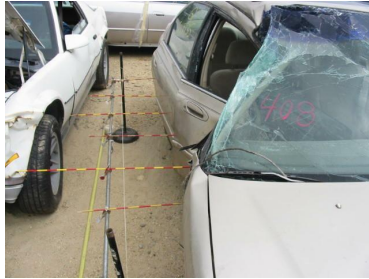
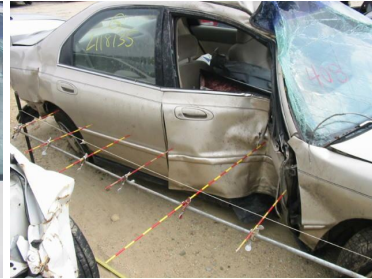
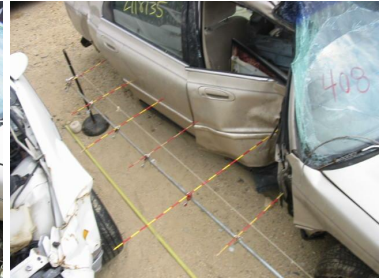
Occupant: 2003-9-154-2-1

Nr. Quarter Turns	No rollover
Impact Speed	998
Total, Longitudal, and Lateral δV	22 -4 -22
Est. δV with sequence number	DELTA V CODED 3
CDC	3 R P A W 3
Damage (C1-C6)	0 1 4 8 41 0
Crush (L and D)	178 43
Object Contacted 1	LARGE TREE
Object Contacted 2	VEHICLE NO. 1

AIS Level	Injury Description	Contacts
3=Serious	Single rib fracture with hemo-/pneumothorax	Steering comb

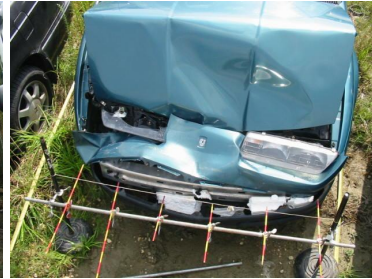
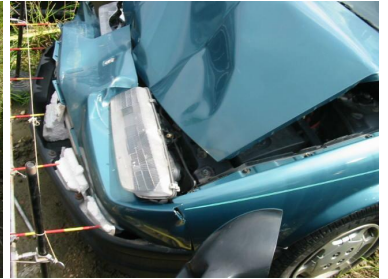
Occupant: 2003-9-154-3-1

Nr. Quarter Turns	No rollover
Impact Speed	998
Total, Longitudal, and Lateral δV	13 -13 -2
Est. δV with sequence number	DELTA V CODED 4
CDC	12 F D E W 2
Damage (C1-C6)	0 1 2 3 1 0
Crush (L and D)	132 0
Object Contacted 1	VEHICLE NO. 1
Object Contacted 2	0

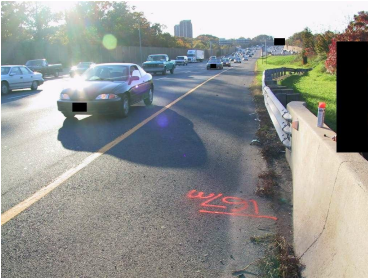
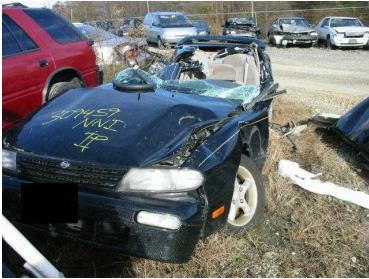
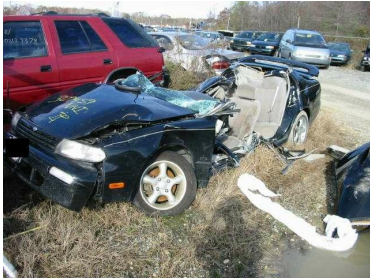
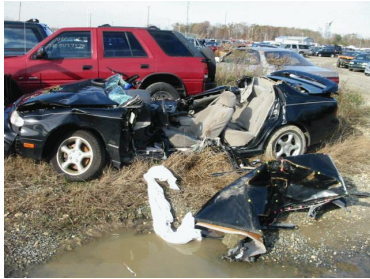
Occupant: 2003-9-220-1-1

Nr. Quarter Turns	No rollover
Impact Speed	999
Total, Longitudal, and Lateral δV	999 999 999
Est. δV with sequence number	SEVERE 2
CDC	2 R D A W 5
Damage (C1-C6)	3 21 42 57 8 0
Crush (L and D)	340 50
Object Contacted 1	VEHICLE NO. 2
Object Contacted 2	OBJ FELL FRM VEH

AIS Level	Injury Description	Contacts
1=Minor	Facial skin abrasion	Right B pillar
1=Minor	Facial skin abrasion	Right wind frame
1=Minor	Facial skin abrasion	Right wind frame
1=Minor	297402	Right wind frame
2=Moderate	Maxillary fracture, closed	Right B pillar
1=Minor	Mandible fracture, closed, location NFS	Right B pillar
4=Severe	Basilar skull fracture, open, with brain tissue loss.	Right B pillar
3=Serious	Pituitary injury, NFS	Right B pillar
3=Serious	Cerebral subarachnoid hemorrhage	Right B pillar
1=Minor	Upper extremity skin abrasion	Belt webb/buckle
1=Minor	690202	Seat, back
2=Moderate	Clavicle fracture	Right B pillar
3=Serious	Lung contusion, unilateral	Right B pillar
3=Serious	Single rib fracture with hemo-/pneumothorax	Right B pillar

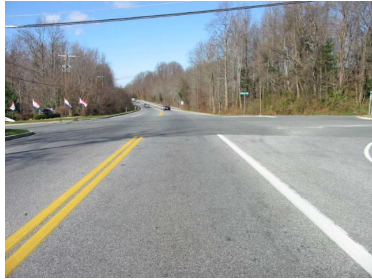
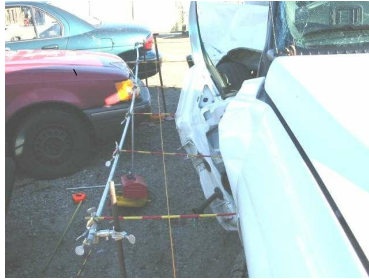
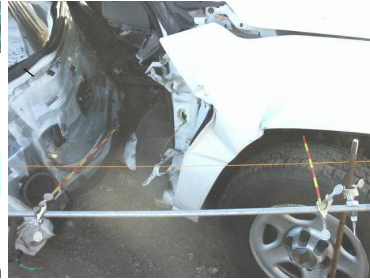
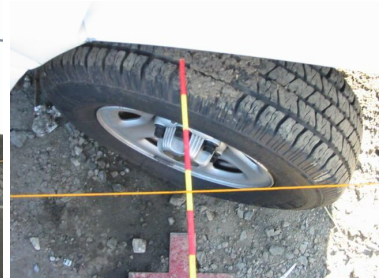
Occupant: 2003-9-239-1-1

AIS Level	Injury Description	Contacts
1=Minor	Scalp contusion	Other occupants
4=Severe	Cerebral subdural hematoma, NFS	Other occupants
3=Serious	Cerebral subarachnoid hemorrhage	Other occupants
3=Serious	Cerebral subarachnoid hemorrhage	Other occupants
2=Moderate	Skull fracture, vault, closed (simple, undisplaced)	Other occupants
3=Serious	Dislocation of atlanto-axial joint (odontoid)	Other occupants
3=Serious	Lung laceration, unilateral NFS	Other occupants
3=Serious	>3 rib fractures one side & <3 other side, with stable chest	Other occupants
1=Minor	Abdominal skin abrasion	Belt webb/buckle
2=Moderate	Hepatic laceration NFS	Belt webb/buckle

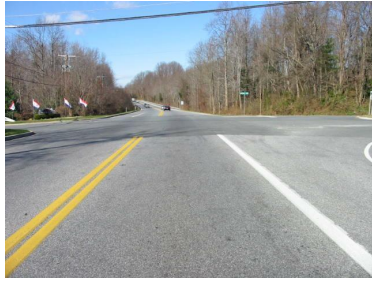
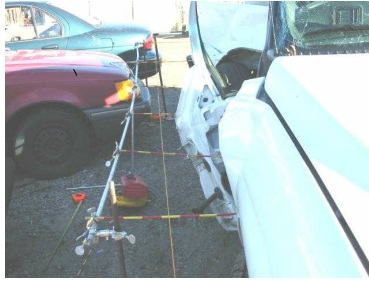
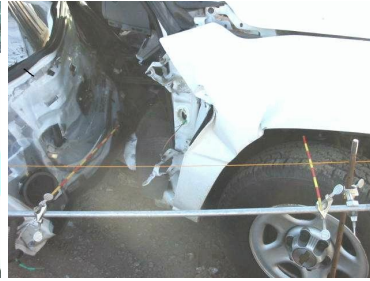
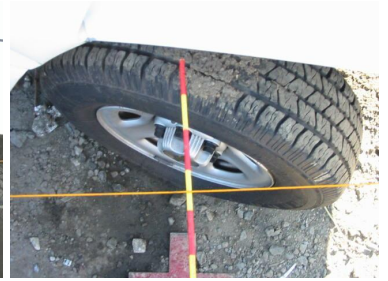
Occupant: 2003-9-239-1-2

2=Moderate	Ulnar fracture NFS	Right interior
1=Minor	Upper extremity skin abrasion	Other occupants

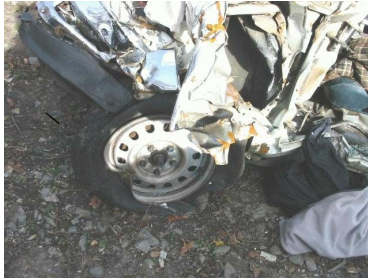
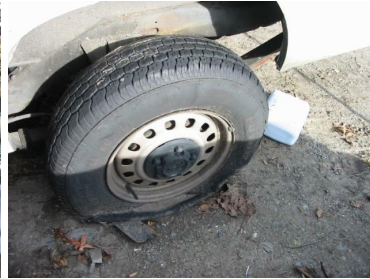
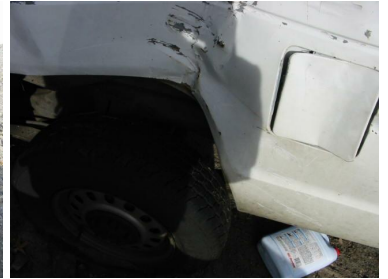
Occupant: 2003-9-239-2-1

Fire Occurrence	No fire
Fire Origin	No fire
Location of Fuel Leakage	No fuel leakage
Type of Fuel Tank	Metallic
Fuel Tank Location	Forward of rear axle, centered
Fuel Cap Location	Left side, behind rear axle
Fuel Tank Damage	No damage
Fuel Type	Gasoline

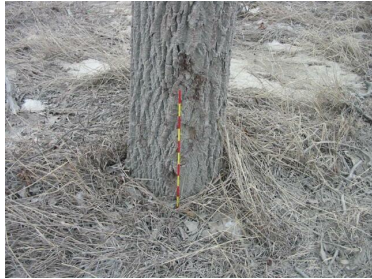
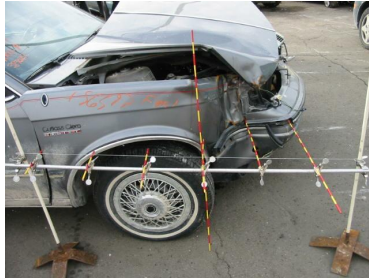
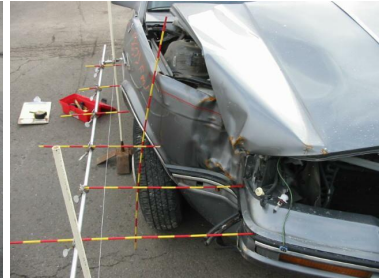
Occupant: 2003-11-20-1-1

Nr. Quarter Turns	No rollover
Impact Speed	998
Total, Longitudal, and Lateral δV	15 -8 -13
Est. δV with sequence number	DELTA V CODED 1
CDC	82 R F E N 3
Damage (C1-C6)	0 0 5 16 32 22
Crush (L and D)	120 189
Object Contacted 1	LARGE TREE
Object Contacted 2	0

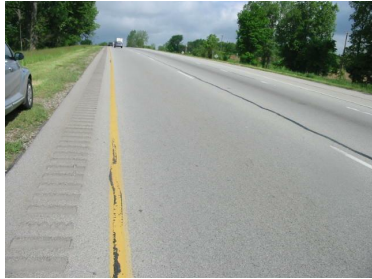
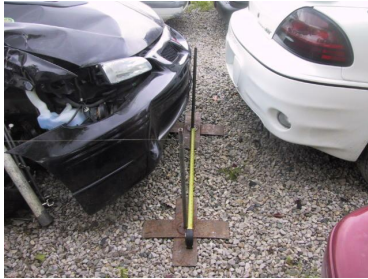
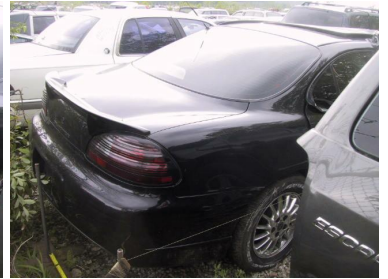
Occupant: 2003-11-87-1-1

Nr. Quarter Turns	No rollover
Impact Speed	998
Total, Longitudal, and Lateral δV	26 -13 -23
Est. δV with sequence number	DELTA V CODED 1
CDC	2 R Y E W 3
Damage (C1-C6)	1 15 18 38 17 0
Crush (L and D)	231 121
Object Contacted 1	LARGE TREE
Object Contacted 2	LARGE TREE

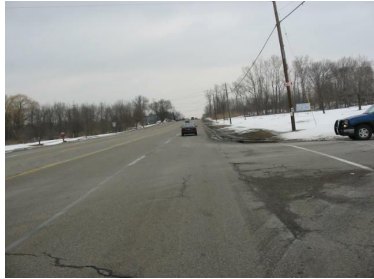
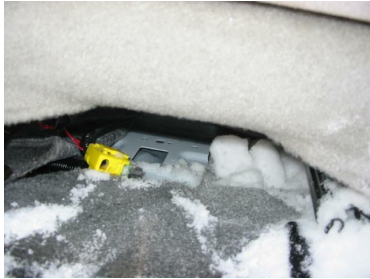
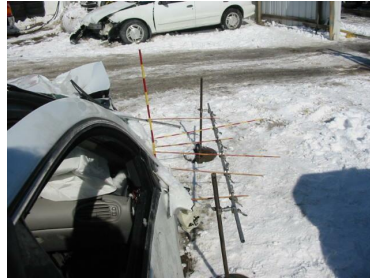
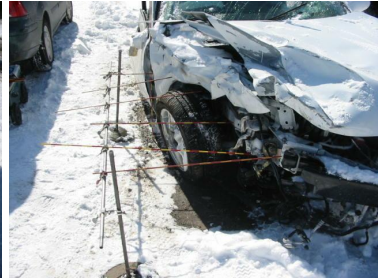
Occupant: 2003-12-27-1-1

Nr. Quarter Turns	No rollover
Impact Speed	998
Total, Longitudal, and Lateral δV	45 -23 -39
Est. δV with sequence number	DELTA V CODED 1
CDC	82 R F E W 4
Damage (C1-C6)	5 25 45 61 71 62
Crush (L and D)	119 154
Object Contacted 1	VEHICLE NO. 2
Object Contacted 2	VEHICLE NO. 2

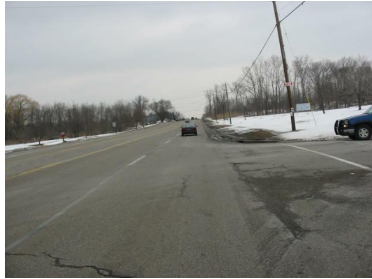
Occupant: 2003-12-27-1-2

Nr. Quarter Turns	No rollover
Impact Speed	998
Total, Longitudal, and Lateral δV	45 -23 -39
Est. δV with sequence number	DELTA V CODED 1
CDC	82 R F E W 4
Damage (C1-C6)	5 25 45 61 71 62
Crush (L and D)	119 154
Object Contacted 1	VEHICLE NO. 2
Object Contacted 2	VEHICLE NO. 2

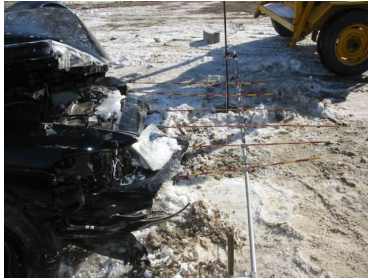
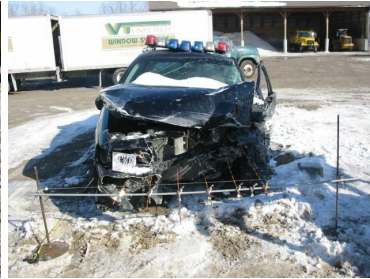
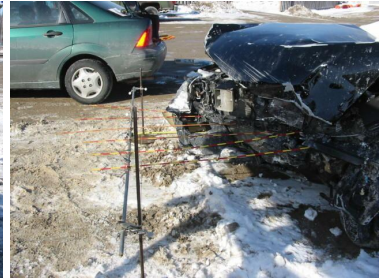
Occupant: 2003-12-27-2-1

Nr. Quarter Turns	No rollover
Impact Speed	998
Total, Longitudal, and Lateral δV	32 -32 6
Est. δV with sequence number	DELTA V CODED 1
CDC	12 F D E W 3
Damage (C1-C6)	6 39 63 86 90 80
Crush (L and D)	103 0
Object Contacted 1	VEHICLE NO. 1
Object Contacted 2	VEHICLE NO. 1

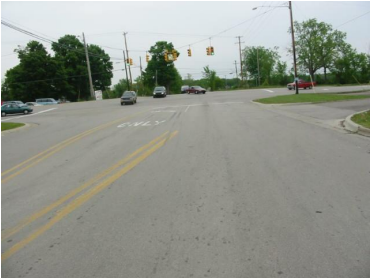
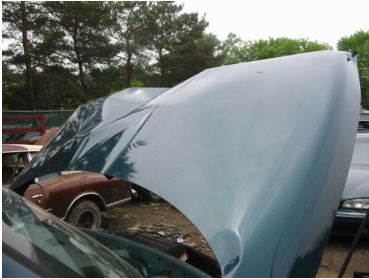
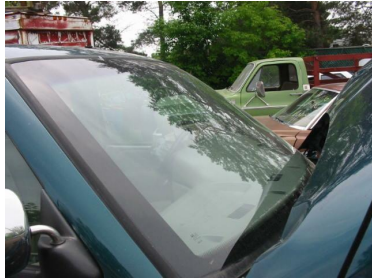
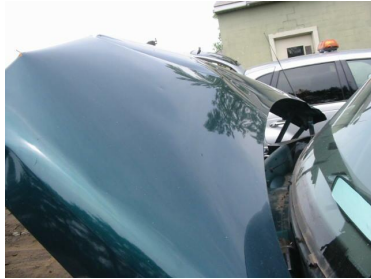
Occupant: 2003-12-91-1-1

Nr. Quarter Turns	No rollover
Impact Speed	998
Total, Longitudal, and Lateral δV	16 -15 6
Est. δV with sequence number	DELTA V CODED 1
CDC	11 F 9 9 9 99
Damage (C1-C6)	0 0 0 0 0 0
Crush (L and D)	0 0
Object Contacted 1	VEHICLE NO. 2
Object Contacted 2	VEHICLE NO. 2

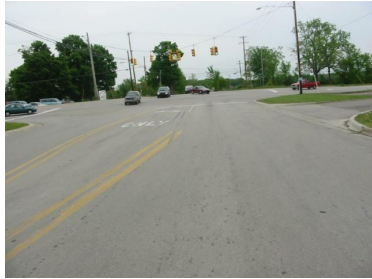
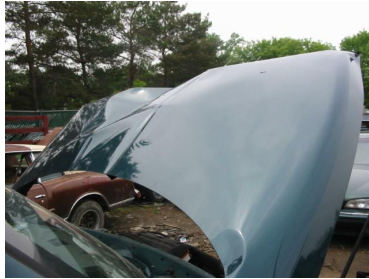
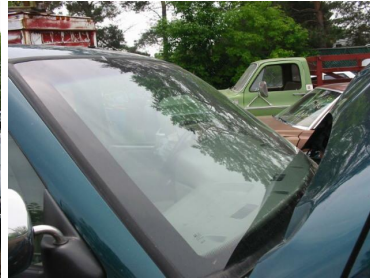
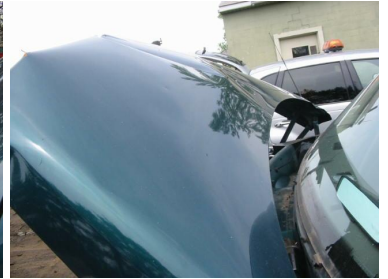
Occupant: 2003-12-91-1-2

Nr. Quarter Turns	No rollover
Impact Speed	998
Total, Longitudal, and Lateral δV	16 -15 6
Est. δV with sequence number	DELTA V CODED 1
CDC	11 F 9 9 9 99
Damage (C1-C6)	0 0 0 0 0 0
Crush (L and D)	0 0
Object Contacted 1	VEHICLE NO. 2
Object Contacted 2	VEHICLE NO. 2

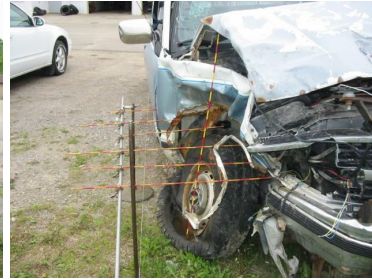
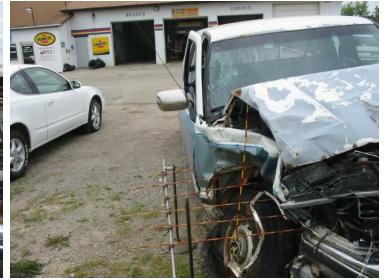
Occupant: 2003-12-91-2-1

Nr. Quarter Turns	No rollover
Impact Speed	998
Total, Longitudal, and Lateral δV	16 -12 -10
Est. δV with sequence number	DELTA V CODED 1
CDC	1 R F E W 4
Damage (C1-C6)	7 21 47 54 57 57
Crush (L and D)	85 185
Object Contacted 1	VEHICLE NO. 1
Object Contacted 2	VEHICLE NO. 1

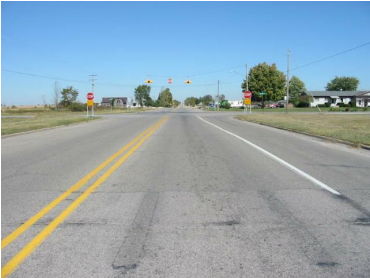
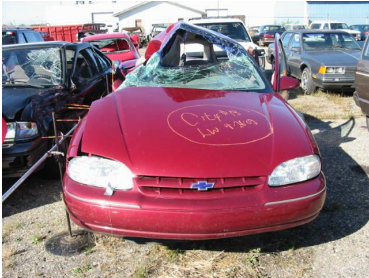
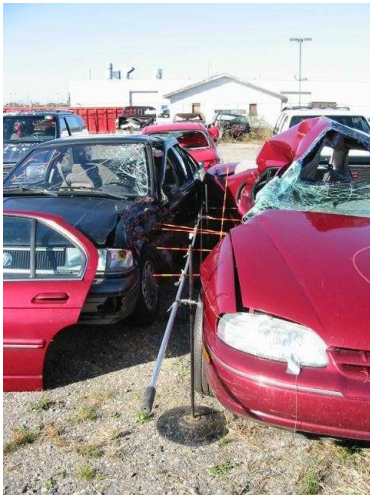
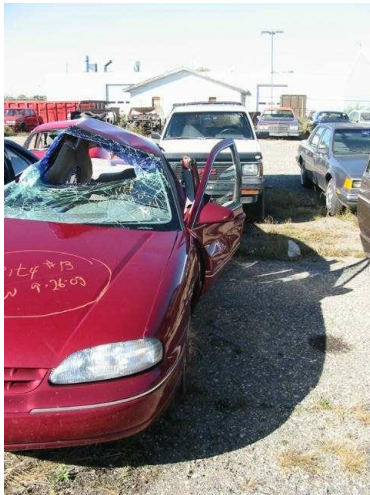
Occupant: 2003-12-167-1-1

Nr. Quarter Turns	No rollover
Impact Speed	999
Total, Longitudal, and Lateral δV	999 999 999
Est. δV with sequence number	DELTA V CODED 1
CDC	63 R D A W 4
Damage (C1-C6)	5 43 66 62 33 0
Crush (L and D)	303 19
Object Contacted 1	VEHICLE NO. 2
Object Contacted 2	0

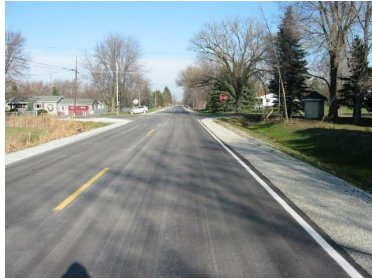
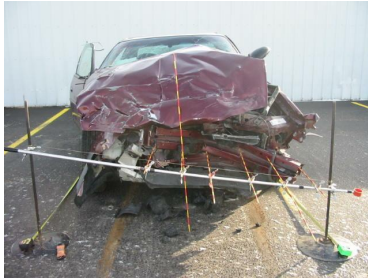
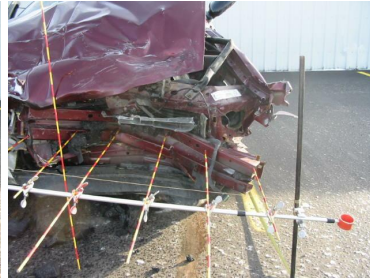
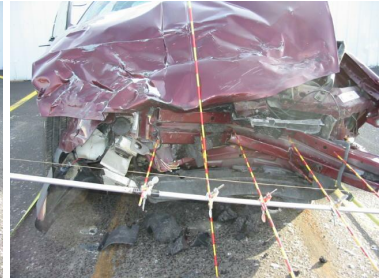
Occupant: 2003-12-186-2-1

AIS Level	Injury Description	Contacts
5=Critical	Cerebral diffuse axonal injury	Right B pillar
4=Severe	Lung contusion, bilateral	Right B pillar
1=Minor	Facial skin contusion	Right interior
1=Minor	Leg skin contusion (hematoma)	Right hardware
2=Moderate	Pancreatic laceration, minor (no duct involvement)	Right B pillar
1=Minor	Conjunctiva injury	Right interior
1=Minor	297602	Right interior
5=Critical	Intracerebral hematoma, small, bilateral	Right B pillar
2=Moderate	Pelvic fracture, closed	Right B pillar
3=Serious	Orbit fracture, open/displaced/comminuted	Right interior
2=Moderate	Orbit fracture, closed	Other occupants
3=Serious	Basilar skull fracture, NFS	Other occupants
3=Serious	Cerebral contusions, multiple, bilateral but NFS	Right B pillar
1=Minor	Facial skin laceration NFS	Right interior

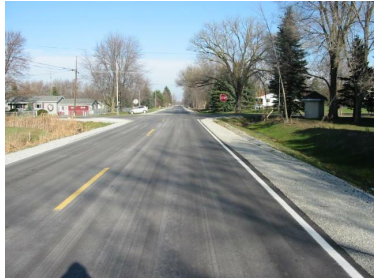
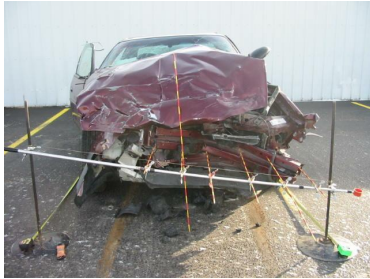
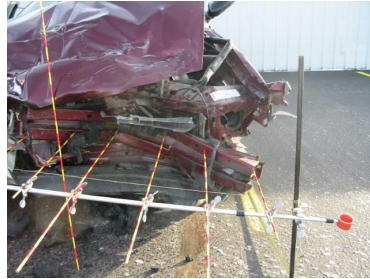
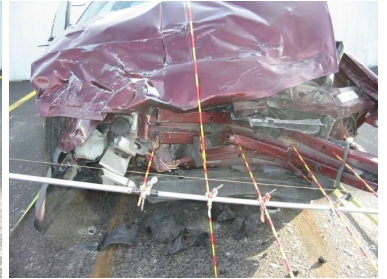
Occupant: 2003-12-186-2-2

AIS Level	Injury Description	Contacts
1=Minor	Neck skin abrasion	Belt webb/buckle
1=Minor	Neck skin contusion (hematoma)	Belt webb/buckle
1=Minor	Abdominal skin contusion	Belt webb/buckle
1=Minor	Upper extremity skin contusion	Other occupants
1=Minor	Upper extremity skin laceration, minor	Other occupants
1=Minor	Thoracic skin contusion	Belt webb/buckle
1=Minor	Leg skin contusion (hematoma)	Knee bolster
1=Minor	Upper extremity skin abrasion	Air bag-DR side

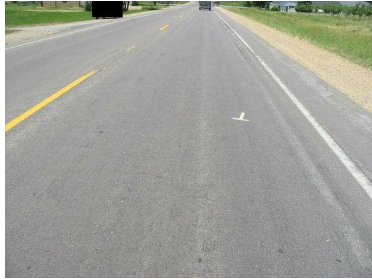
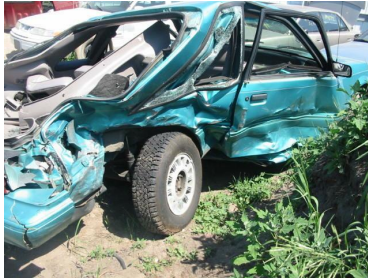
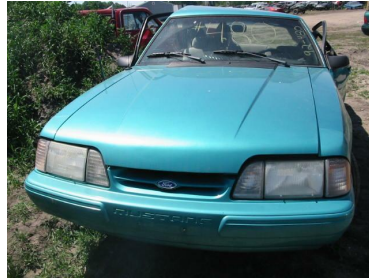
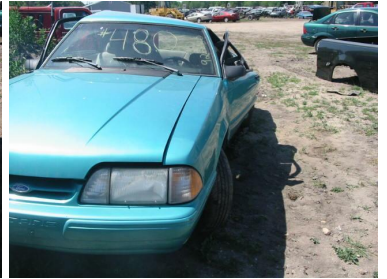
Occupant: 2003-13-75-1-1

V1 was traveling westbound on a dry, 2-lane, 2-way road. V1 passed a vehicle ahead and lost control. V1 spun 100 degrees counterclockwise into the path of V2, which was traveling eastbound on the same road. The front of V2 impacted the right side of V1. Both vehicles were towed from the scene with moderate damage. The driver of V1 was hospitalized with critical head injuries. The driver of V2 was treated and released from the ER with minor injuries.)

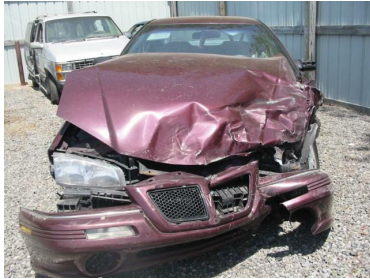
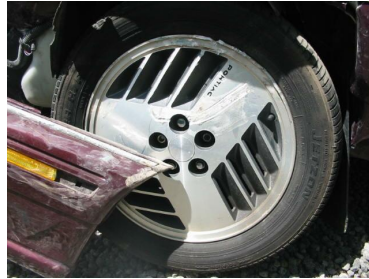
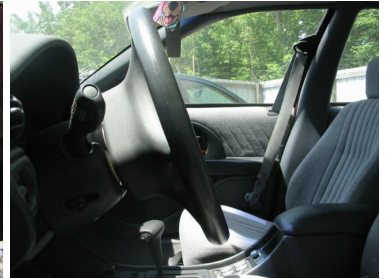
Occupant: 2003-13-75-2-1

AIS Level	Injury Description	Contacts
1=Minor	297202	Right interior
1=Minor	Leg skin abrasion	Left apnel
1=Minor	Facial skin contusion	Right interior
3=Serious	Lung contusion, unilateral	Transmiss lever
1=Minor	Scalp contusion	Right interior
5=Critical	Intracerebral hematoma, small, bilateral	Right interior

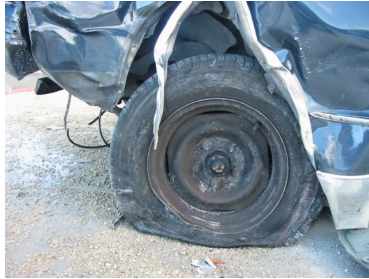
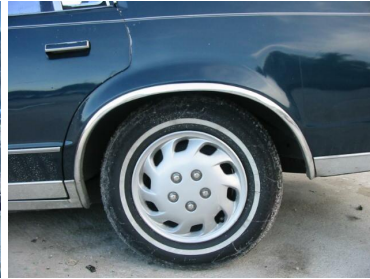
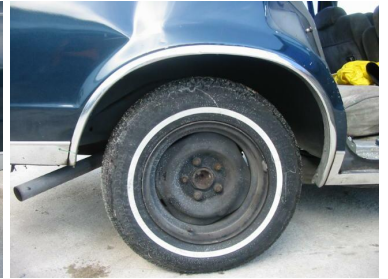
Occupant: 2003-41-125-2-1

1=Minor	Upper extremity skin abrasion	Air bag-DR side
1=Minor	Leg skin abrasion	Seat, back
1=Minor	Leg skin contusion (hematoma)	Transmiss lever
1=Minor	Leg skin contusion (hematoma)	Knee bolster
1=Minor	Leg skin abrasion	Knee bolster
1=Minor	Upper extremity skin laceration NFS	Left interior
2=Moderate	Pelvic fracture NFS	Transmiss lever
1=Minor	Leg skin contusion (hematoma)	Foot controls
1=Minor	Leg skin abrasion	Foot controls
1=Minor	Leg skin abrasion	Center panel

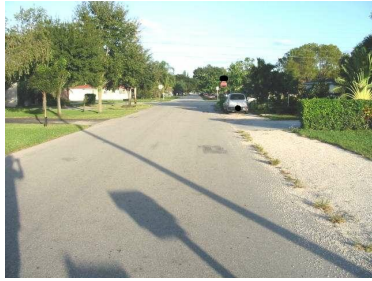
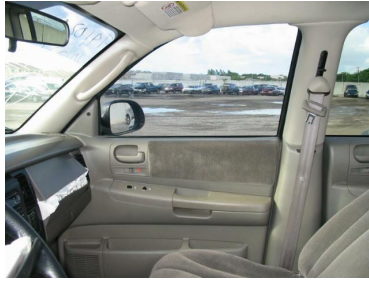
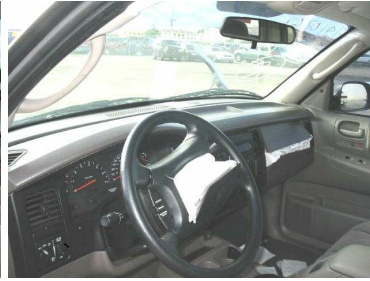
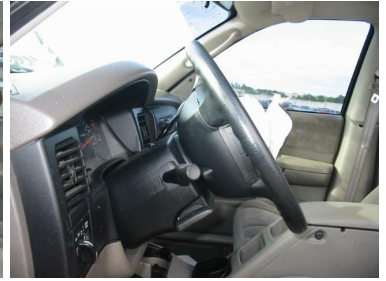
Occupant: 2003-41-156-2-1

AIS Level	Injury Description	Contacts
2=Moderate	Mesenteric laceration, minor	Transmiss lever
2=Moderate	Pancreatic contusion NFS	Transmiss lever
1=Minor	Facial skin laceration NFS	Center panel
1=Minor	Scalp contusion	Center panel
3=Serious	Cerebral contusion, NFS	Center panel
3=Serious	Unconscious on admission, length NFS	Center panel

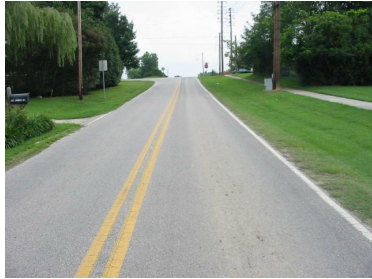
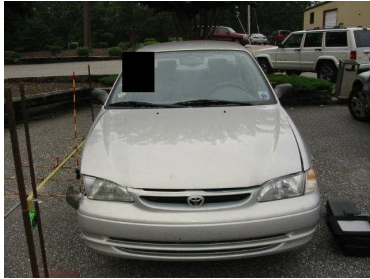
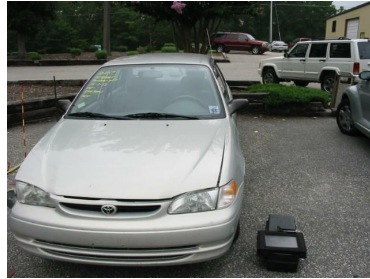
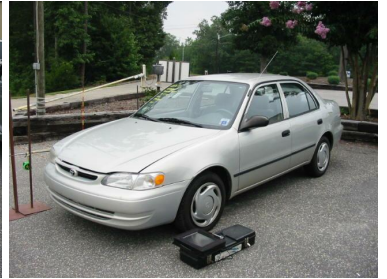
Occupant: 2003-43-183-1-1

V1, a 2000 Toyota Corolla, was traveling east towards an intersection on a dry, bituminous, two-lane roadway. V2, a 1994 Eagle Vision, was traveling north towards the same intersection on a dry, bituminous, two-lane roadway. Weather was clear and lighting condition was daylight. Both vehicles entered the intersection. The front of V2 contacted the right side of V1. Both vehicles were towed due to damage. The driver of V1 sustained "A" injuries and was transported and released from a hospital. The driver of V2 sustained "B" injuries. The RF passenger of V2 reported no injuries at the time. V1 was equipped with driver and passenger frontal airbags, none of which deployed. V2 was equipped with driver and passenger frontal airbags, which deployed due to impact forces.

Nr. Quarter Turns	No rollover
Impact Speed	998
Total, Longitudal, and Lateral δV	17 -6 -16
Est. δV with sequence number	DELTA V CODED 1
CDC	2 R Y E W 2
Damage (C1-C6)	0 10 15 19 16 4
Crush (L and D)	133 128
Object Contacted 1	VEHICLE NO. 2
Object Contacted 2	0

AIS Level	Injury Description	Contacts
3=Serious	Radial fracture, open/displaced/comminuted	Steering rim
1=Minor	Upper extremity skin contusion	Steering rim
1=Minor	Upper extremity skin contusion	Left interior
1=Minor	Leg skin contusion (hematoma)	Transmiss lever
1=Minor	Leg skin contusion (hematoma)	Knee bolster

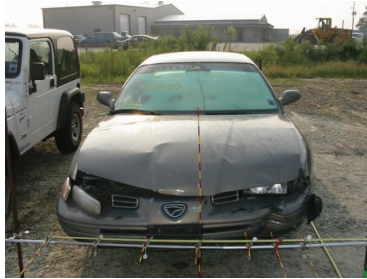
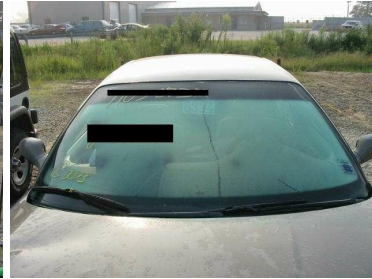
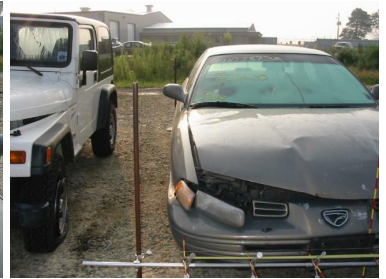
Occupant: 2003-43-183-2-1

Nr. Quarter Turns	No rollover
Impact Speed	998
Total, Longitudal, and Lateral δV	12 -10 6
Est. δV with sequence number	DELTA V CODED 1
CDC	11 F D E W 1
Damage (C1-C6)	4 8 7 5 2 1
Crush (L and D)	152 0
Object Contacted 1	VEHICLE NO. 1
Object Contacted 2	0

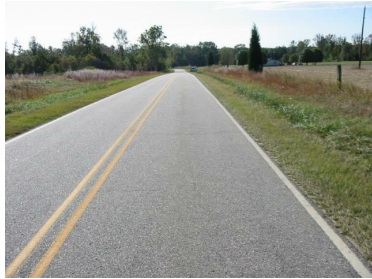
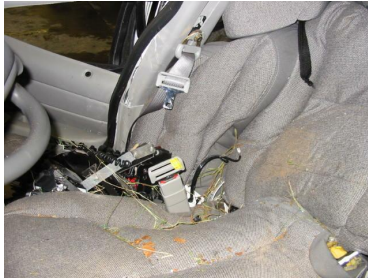
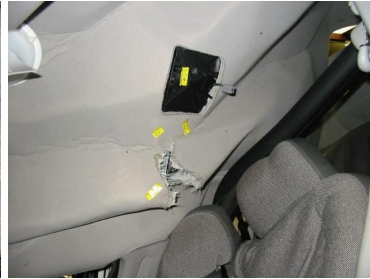
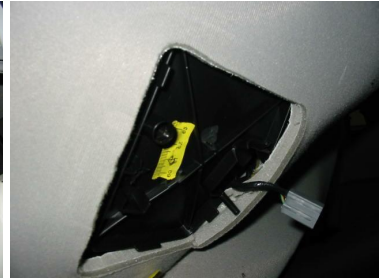
Occupant: 2003-43-222-1-1

Nr. Quarter Turns	No rollover
Impact Speed	998
Total, Longitudal, and Lateral δV	70 < 0.5 KMPH -70
Est. δV with sequence number	DELTA V CODED 1
CDC	3 R P A W 5
Damage (C1-C6)	2 32 87 109 63 13
Crush (L and D)	266 -31
Object Contacted 1	LARGE TREE
Object Contacted 2	0

1=Minor	Facial skin abrasion	Roof
1=Minor	Upper extremity skin contusion	Right interior
1=Minor	Leg skin abrasion	Seat, back
1=Minor	Upper extremity skin abrasion	Right interior
2=Moderate	751900	Right interior
1=Minor	Mandible fracture NFS	Roof
4=Severe	Basilar skull fracture, open, with brain tissue loss.	Roof
3=Serious	Cerebral subarachnoid hemorrhage	Roof
2=Moderate	Cervical vertebral body fracture, no cord injury NFS	Roof
2=Moderate	Clavicle fracture	Right B pillar
2=Moderate	Clavicle fracture	Right B pillar
5=Critical	>3 rib fxs on each side, stable chest & hemo-/pneumothorax	Right B pillar
2=Moderate	Pericardial laceration (puncture)	Right B pillar
5=Critical	Myocardial laceration with perforation (+/- tamponade)	Right B pillar
4=Severe	Vena cava laceration, major (complete transect or EBL>204=Severe	Hepatic laceration, major (<502=Moderate
Pelvic fracture NFS	Right B pillar	
4=Severe	Lung contusion, bilateral	Right B pillar

2=Moderate	Skull fracture, vault, NFS	Roof

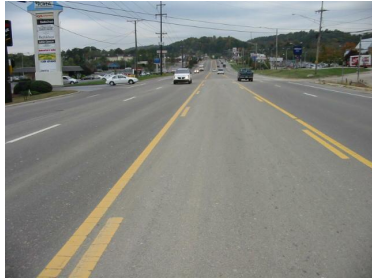
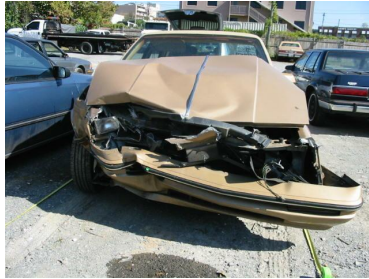
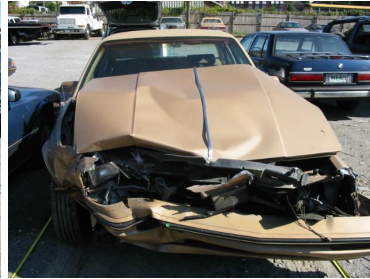
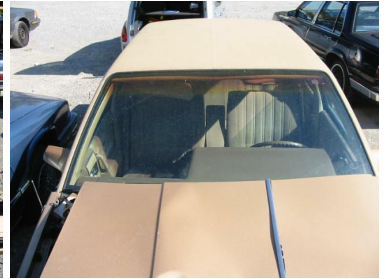
Occupant: 2003-45-178-1-1

V1 a 1985 Oldsmobile Cutlass was traveling north on a five lane non-physically divided asphalt highway with a center two way left turn lane in daylight and dry conditions. V2 a 2002 Chrysler PT Cruiser was traveling south in the right lane. The driver of V1 attempted to turn left into a shopping center. As V1 was crossing the southbound lanes, the right of V1 and front of V2 contacted. V1 rotated counter-clockwise traveling southwest across the curb, and down a grassy hill before it's front contacted the front of V3, a parked 1994 Chevrolet Astro van, where V1 came to rest. V2 traveled southwest coming to rest facing southwest near the curb at the southwest corner of the intersection. The belted driver of V1 was hospitalized, while the non-belted airbag deployed V2 driver was transported and released from the hospital. The disabled V1 and V2 were towed from the crash, while parked V3 was driven from the scene.)

Nr. Quarter Turns	No rollover
Impact Speed	998
Total, Longitudal, and Lateral δV	20 -10 -17
Est. δV with sequence number	DELTA V CODED 1
CDC	2 R F E E 4
Damage (C1-C6)	0 2 7 15 38 53
Crush (L and D)	119 191
Object Contacted 1	VEHICLE NO. 2
Object Contacted 2	Not IN TRAN LGTVEH

AIS Level	Injury Description	Contacts
1=Minor	Upper extremity skin contusion	Belt webb/buckle
1=Minor	Thoracic skin contusion	Belt webb/buckle
1=Minor	Abdominal skin contusion	Belt webb/buckle
4=Severe	Colonic laceration massive (tissue loss, gross contamination	Belt webb/buckle
2=Moderate	Colonic contusion (hematoma)	Belt webb/buckle

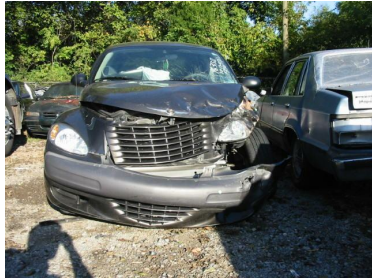
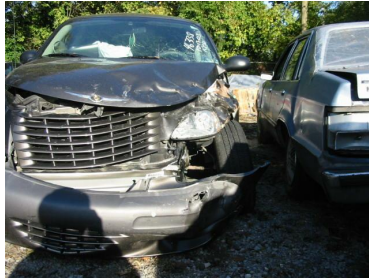
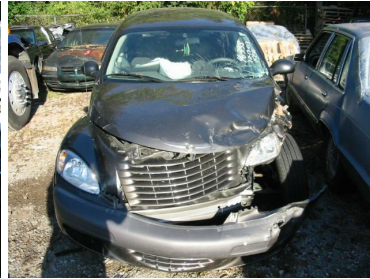
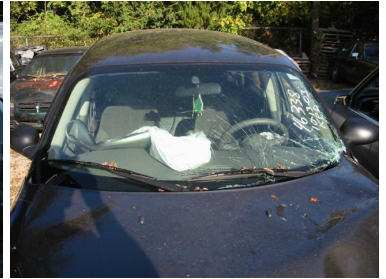
Occupant: 2003-45-178-2-1

Nr. Quarter Turns	No rollover
Impact Speed	998
Total, Longitudal, and Lateral δV	18 -16 9
Est. δV with sequence number	DELTA V CODED 1
CDC	11 F L E E 5
Damage (C1-C6)	20 12 8 5 9 17
Crush (L and D)	150 -58
Object Contacted 1	VEHICLE NO. 1
Object Contacted 2	0

AIS Level	Injury Description	Contacts
1=Minor	Acute cervical spine strain without fracture or dislocation	Other noncontact
1=Minor	Lumbar spine acute strain without fracture or dislocation	Seat, back
1=Minor	Leg skin abrasion	Knee bolster
2=Moderate	C-spine dislocation no bone or cord involvement NFS	Other noncontact
1=Minor	Upper extremity skin abrasion	Air bag-DR side

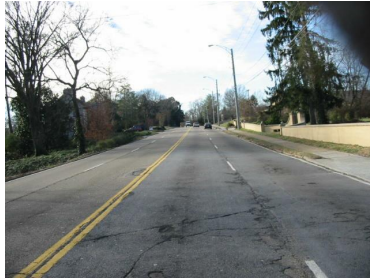
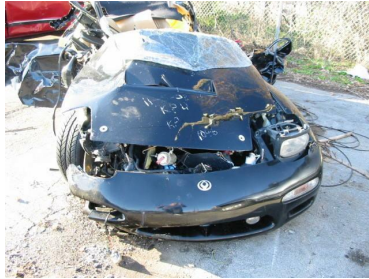
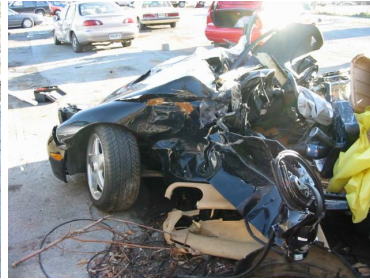
Occupant: 2003-45-203-1-1

Nr. Quarter Turns	No rollover
Impact Speed	998
Total, Longitudal, and Lateral δV	34 -17 -29
Est. δV with sequence number	DELTA V CODED 1
CDC	2 R Y E W 4
Damage (C1-C6)	0 0 0 0 0 0
Crush (L and D)	0 0
Object Contacted 1	VEHICLE NO. 2
Object Contacted 2	VEHICLE NO. 3

AIS Level	Injury Description	Contacts
3=Serious	Humeral fracture, open/displaced/comminuted	Left interior
4=Severe	Bladder laceration with perforation (full thickness)	Left interior
3=Serious	Sacroiliac fracture	Seat, back
3=Serious	Pelvic fracture, open/displaced/comminuted	Left interior
2=Moderate	Pelvic fracture, closed	Left interior
2=Moderate	2-3 rib fractures with stable chest	Left interior
4=Severe	Cerebral subdural hematoma, small (<50ccs)	Left interior
3=Serious	Cerebral subarachnoid hemorrhage	Left interior

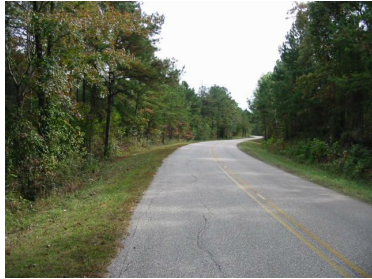
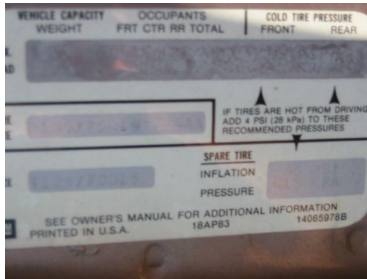
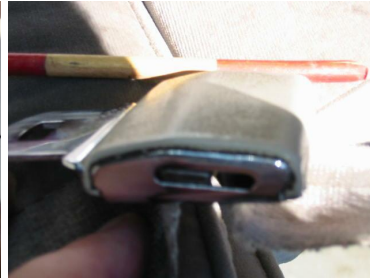
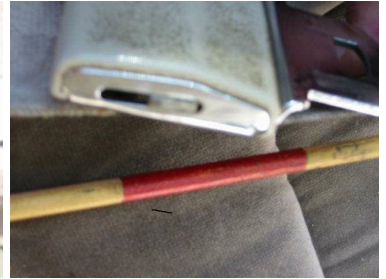
Occupant: 2003-48-206-1-1

Nr. Quarter Turns	No rollover
Impact Speed	998
Total, Longitudal, and Lateral δV	23 -8 -22
Est. δV with sequence number	DELTA V CODED 1
CDC	2 R Y E N 3
Damage (C1-C6)	37 46 30 19 11 4
Crush (L and D)	91 107
Object Contacted 1	LARGE TREE
Object Contacted 2	0

AIS Level	Injury Description	Contacts
3=Serious	Symphysis pubis separation or fracture	Belt webb/buckle
2=Moderate	Pelvic fracture, closed	Belt webb/buckle
2=Moderate	Pelvic fracture, closed	Belt webb/buckle
2=Moderate	Diaphragm contusion	Belt webb/buckle
2=Moderate	Esophageal contusion or hematoma	Belt webb/buckle
3=Serious	Thoracic cavity injury NFS, with hemo-/pneumothorax	Belt webb/buckle
1=Minor	Toe fracture	Floor
1=Minor	Acute cervical spine strain without fracture or dislocation	Belt webb/buckle
1=Minor	Neck skin contusion (hematoma)	Belt webb/buckle
1=Minor	Leg skin contusion (hematoma)	Floor
2=Moderate	Awake on admission, unconscious <1 hour	Left B pillar
1=Minor	Skin abrasion (body region unknown)	Unknown SOURCE
1=Minor	Skin contusion (body region unknown)	Unknown SOURCE

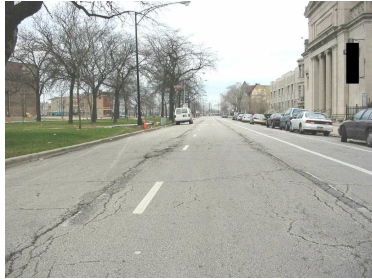
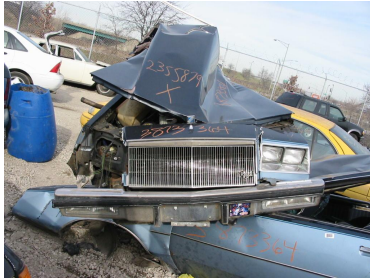
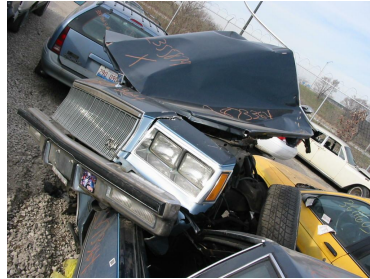
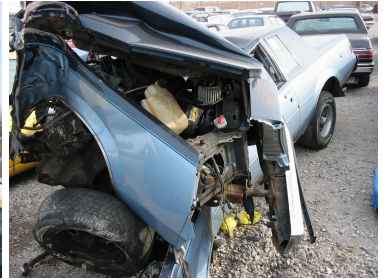
Occupant: 2003-72-148-1-1

Vehicle one was traveling northbound in the second lane of a two-lane, one-way, undivided roadway. Vehicle one traveled off the left side of the roadway. Vehicle one right struck the curb and then a utility pole. Vehicle one came to rest off the roadway. Vehicle one was towed due to damage. The restrained driver was hospitalized with both bone lower leg fractures. Unrestrained passenger 4 was treated and released with minor leg abrasion and contusion. Unrestrained passenger 2 was transported with unspecified injury. Unrestrained passenger 3 was hospitalized with a brain hemorrhage.)

Nr. Quarter Turns	No rollover
Impact Speed	999
Total, Longitudal, and Lateral δV	999 999 999
Est. δV with sequence number	SEVERE 2
CDC	99 R Y E N 99
Damage (C1-C6)	0 0 0 0 0 0
Crush (L and D)	0 0
Object Contacted 1	MEDIUM POLE
Object Contacted 2	CURB

AIS Level	Injury Description	Contacts
3=Serious	Tibial shaft fracture, open/displaced/comminuted	Left apnel
2=Moderate	Fibular head, neck, or shaft fracture	Left apnel
2=Moderate	Awake on admission, unconscious <1 hour	Steering comb

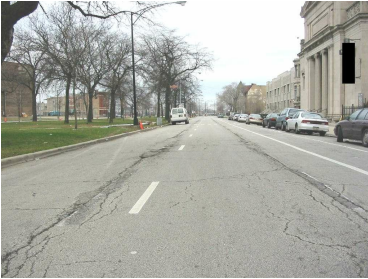
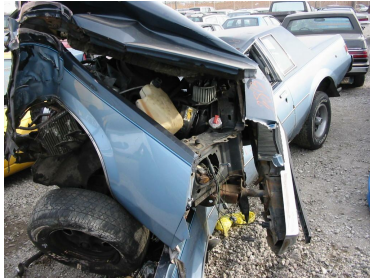
Occupant: 2003-72-148-1-3

Nr. Quarter Turns	No rollover
Impact Speed	999
Total, Longitudal, and Lateral δV	999 999 999
Est. δV with sequence number	SEVERE 2
CDC	99 R Y E N 99
Damage (C1-C6)	0 0 0 0 0 0
Crush (L and D)	0 0
Object Contacted 1	MEDIUM POLE
Object Contacted 2	CURB

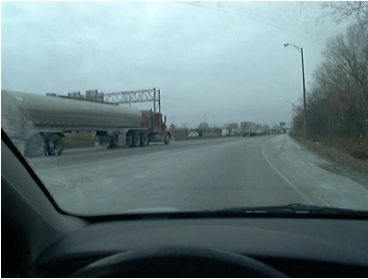
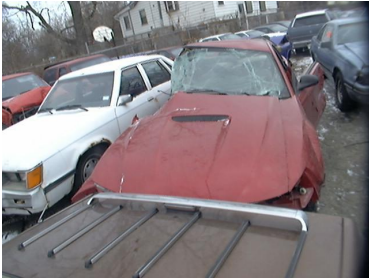
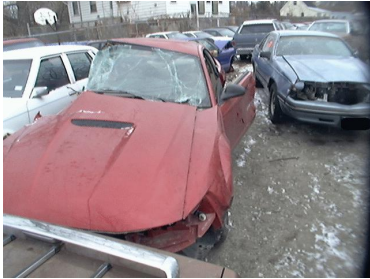
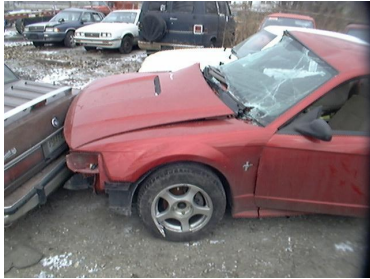
Occupant: 2003-73-20-1-1

Nr. Quarter Turns	No rollover
Impact Speed	999
Total, Longitudal, and Lateral δV	999 999 999
Est. δV with sequence number	SEVERE 1
CDC	2 R D A W 4
Damage (C1-C6)	0 0 0 0 0 0
Crush (L and D)	0 0
Object Contacted 1	VEHICLE NO. 5
Object Contacted 2	VEHICLE NO. 2

AIS Level	Injury Description	Contacts
3=Serious	2-3 rib fractures with stable chest and hemo-/pneumothorax	Right hardware
2=Moderate	Sternal fracture	Right hardware
2=Moderate	Clavicle fracture	Belt webb/buckle
1=Minor	Thoracic skin contusion	Belt webb/buckle
1=Minor	Leg skin contusion (hematoma)	Belt webb/buckle
5=Critical	Brainstem contusion	Right interior
3=Serious	Cerebellar contusion, small or superficial (<15 ccs)	Right interior
3=Serious	Cerebral contusion, single, small (<30ccs)	Right interior
3=Serious	Cerebral brain swelling, mild	Right interior
3=Serious	Cerebral subarachnoid hemorrhage	Right interior
3=Serious	Cerebral subarachnoid hemorrhage	Right interior
2=Moderate	Oculomotor nerve injury, NFS	Right interior
4=Severe	Lung contusion, bilateral	Right hardware
1=Minor	297402	Right interior
1=Minor	Facial skin abrasion	Right interior
1=Minor	Facial skin contusion	Right interior
1=Minor	Facial skin laceration, minor	Flying glass

1=Minor	Upper extremity skin contusion	Belt webb/buckle
5=Critical	Unconscious on admission, inappropriate movements	Right interior

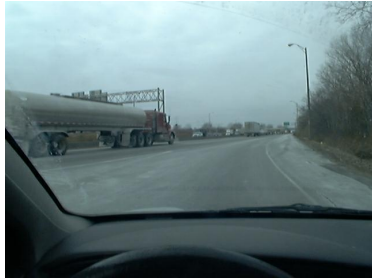
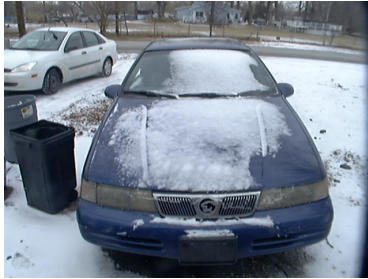
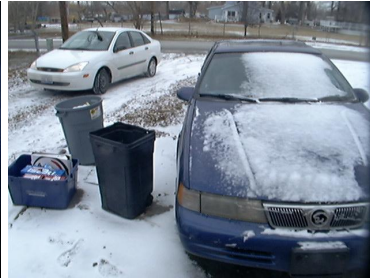
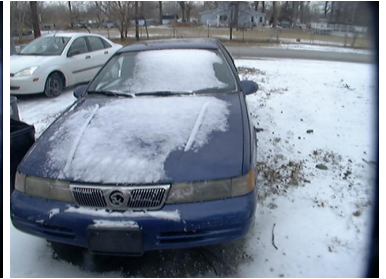
Occupant: 2003-73-20-2-1

Nr. Quarter Turns	No rollover
Impact Speed	999
Total, Longitudal, and Lateral δV	999 999 999
Est. δV with sequence number	MODERATE 2
CDC	1 R Z E W 2
Damage (C1-C6)	0 0 0 0 0 0
Crush (L and D)	0 0
Object Contacted 1	VEHICLE NO. 1
Object Contacted 2	CONCRETE BARRIER

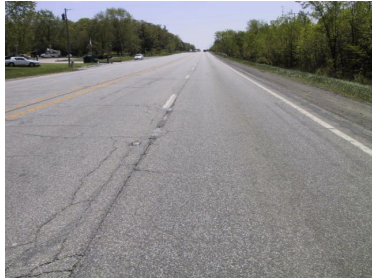
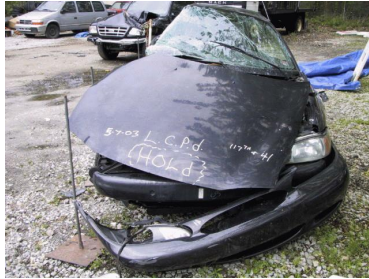
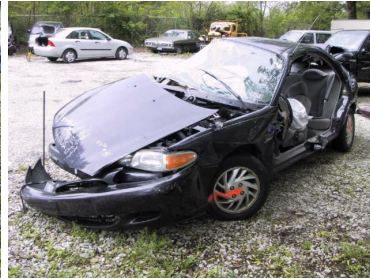
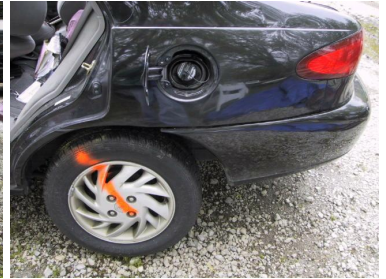
Occupant: 2003-73-77-1-1

Vehicle	Body type	Make	Model	Year	Occ.#	Age	Occupant's sex	Maximum known occupant ais
1	4-DR SEDAN/HDTOP	Ford	Escort/EXP	1997	1	37	MALE	5=Critical
2	MINIVAN	Dodge	Caravan	2001	1	34	FEMALE-NOT PREG	2=Moderate
2	MINIVAN	Dodge	Caravan	2001	2	54	FEMALE-NOT PREG	3=Serious
2	MINIVAN	Dodge	Caravan	2001	3	2	FEMALE-NOT PREG	1=Minor
2	MINIVAN	Dodge	Caravan	2001	4	1	MALE	0=None

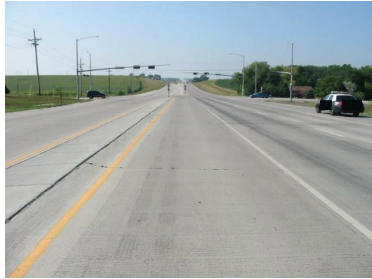
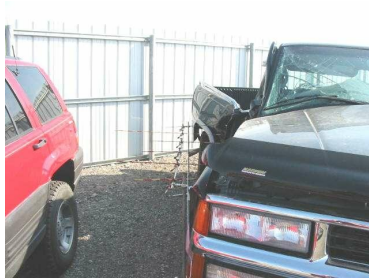
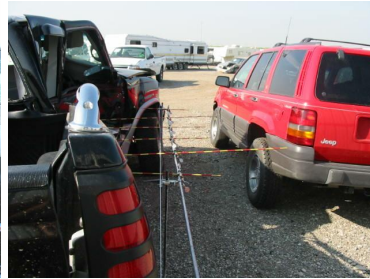
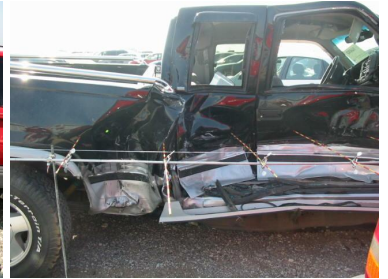
Occupant: 2003-74-140-1-1

Vehicle	Body type	Make	Model	Year	Occ Age	Occupant's sex	Maximum known occupant ais
1	LARGE PICKUP	Chevrolet	C,K,R,V-series Pickup	1997	74	FEMALE-NOT PREG	3=Serious

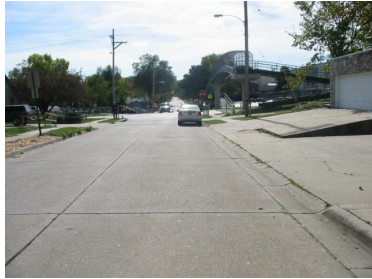
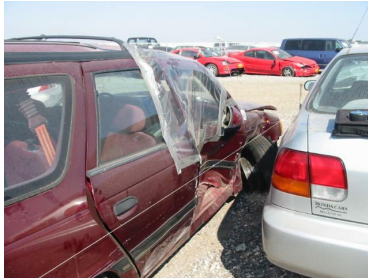
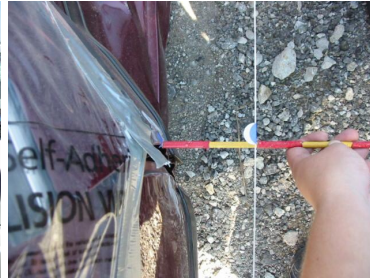
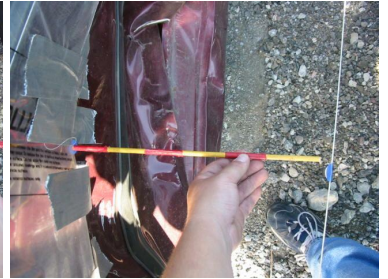
Occupant: 2003-74-183-1-1

AIS Level	Injury Description	Contacts
4=Severe	>3 rib fxs on one side & <3 other side & hemo-/pneumothorax	Unknown SOURCE
3=Serious	Lung contusion, unilateral	Unknown SOURCE
1=Minor	Leg skin contusion (hematoma)	Center panel

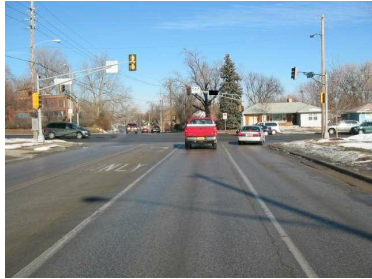
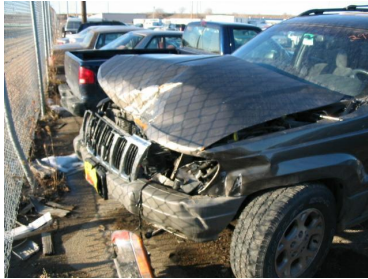
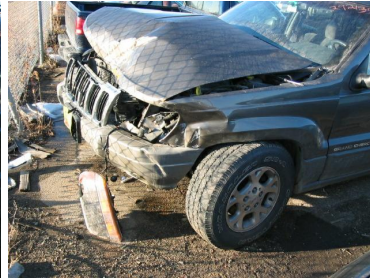
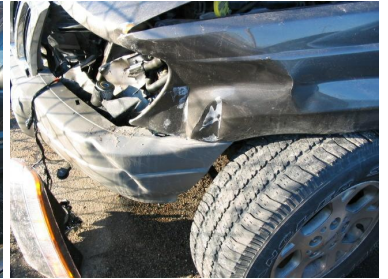
Occupant: 2003-74-233-1-1

Nr. Quarter Turns	No rollover
Impact Speed	998
Total, Longitudal, and Lateral δV	17 -6 16
Est. δV with sequence number	DELTA V CODED 1
CDC	70 F D E W 1
Damage (C1-C6)	9 8 9 9 0 4
Crush (L and D)	162 -5
Object Contacted 1	VEHICLE NO. 2
Object Contacted 2	0

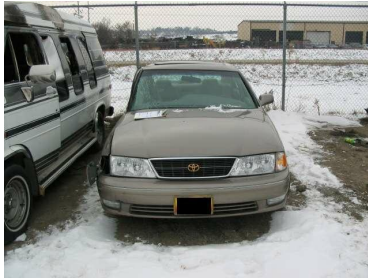
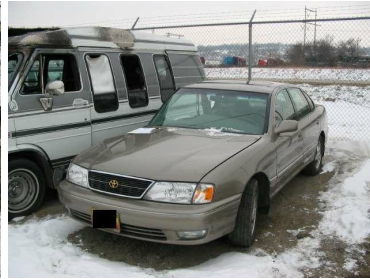
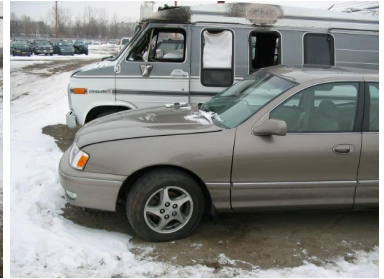
Occupant: 2003-74-233-2-1

Nr. Quarter Turns	No rollover
Impact Speed	998
Total, Longitudal, and Lateral δV	20 -20 -4
Est. δV with sequence number	DELTA V CODED 1
CDC	12 R Y E W 3
Damage (C1-C6)	0 16 42 30 7 6
Crush (L and D)	306 69
Object Contacted 1	VEHICLE NO. 1
Object Contacted 2	FENCE

AIS Level	Injury Description	Contacts
1=Minor	Abdominal skin contusion	Transmiss lever
1=Minor	Upper extremity skin abrasion	Belt webb/buckle
1=Minor	Upper extremity skin contusion	Belt webb/buckle
3=Serious	Single rib fracture with hemo-/pneumothorax	Transmiss lever
