Crash Reports

Prepared by Ken Digges

Mon Jan 16 14:44:34 2006

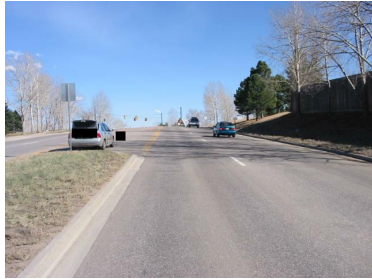
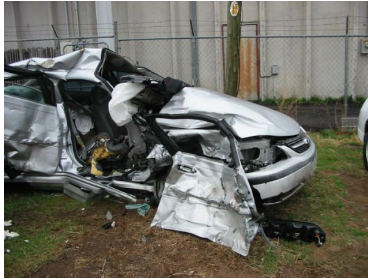
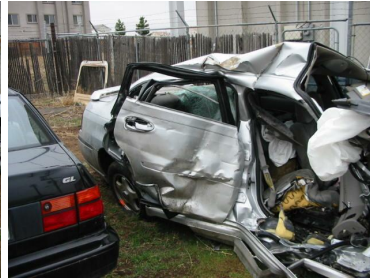
Occupant: 2003-75-29-1-1

Nr. Quarter Turns	No rollover
Impact Speed	999
Total, Longitudal, and Lateral δV	999 999 999
Est. δV with sequence number	SEVERE 1
CDC	1 R Y A W 4
Damage (C1-C6)	0 0 0 0 0 0
Crush (L and D)	0 0
Object Contacted 1	VEHICLE NO. 2
Object Contacted 2	0

AIS Level	Injury Description	Contacts
5=Critical	Cerebral diffuse axonal injury	Unknown SOURCE
4=Severe	Cerebral intraventricular hemorrhage	Unknown SOURCE
4=Severe	Cerebral intraventricular hemorrhage	Unknown SOURCE
3=Serious	Unconscious on admission, length <1 hour	Unknown SOURCE
4=Severe	Lung contusion, bilateral	Seat, back
3=Serious	>3 rib fractures one side & <3 other side, with stable chest	Seat, back
2=Moderate	Hepatic laceration, minor (<3cms deep, EBL<201=Minor	Upper extremity skin abrasion
Belt webb/buckle		
1=Minor	690202	Belt webb/buckle
1=Minor	Leg skin abrasion	Center panel

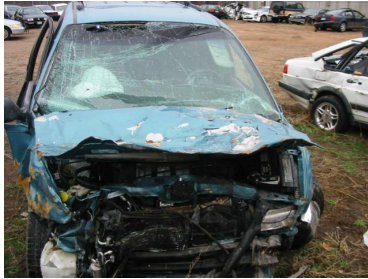
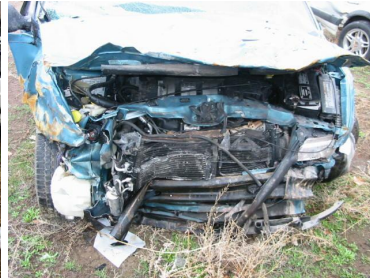
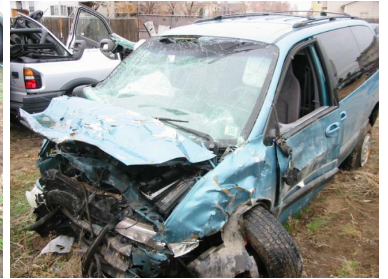
Occupant: 2003-75-29-2-1

Fire Occurrence	No fire
Fire Origin	No fire
Location of Fuel Leakage	No fuel leakage
Type of Fuel Tank	Metallic
Fuel Tank Location	Forward of rear axle, left side
Fuel Cap Location	Left side, forward rear axle
Fuel Tank Damage	No damage
Fuel Type	Gasoline

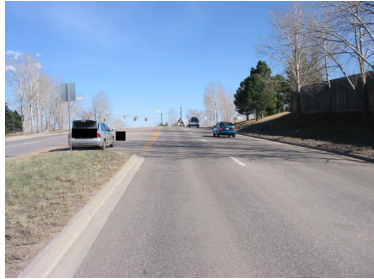
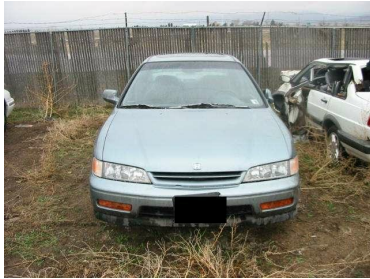
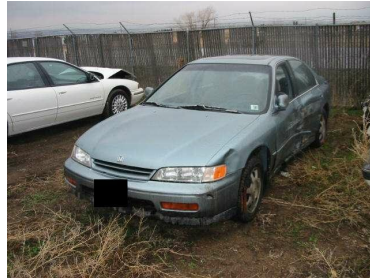
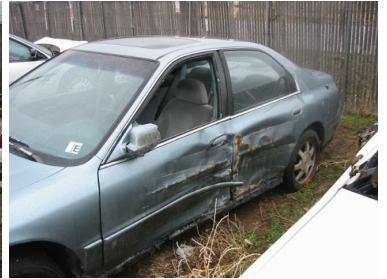
Occupant: 2003-75-29-3-1

Fire Occurrence	No fire
Fire Origin	No fire
Location of Fuel Leakage	No fuel leakage
Type of Fuel Tank	Metallic
Fuel Tank Location	Forward of rear axle, left side
Fuel Cap Location	Left side, behind rear axle
Fuel Tank Damage	No damage
Fuel Type	Gasoline

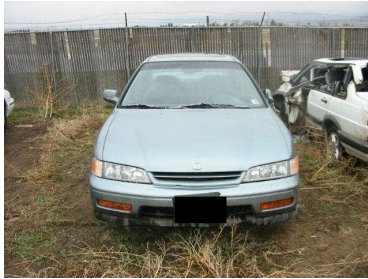
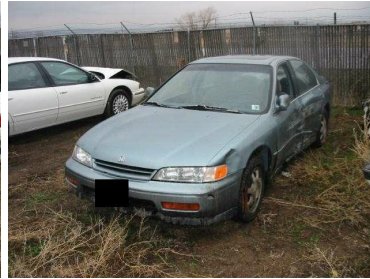
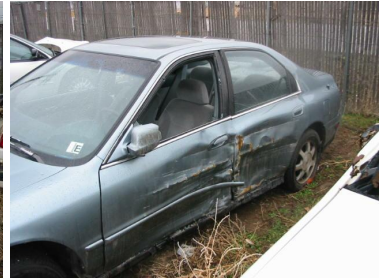
Occupant: 2003-75-29-3-2

Fire Occurrence	No fire
Fire Origin	No fire
Location of Fuel Leakage	No fuel leakage
Type of Fuel Tank	Metallic
Fuel Tank Location	Forward of rear axle, left side
Fuel Cap Location	Left side, behind rear axle
Fuel Tank Damage	No damage
Fuel Type	Gasoline

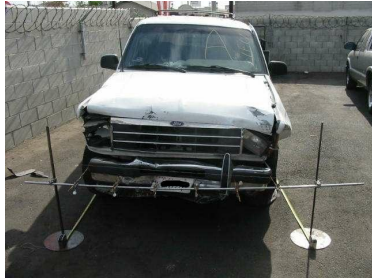
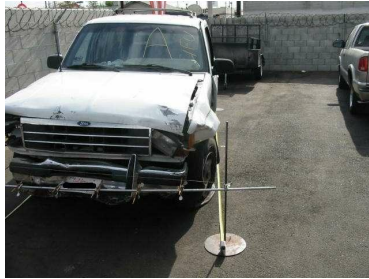
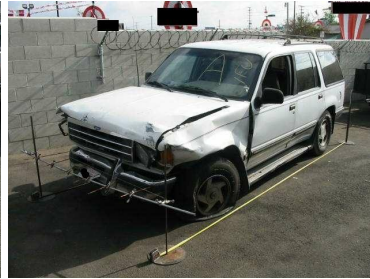
Occupant: 2003-79-179-1-1

Fire Occurrence	No fire
Fire Origin	No fire
Location of Fuel Leakage	No fuel leakage
Type of Fuel Tank	Metallic
Fuel Tank Location	Forward of rear axle, left side
Fuel Cap Location	Left side, behind rear axle
Fuel Tank Damage	No damage
Fuel Type	Gasoline

AIS Level	Injury Description	Contacts
1=Minor	Scalp laceration, minor	Windshield
1=Minor	Awake on admission, never unconscious	Windshield

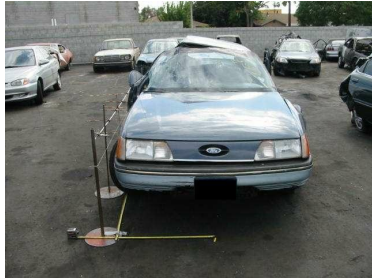
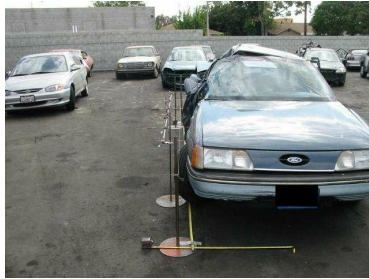
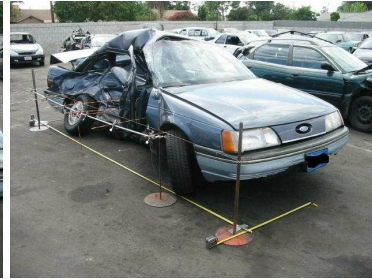
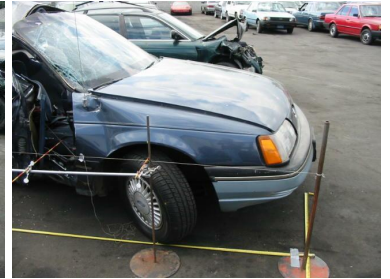
Occupant: 2003-79-179-2-1

Fire Occurrence	No fire
Fire Origin	No fire
Location of Fuel Leakage	No fuel leakage
Type of Fuel Tank	Metallic
Fuel Tank Location	Forward of rear axle, centered
Fuel Cap Location	Right side, behind rear axle
Fuel Tank Damage	Deformed
Fuel Type	Gasoline

AIS Level	Injury Description	Contacts
5=Critical	Cerebral diffuse ax-onal injury	Other occupants
4=Severe	Unconscious on admission, length <1 hour & neuro deficit	Other occupants
1=Minor	Myocardial contusion, minor	Left interior

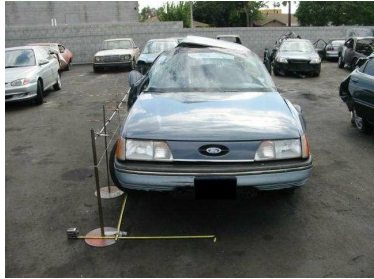
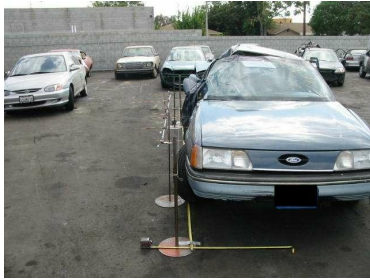
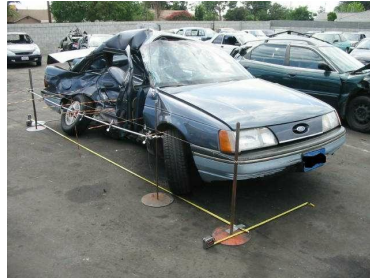
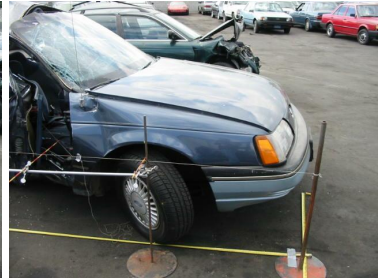
Occupant: 2003-79-179-2-2

Fire Occurrence	No fire
Fire Origin	No fire
Location of Fuel Leakage	No fuel leakage
Type of Fuel Tank	Metallic
Fuel Tank Location	Forward of rear axle, centered
Fuel Cap Location	Right side, behind rear axle
Fuel Tank Damage	Deformed
Fuel Type	Gasoline

AIS Level	Injury Description	Contacts
2=Moderate	Rib cage fracture NFS	Right interior
3=Serious	Lung contusion, uni-lateral	Right interior
2=Moderate	Hepatic injury NFS	Right interior
2=Moderate	Scapular fracture	Right B pillar
2=Moderate	Scapular fracture	Right B pillar
2=Moderate	Pelvic fracture NFS	Right interior
2=Moderate	Arm, forearm, hand fracture NFS	Right interior

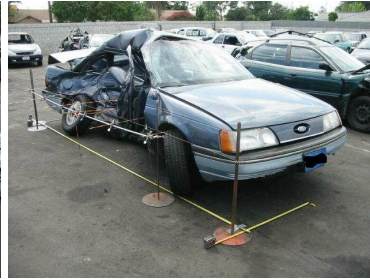
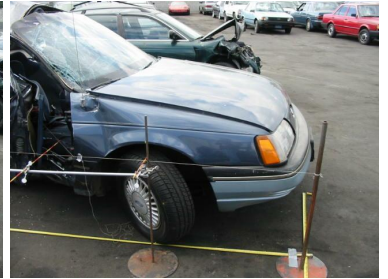
Occupant: 2003-79-179-2-3

Fire Occurrence	No fire
Fire Origin	No fire
Location of Fuel Leakage	No fuel leakage
Type of Fuel Tank	Metallic
Fuel Tank Location	Forward of rear axle, centered
Fuel Cap Location	Right side, behind rear axle
Fuel Tank Damage	Deformed
Fuel Type	Gasoline

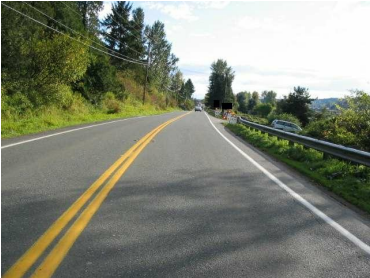
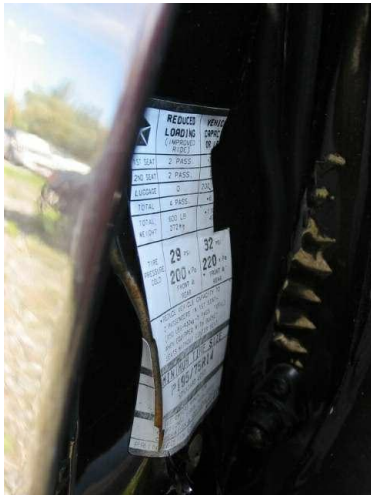
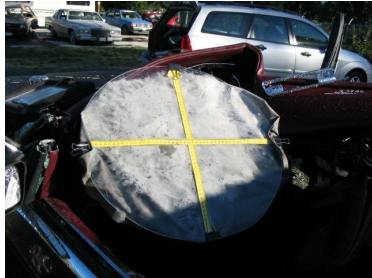
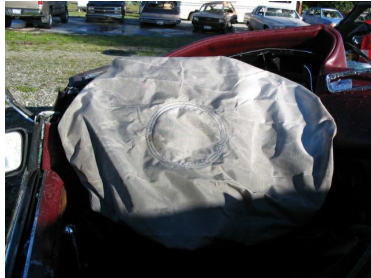
Occupant: 2003-81-54-1-1

Fire Occurence	No fire
Fire Origin	No fire
Location of Fuel Leakage	No fuel leakage
Type of Fuel Tank	Metallic
Fuel Tank Location	Behind rear axle, centered
Fuel Cap Location	Right side, behind rear axle
Fuel Tank Damage	No damage
Fuel Type	Gasoline
