Crash Reports

Prepared by Ken Digges

1 Case 2004-2-4

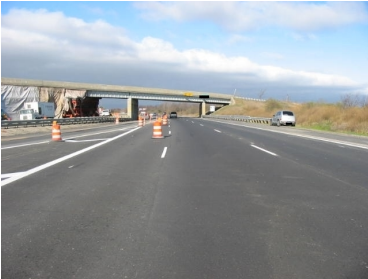
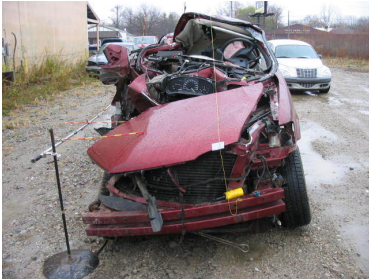
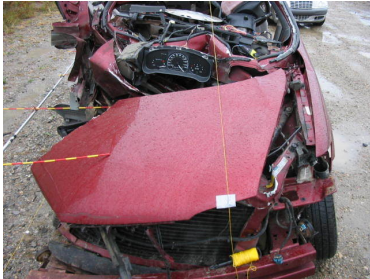
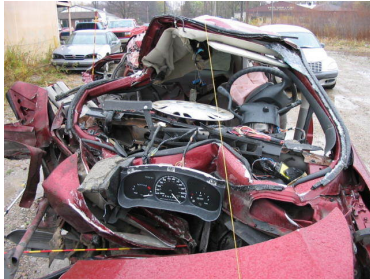
Occupant: 2004-12-175-1-1

V1, a 1999 Chevrolet Venture, was traveling north on a wet, asphalt, expressway where 2 lanes were closed due to construction. Driving was allowed on the right shoulder. There was construction going on at the overpass where they were painting the bridge. V1 started to lose control and rotated in a counter clockwise rotation. The right of the V1 contacted a hi-lo sandblaster trailer causing severe damage to the right side of the vehicle. V1 was towed due to damage. The only occupant of V1 was dead at the scene.)

Nr. Quarter Turns	No rollover
Impact Speed	999
Total, Longitudal, and Lateral δV	999 999 999
Est. δV with sequence number	DELTA V CODED 1
CDC	62 R D A W 5
Damage (C1-C6)	0 0 33 37 70 26
Crush (L and D)	410 -8
Object Contacted 1	Oth NONFIXED OBJ
Object Contacted 2	0

AIS Level	Injury Description	Contacts
6=Maximum	Head injury, crush (massive destruction of skull and brain)	Other veh or obj
1=Minor	Facial skin laceration, minor	Other veh or obj
1=Minor	Facial bone fracture NFS	Other veh or obj
1=Minor	Teeth fracture	Other veh or obj
6=Maximum	Cord laceration, complete, C3 or above, with fx&dislocation	Other veh or obj
1=Minor	Upper extremity skin abrasion	Right interior
1=Minor	Abdominal skin abrasion	Right interior
1=Minor	690202	Oth interior obj
2=Moderate	Clavicle fracture	Right interior
5=Critical	Flail chest, bilateral	Right interior
3=Serious	Lung laceration, unilateral NFS	Right interior
5=Critical	Massive hepatic injury (>503=Serious	Humeral fracture, open/displaced/comminuted
Right interior		
1=Minor	Leg skin abrasion	Center panel
1=Minor	Leg skin contusion (hematoma)	Center panel

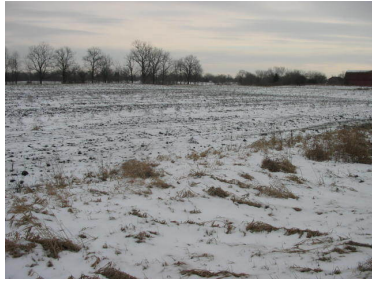
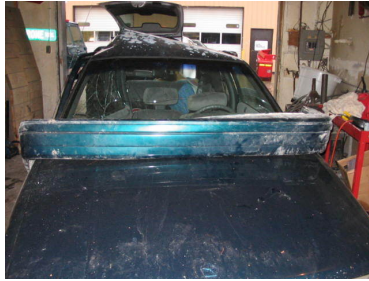
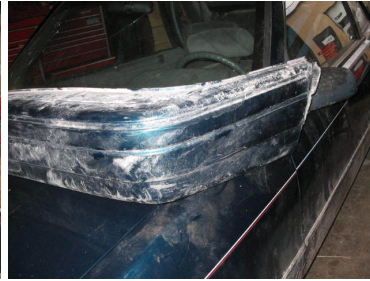
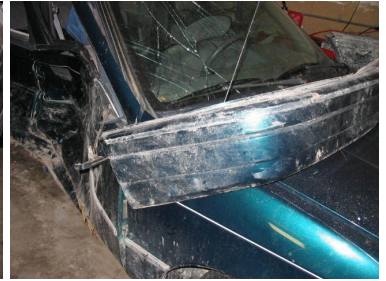
Occupant: 2004-12-196-1-1

Nr. Quarter Turns	No rollover
Impact Speed	998
Total, Longitudal, and Lateral δV	40 -20 -35
Est. δV with sequence number	DELTA V CODED 1
CDC	62 R Z E W 4
Damage (C1-C6)	0 26 47 54 27 0
Crush (L and D)	249 -49
Object Contacted 1	VEHICLE NO. 2
Object Contacted 2	0

AIS Level	Injury Description	Contacts
2=Moderate	Mesenteric laceration NFS	Transmiss lever
4=Severe	Lung contusion, bilat- eral	Belt webb/buckle
1=Minor	Scalp contusion	Right wind frame
6=Maximum	Cord laceration, com- plete, C3 or above, with fx&dislocation	Right windowsill
6=Maximum	Brain stem laceration	Right windowsill
1=Minor	Upper extremity skin contusion	Belt webb/buckle
1=Minor	Thoracic skin contu- sion	Belt webb/buckle
1=Minor	Abdominal skin con- tusion	Belt webb/buckle
1=Minor	Leg skin contusion (hematoma)	Belt webb/buckle
4=Severe	>3 rib fxs on each side, stable chest	Belt webb/buckle
2=Moderate	Sternal fracture	Belt webb/buckle
4=Severe	Lung laceration, bilat- eral NFS	Belt webb/buckle
2=Moderate	Colonic contusion (hematoma)	Belt webb/buckle

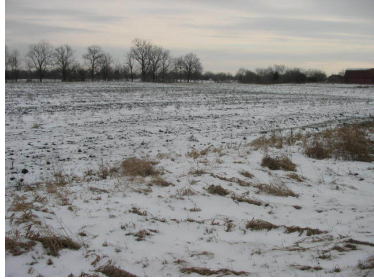
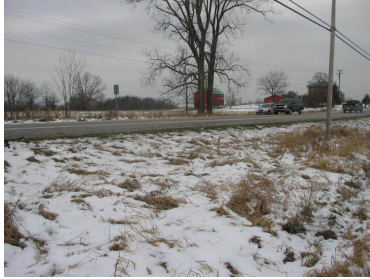
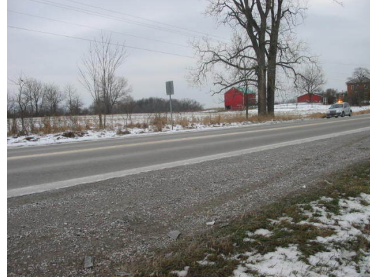
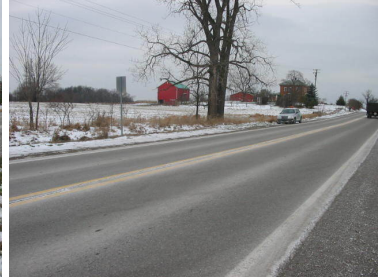
Occupant: 2004-12-196-2-1

Nr. Quarter Turns	No rollover
Impact Speed	998
Total, Longitudal, and Lateral δV	46 -43 16
Est. δV with sequence number	DELTA V CODED 1
CDC	No data No data No data No data
Damage (C1-C6)	No data No data No data No data
Crush (L and D)	No data No data
Object Contacted 1	No data
Object Contacted 2	No data

AIS Level	Injury Description	Contacts
1=Minor	Acute cervical spine strain without fracture or dislocation	Unknown SOURCE
1=Minor	Thoracic skin abrasion	Unknown SOURCE
1=Minor	Thoracic skin contusion	Unknown SOURCE
1=Minor	Neck skin contusion (hematoma)	Unknown SOURCE
1=Minor	Upper extremity skin contusion	Belt webb/buckle
1=Minor	Abdominal skin contusion	Belt webb/buckle
1=Minor	Leg skin contusion (hematoma)	Unknown SOURCE

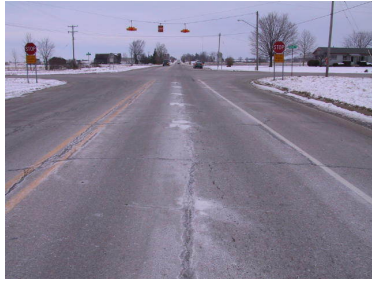
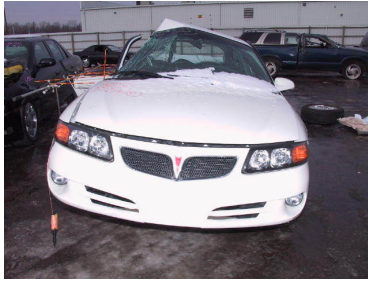
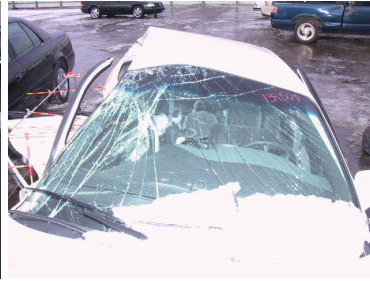
Occupant: 2004-12-199-1-1

Nr. Quarter Turns	No rollover
Impact Speed	998
Total, Longitudal, and Lateral δV	27 -5 -27
Est. δV with sequence number	DELTA V CODED 1
CDC	63 R Y A W 4
Damage (C1-C6)	3 22 55 58 44 8
Crush (L and D)	237 -4
Object Contacted 1	VEHICLE NO. 2
Object Contacted 2	CURB

AIS Level	Injury Description	Contacts
2=Moderate	Hepatic laceration, minor (<3cms deep, EBL<203=Serious	2-3 rib fractures with stable chest and hemo-/pneumothorax
Transmiss lever 1=Minor	Upper extremity skin laceration, minor	Transmiss lever
1=Minor	Facial skin contusion	Other occupants
1=Minor	Upper extremity skin abrasion	Transmiss lever

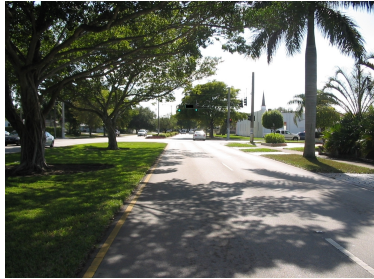
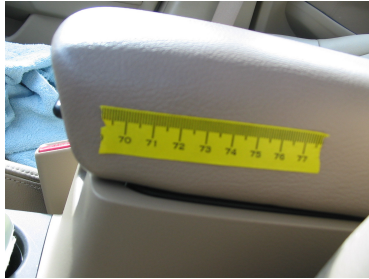
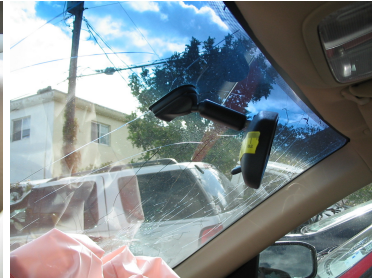
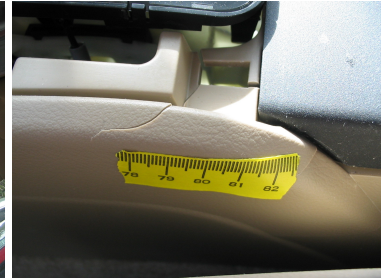
Occupant: 2004-41-146-1-1

Nr. Quarter Turns	No rollover
Impact Speed	998
Total, Longitudal, and Lateral δV	23 -12 -20
Est. δV with sequence number	DELTA V CODED 1
CDC	2 R F E W 3
Damage (C1-C6)	0 0 0 0 0 0
Crush (L and D)	0 0
Object Contacted 1	VEHICLE NO. 2
Object Contacted 2	MEDIUM POLE

AIS Level	Injury Description	Contacts
1=Minor	Upper extremity skin contusion	Air bag-DR side
1=Minor	Leg skin contusion (hematoma)	Knee bolster
3=Serious	Pelvic fracture, open/displaced/comminuted	Knee bolster
3=Serious	851614	Floor
2=Moderate	Rib cage fracture NFS	Left interior
1=Minor	Facial skin contusion	Steering rim
1=Minor	Leg skin contusion (hematoma)	Belt webb/buckle

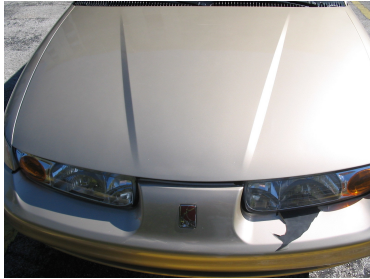
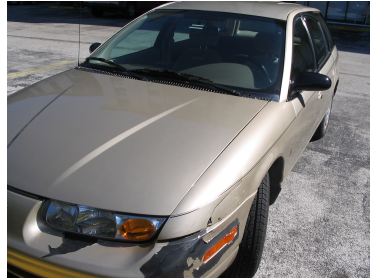
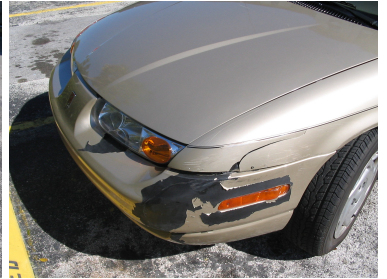
Occupant: 2004-41-146-3-1

Nr. Quarter Turns	No rollover
Impact Speed	999
Total, Longitudal, and Lateral δV	999 999 999
Est. δV with sequence number	MINOR 3
CDC	12 F L E S 99
Damage (C1-C6)	0 0 0 0 0 0
Crush (L and D)	0 0
Object Contacted 1	VEHICLE NO. 2
Object Contacted 2	0

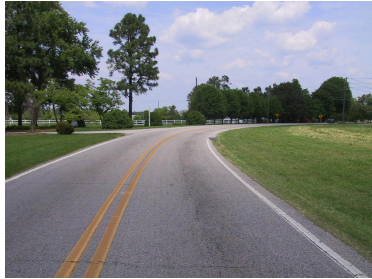
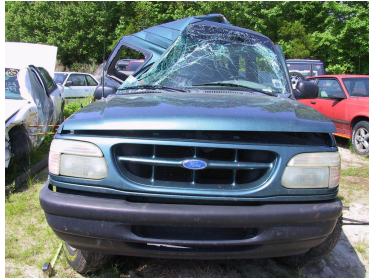
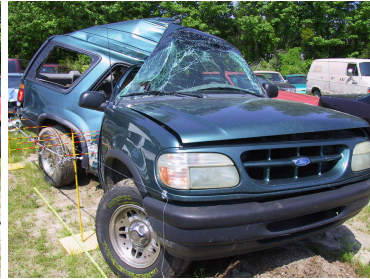
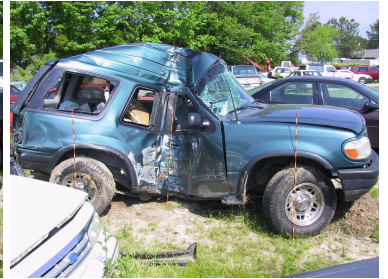
Occupant: 2004-43-144-1-1

Nr. Quarter Turns	No rollover
Impact Speed	998
Total, Longitudal, and Lateral δV	51 9 -50
Est. δV with sequence number	DELTA V CODED 1
CDC	3 R P A W 6
Damage (C1-C6)	0 6 18 57 78 14
Crush (L and D)	247 -9
Object Contacted 1	LARGE TREE
Object Contacted 2	0

AIS Level	Injury Description	Contacts
3=Serious	Cerebral subarachnoid hemorrhage	Right wind frame
5=Critical	Intracerebral hematoma, small, bilateral	Right wind frame
2=Moderate	Clavicle fracture	Right B pillar
1=Minor	Neck skin laceration, minor	Right B pillar
3=Serious	Cerebral contusions, multiple, unilateral but NFS	Right wind frame
4=Severe	Cerebral intraventricular hemorrhage	Right wind frame
2=Moderate	Skull fracture, vault, closed (simple, undisplaced)	Right wind frame

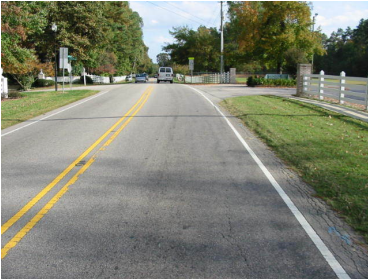
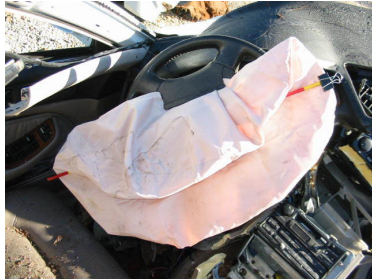
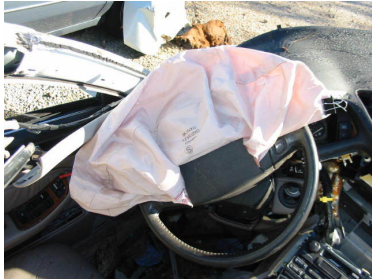
Occupant: 2004-43-312-1-1

Nr. Quarter Turns	No rollover
Impact Speed	998
Total, Longitudal, and Lateral δV	29 -19 -22
Est. δV with sequence number	DELTA V CODED 5
CDC	2 R Y A W 3
Damage (C1-C6)	0 0 23 27 8 21
Crush (L and D)	390 104
Object Contacted 1	LARGE TREE
Object Contacted 2	LARGE TREE

AIS Level	Injury Description	Contacts
1=Minor	297202	Air bag-DR side
1=Minor	Abdominal skin abrasion	Transmiss lever
1=Minor	Abdominal skin contusion	Belt webb/buckle
1=Minor	Upper extremity skin abrasion	Seat, back
1=Minor	Upper extremity skin abrasion	Center panel
3=Serious	Thoracic cavity injury NFS, with hemo-/pneumothorax	Belt webb/buckle
4=Severe	Cerebral hematoma, NFS	Roof
3=Serious	Cerebral subarachnoid hemorrhage	Roof

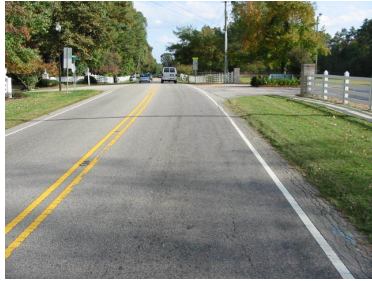
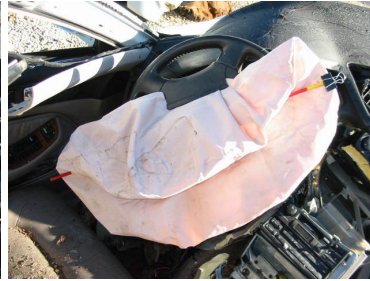
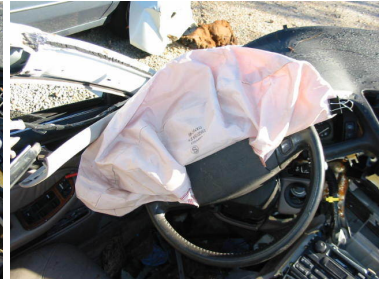
Occupant: 2004-43-312-1-2

Nr. Quarter Turns	No rollover
Impact Speed	998
Total, Longitudal, and Lateral δV	29 -19 -22
Est. δV with sequence number	DELTA V CODED 5
CDC	2 R Y A W 3
Damage (C1-C6)	0 0 23 27 8 21
Crush (L and D)	390 104
Object Contacted 1	LARGE TREE
Object Contacted 2	LARGE TREE

AIS Level	Injury Description	Contacts
1=Minor	Facial skin laceration, minor	Other veh or obj
1=Minor	Facial skin laceration, minor	Other veh or obj
3=Serious	Skull fracture, vault, comminuted (compound, depressed)	Other veh or obj
1=Minor	Scalp laceration, minor	Right A pillar
1=Minor	Facial skin abrasion	Flying glass
1=Minor	Scalp contusion	Other veh or obj
4=Severe	Basilar skull fracture, open, with brain tissue loss.	Other veh or obj
3=Serious	Cerebral subarachnoid hemorrhage	Other veh or obj
6=Maximum	Brain stem laceration	Other veh or obj
1=Minor	Thoracic skin abrasion	Flying glass
1=Minor	Thoracic skin contusion	Right interior
1=Minor	Abdominal skin abrasion	Right interior
1=Minor	Abdominal skin contusion	Right interior
1=Minor	Perineal laceration NFS	Right interior
4=Severe	>3 rib fxs on one side & <3 other side & hemo-/pneumothorax	Right interior
5=Critical	Thoracic aortic laceration, major NFS	Right interior

4=Severe	440606	Right interior
5=Critical	Massive hepatic injury (>502=Moderate	Pelvic fracture NFS
Right interior		
1=Minor	Leg skin laceration NFS	Right interior
3=Serious	Femur fracture NFS	Right interior
3=Serious	Tibial shaft fracture, open/displaced/comminuted	Right interior
2=Moderate	Fibular head, neck, or shaft fracture	Right interior
1=Minor	Leg skin contusion (hematoma)	Right panel
2=Moderate	851605	Right panel
2=Moderate	Tibial fracture NFS	Right panel
1=Minor	Leg skin abrasion	Right panel
1=Minor	Upper extremity skin abrasion	Right interior
1=Minor	Upper extremity skin contusion	Right interior

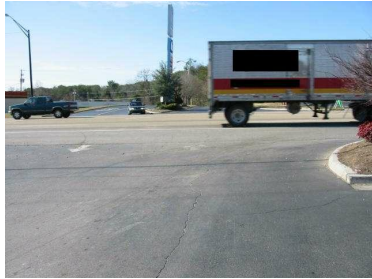
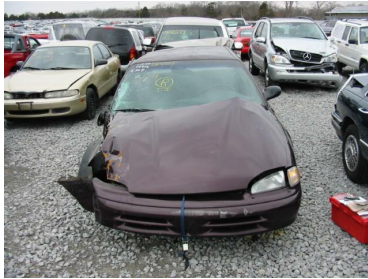
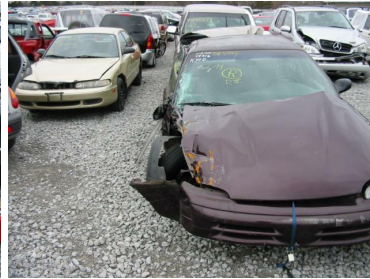
Occupant: 2004-45-4-1-1

Nr. Quarter Turns	No rollover
Impact Speed	998
Total, Longitudal, and Lateral δV	31 -20 -24
Est. δV with sequence number	DELTA V CODED 1
CDC	2 R Y A W 3
Damage (C1-C6)	2 5 15 27 42 24
Crush (L and D)	214 151
Object Contacted 1	VEHICLE NO. 2
Object Contacted 2	VEHICLE NO. 2

AIS Level	Injury Description	Contacts
2=Moderate	Pelvic fracture NFS	Oth interior obj
2=Moderate	Pelvic fracture NFS	Oth interior obj
1=Minor	Leg skin contusion (hematoma)	Knee bolster
1=Minor	Leg skin abrasion	Knee bolster
3=Serious	2-3 rib fractures with stable chest and hemo-/pneumothorax	Oth interior obj
2=Moderate	Tibial condylar fracture	Knee bolster
1=Minor	Thoracic skin contusion	Unknown SOURCE

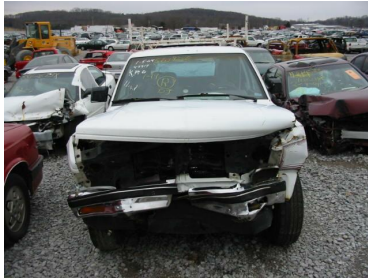
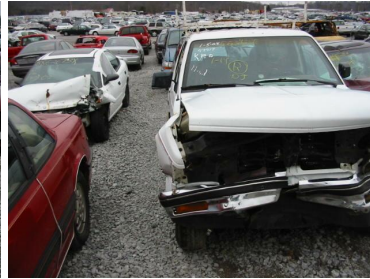
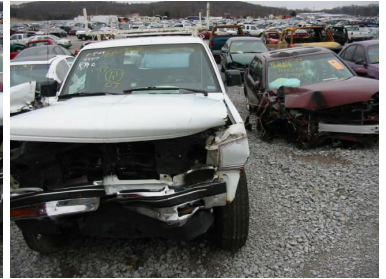
Occupant: 2004-45-4-2-1

AIS Level	Injury Description	Contacts
1=Minor	Lumbar spine acute strain without fracture or dislocation	Other noncontact

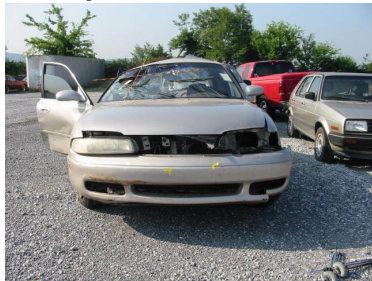
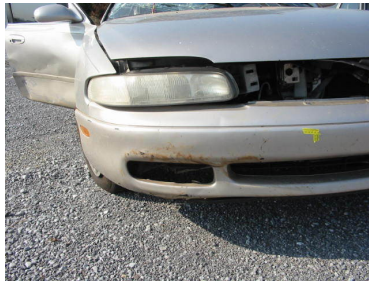
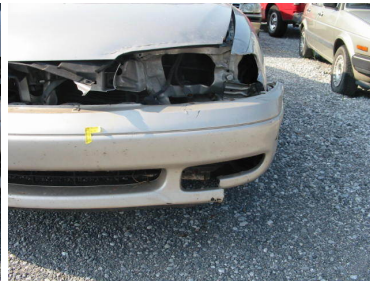
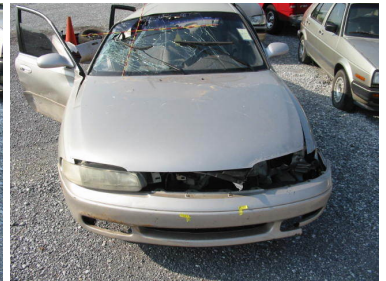
Occupant: 2004-45-130-1-1

Fire Occurrence	No fire
Fire Origin	No fire
Location of Fuel Leakage	No fuel leakage
Type of Fuel Tank	Metallic
Fuel Tank Location	Forward of rear axle, centered
Fuel Cap Location	Left side, behind rear axle
Fuel Tank Damage	Deformed
Fuel Type	Gasoline

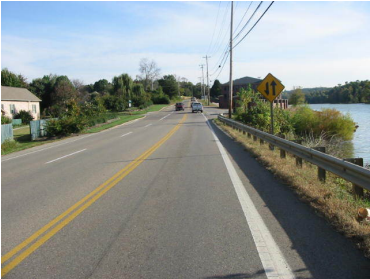
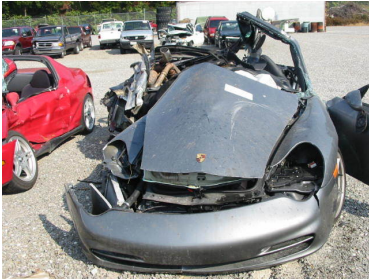
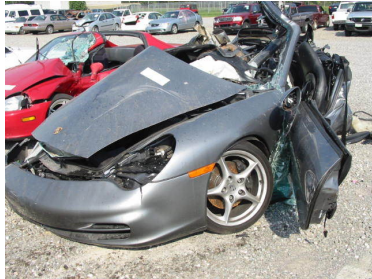
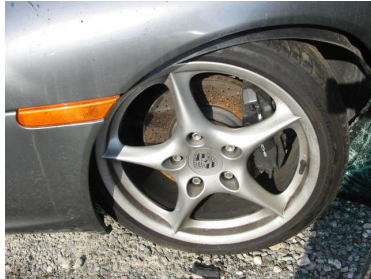
Occupant: 2004-45-173-1-1

AIS Level	Injury Description	Contacts
6=Maximum	Head injury, crush (massive destruction of skull and brain)	Right A pillar
2=Moderate	Sclera laceration involving globe (includes rupture)	Right A pillar
2=Moderate	Clavicle fracture	Belt webb/buckle
2=Moderate	Clavicle fracture	Right interior
2=Moderate	Sternal fracture	Right interior
2=Moderate	2-3 rib fractures with stable chest	Right interior
1=Minor	Upper extremity skin abrasion	Belt webb/buckle
1=Minor	Thoracic skin abrasion	Belt webb/buckle
3=Serious	Pelvic fracture, open/displaced/comminuted	Right interior
3=Serious	851801	Right interior
3=Serious	Penile laceration, massive (amputation, complex, rupture)	Right interior
2=Moderate	Scrotal laceration, major (amputation, avulsion, complex)	Right interior
1=Minor	Leg skin laceration, minor	Left interior
2=Moderate	Humeral fracture NFS	Right interior
1=Minor	Upper extremity skin laceration NFS	Right interior

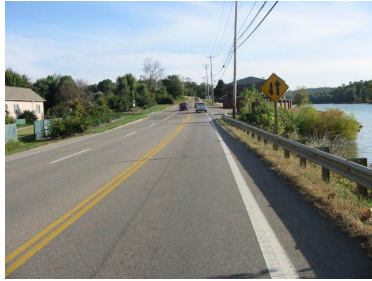
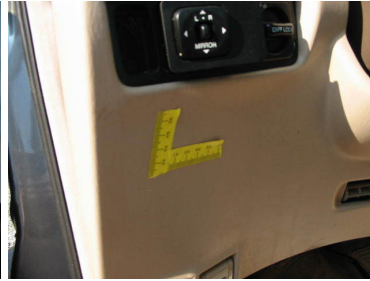
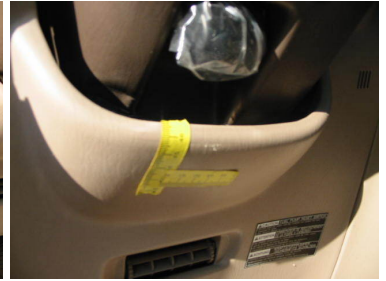
Occupant: 2004-45-173-2-1

Fire Occurrence	No fire
Fire Origin	No fire
Location of Fuel Leakage	No fuel leakage
Type of Fuel Tank	Metallic
Fuel Tank Location	Forward of rear axle, centered
Fuel Cap Location	Left side, behind rear axle
Fuel Tank Damage	No damage
Fuel Type	Gasoline

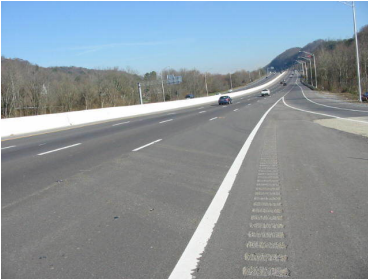
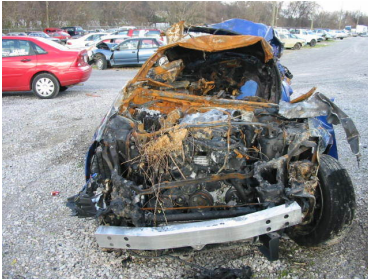
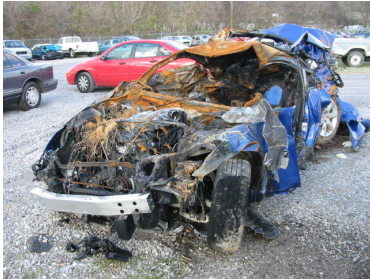
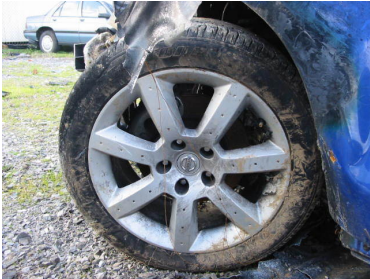
Occupant: 2004-45-219-1-1

Fire Occurence	Major fire
Fire Origin	Fuel tank
Location of Fuel Leakage	Tank
Type of Fuel Tank	Metallic
Fuel Tank Location	Forward of rear axle, right side
Fuel Cap Location	Right side, behind rear axle
Fuel Tank Damage	Unknown
Fuel Type	Gasoline

Nr. Quarter Turns	No rollover
Impact Speed	999
Total, Longitudal, and Lateral δV	999 999 999
Est. δV with sequence number	SEVERE 1
CDC	2 R P A W 5
Damage (C1-C6)	0 0 0 0 0 0
Crush (L and D)	0 0
Object Contacted 1	LARGE POLE
Object Contacted 2	LARGE TREE

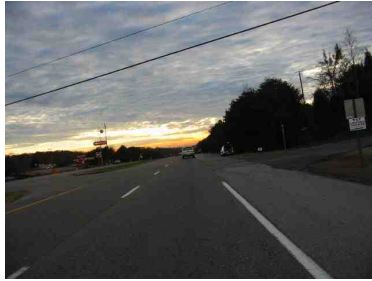
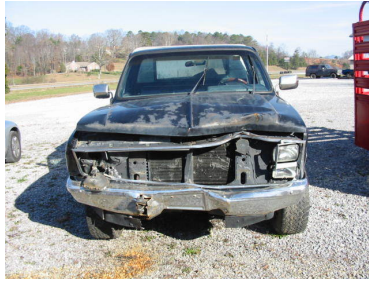
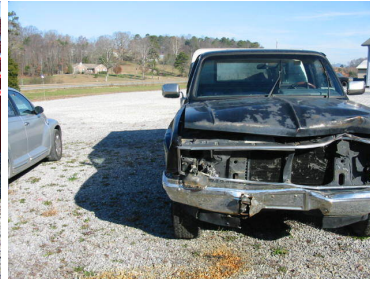
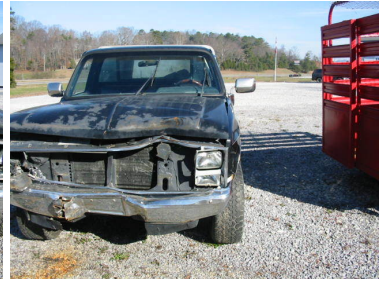
Occupant: 2004-45-222-1-1

Fire Occurrence	No fire
Fire Origin	No fire
Location of Fuel Leakage	No fuel leakage
Type of Fuel Tank	Metallic
Fuel Tank Location	Forward of rear axle, left side
Fuel Cap Location	Left side, forward rear axle
Fuel Tank Damage	No damage
Fuel Type	Gasoline

Nr. Quarter Turns	No rollover
Impact Speed	998
Total, Longitudal, and Lateral δV	22 -22 4
Est. δV with sequence number	DELTA V CODED 1
CDC	12 F D E W 1
Damage (C1-C6)	6 6 16 19 24 25
Crush (L and D)	180 0
Object Contacted 1	VEHICLE NO. 2
Object Contacted 2	0

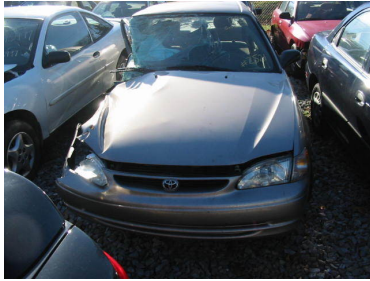
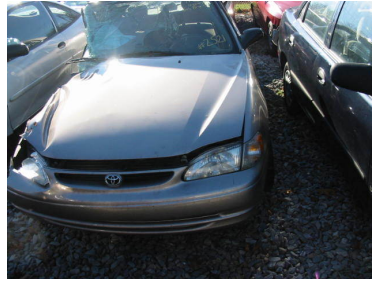
Occupant: 2004-45-222-2-1

Fire Occurrence	No fire
Fire Origin	No fire
Location of Fuel Leakage	No fuel leakage
Type of Fuel Tank	Metallic
Fuel Tank Location	Forward of rear axle, centered
Fuel Cap Location	Left side, behind rear axle
Fuel Tank Damage	No damage
Fuel Type	Gasoline

Nr. Quarter Turns	No rollover
Impact Speed	998
Total, Longitudal, and Lateral δV	40 -20 -35
Est. δV with sequence number	DELTA V CODED 1
CDC	2 R Y A W 3
Damage (C1-C6)	1 3 38 25 24 7
Crush (L and D)	265 86
Object Contacted 1	VEHICLE NO. 1
Object Contacted 2	0

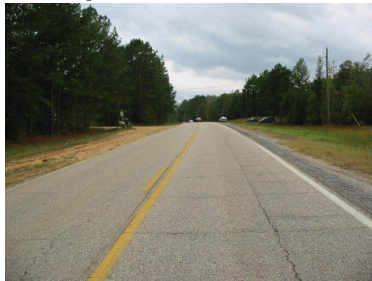
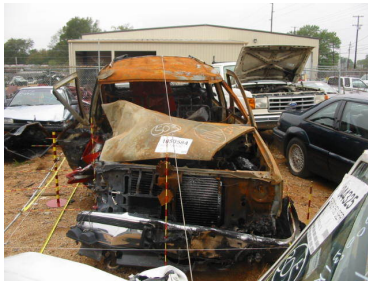
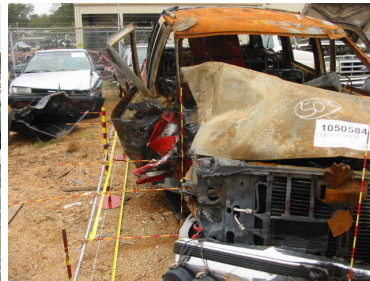
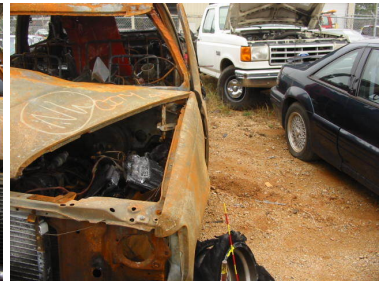
Occupant: 2004-48-237-1-1

Fire Occurrence	Major fire
Fire Origin	Engine compart
Location of Fuel Leakage	No fuel leakage
Type of Fuel Tank	Metallic
Fuel Tank Location	Forward of rear axle, left side
Fuel Cap Location	Left side, behind rear axle
Fuel Tank Damage	No damage
Fuel Type	Gasoline

Nr. Quarter Turns	No rollover
Impact Speed	999
Total, Longitudal, and Lateral δV	999 999 999
Est. δV with sequence number	>24 AND <40 KMPH 3
CDC	61 R Y A W 4
Damage (C1-C6)	0 0 0 0 0 0
Crush (L and D)	0 0
Object Contacted 1	LARGE TREE
Object Contacted 2	SMALL TREE

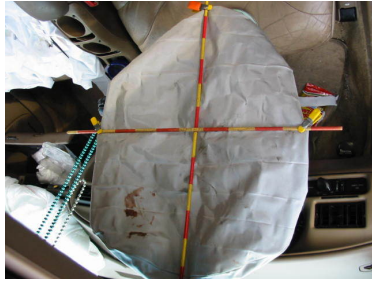
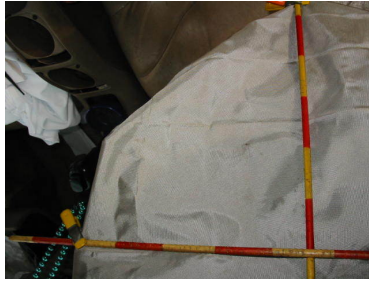
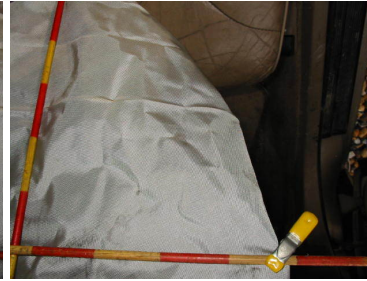
Occupant: 2004-48-298-1-1

Fire Occurrence	No fire
Fire Origin	No fire
Location of Fuel Leakage	No fuel leakage
Type of Fuel Tank	Metallic
Fuel Tank Location	Forward of rear axle, centered
Fuel Cap Location	Left side, behind rear axle
Fuel Tank Damage	No damage
Fuel Type	Gasoline

Nr. Quarter Turns	No rollover
Impact Speed	999
Total, Longitudal, and Lateral δV	999 999 999
Est. δV with sequence number	MODERATE 1
CDC	2 R B E W 3
Damage (C1-C6)	0 0 16 22 12 5
Crush (L and D)	135 -162
Object Contacted 1	VEHICLE NO. 2
Object Contacted 2	VEHICLE NO. 3

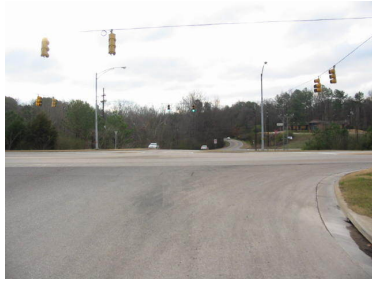
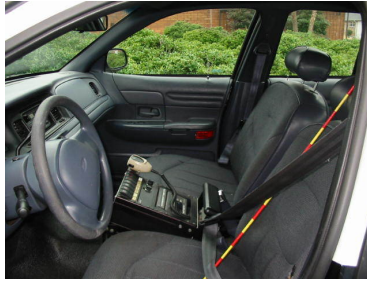
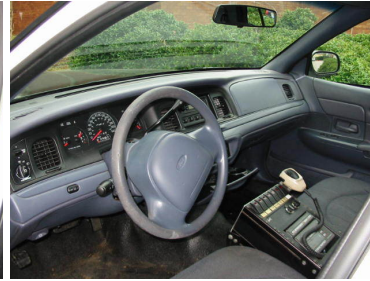
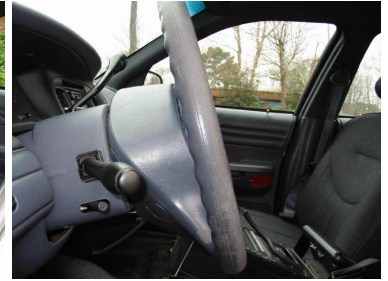
Occupant: 2004-48-298-2-1

Fire Occurrence	No fire
Fire Origin	No fire
Location of Fuel Leakage	Unknown
Type of Fuel Tank	Metallic
Fuel Tank Location	Behind rear axle, centered
Fuel Cap Location	Left side, behind rear axle
Fuel Tank Damage	Unknown
Fuel Type	Gasoline

Nr. Quarter Turns	No rollover
Impact Speed	999
Total, Longitudal, and Lateral δV	999 999 999
Est. δV with sequence number	MODERATE 1
CDC	99 9 9 9 9 99
Damage (C1-C6)	0 0 0 0 0 0
Crush (L and D)	0 0
Object Contacted 1	VEHICLE NO. 1
Object Contacted 2	0

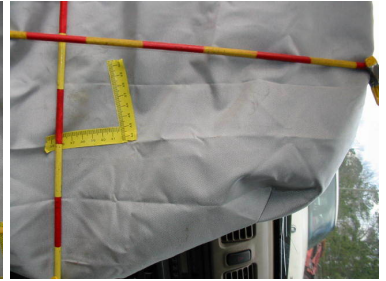
Occupant: 2004-48-298-3-1

Fire Occurrence	No fire
Fire Origin	No fire
Location of Fuel Leakage	No fuel leakage
Type of Fuel Tank	Metallic
Fuel Tank Location	Forward of rear axle, centered
Fuel Cap Location	Left side, behind rear axle
Fuel Tank Damage	No damage
Fuel Type	Gasoline

Nr. Quarter Turns	No rollover
Impact Speed	998
Total, Longitudal, and Lateral δV	24 -24 4
Est. δV with sequence number	DELTA V CODED 2
CDC	12 F Y E W 1
Damage (C1-C6)	0 7 17 14 7 1
Crush (L and D)	150 -18
Object Contacted 1	VEHICLE NO. 1
Object Contacted 2	0

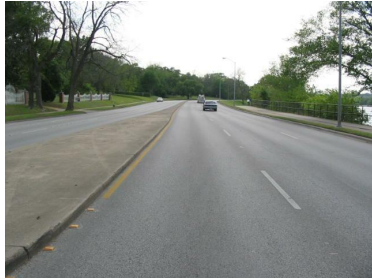
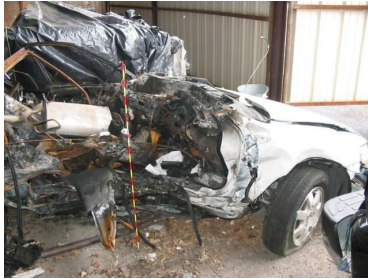
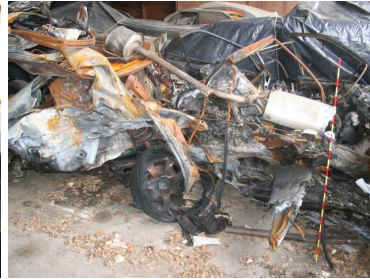
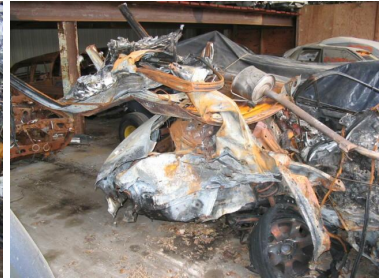
Occupant: 2004-49-84-1-1

Fire Occurrence	Major fire
Fire Origin	9
Location of Fuel Leakage	Unknown
Type of Fuel Tank	Unknown type
Fuel Tank Location	Unknown
Fuel Cap Location	Left side, behind rear axle
Fuel Tank Damage	Other damage
Fuel Type	Gasoline

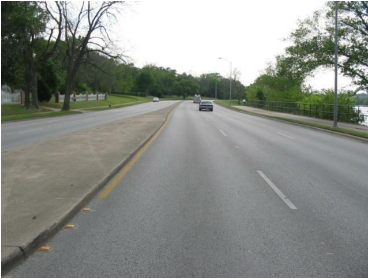
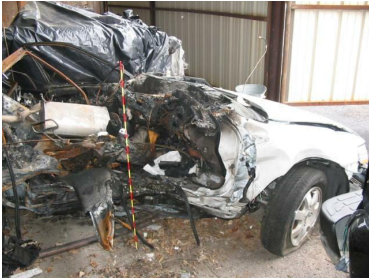
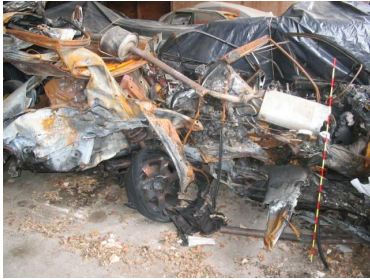
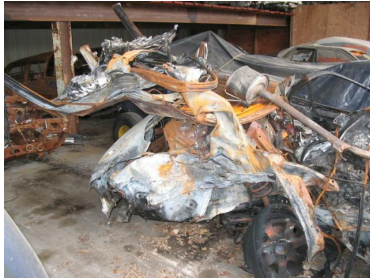
Occupant: 2004-49-84-1-2

Fire Occurence	Major fire
Fire Origin	9
Location of Fuel Leakage	Unknown
Type of Fuel Tank	Unknown type
Fuel Tank Location	Unknown
Fuel Cap Location	Left side, behind rear axle
Fuel Tank Damage	Other damage
Fuel Type	Gasoline

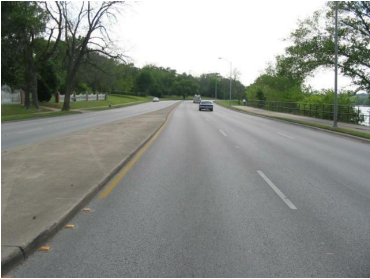
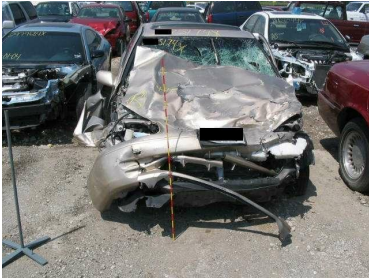
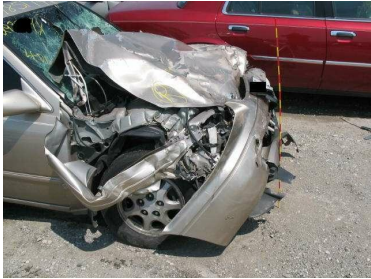
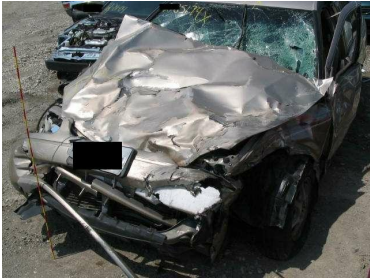
Occupant: 2004-49-84-2-1

Fire Occurence	No fire
Fire Origin	No fire
Location of Fuel Leakage	No fuel leakage
Type of Fuel Tank	Metallic
Fuel Tank Location	Forward of rear axle, centered
Fuel Cap Location	Left side, behind rear axle
Fuel Tank Damage	No damage
Fuel Type	Gasoline

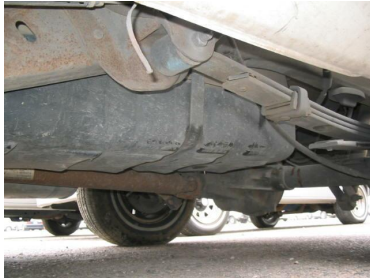
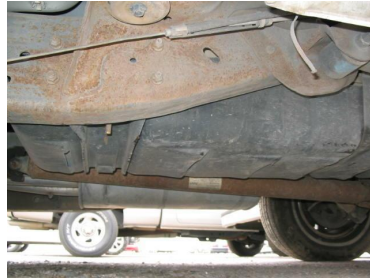
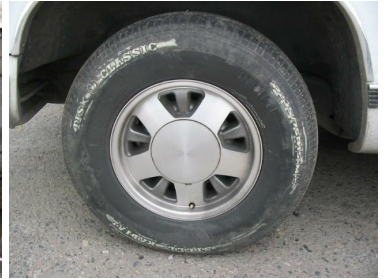
Occupant: 2004-49-84-3-1

Fire Occurrence	No fire
Fire Origin	No fire
Location of Fuel Leakage	No fuel leakage
Type of Fuel Tank	Metallic
Fuel Tank Location	Forward of rear axle, left side
Fuel Cap Location	Left side, forward rear axle
Fuel Tank Damage	No damage
Fuel Type	Gasoline

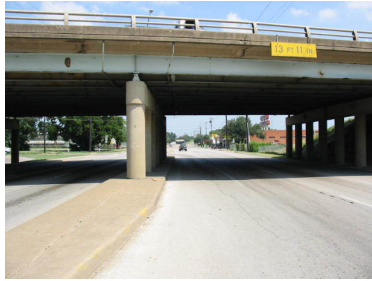
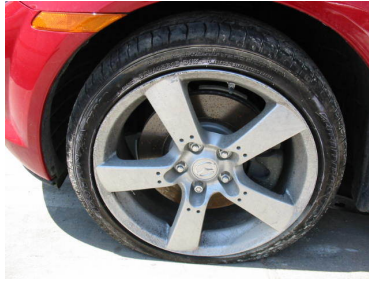
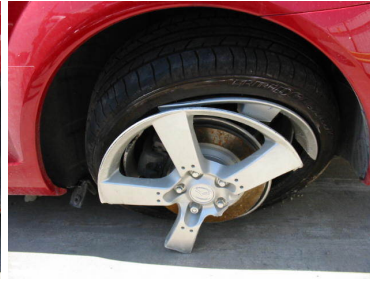
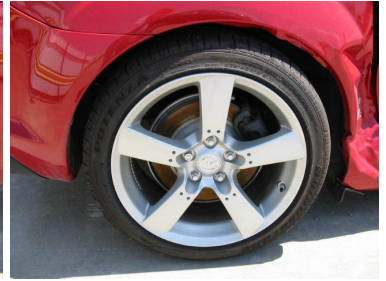
Occupant: 2004-49-221-1-1

Nr. Quarter Turns	No rollover
Impact Speed	998
Total, Longitudal, and Lateral δV	27 -17 -21
Est. δV with sequence number	DELTA V CODED 1
CDC	2 R Y A W 3
Damage (C1-C6)	0 11 29 27 17 0
Crush (L and D)	288 6
Object Contacted 1	VEHICLE NO. 2
Object Contacted 2	CURB

AIS Level	Injury Description	Contacts
4=Severe	Cerebral subdural hematoma, small (<50ccs)	OMV hood edge
3=Serious	Cerebral subarachnoid hemorrhage	OMV hood edge
3=Serious	540640	Right interior
3=Serious	Pelvic fracture, open/displaced/comminuted	Right interior
2=Moderate	Pelvic fracture, closed	Transmiss lever
5=Critical	Unconscious on admission, inappropriate movements	OMV hood edge
1=Minor	Upper extremity skin laceration, minor	Right hardware
1=Minor	Leg skin contusion (hematoma)	Right interior

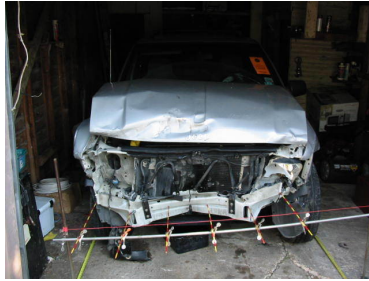
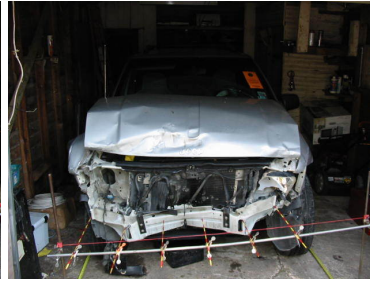
Occupant: 2004-49-221-2-1

Nr. Quarter Turns	No rollover
Impact Speed	998
Total, Longitudal, and Lateral δV	24 -23 8
Est. δV with sequence number	DELTA V CODED 1
CDC	11 F D E W 2
Damage (C1-C6)	18 6 19 17 14 25
Crush (L and D)	160 0
Object Contacted 1	VEHICLE NO. 1
Object Contacted 2	0

AIS Level	Injury Description	Contacts
1=Minor	Thoracic spine strain, acute without fracture or dislocation	Belt webb/buckle
1=Minor	Acute cervical spine strain without fracture or dislocation	Belt webb/buckle

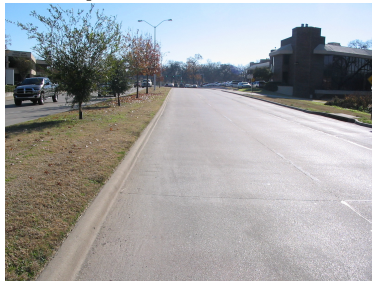
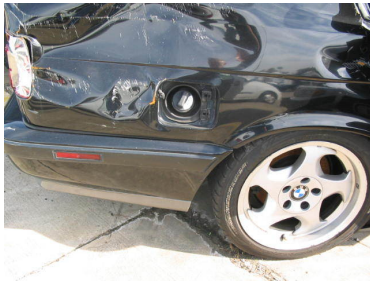
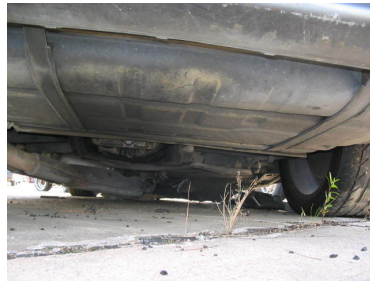
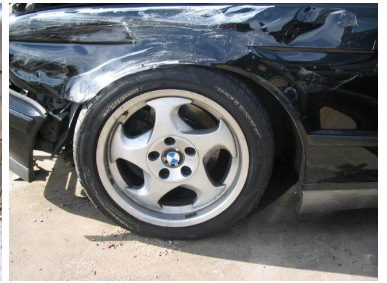
Occupant: 2004-49-260-1-1

Nr. Quarter Turns	No rollover
Impact Speed	998
Total, Longitudal, and Lateral δV	21 -18 -11
Est. δV with sequence number	DELTA V CODED 1
CDC	1 R Y A W 3
Damage (C1-C6)	0 18 36 30 28 6
Crush (L and D)	217 20
Object Contacted 1	VEHICLE NO. 2
Object Contacted 2	VEHICLE NO. 3

AIS Level	Injury Description	Contacts
5=Critical	Unconscious on admission, inappropriate movements	Center panel
3=Serious	Cerebral contusions, multiple, unilateral, small (<30ccs)	Center panel
3=Serious	Cerebral subarachnoid hemorrhage	Center panel
4=Severe	Cerebral subdural hematoma, small (<50ccs)	Center panel
4=Severe	Cerebral intraventricular hemorrhage	Center panel
2=Moderate	Cervical transverse process fracture, no cord injury	Center panel
3=Serious	Lung contusion, unilateral	Steering comb
3=Serious	Pharyngeal laceration without perforation, mucosal tear	Steering rim
1=Minor	Scalp abrasion	Center panel
1=Minor	Scalp laceration, minor	Center panel

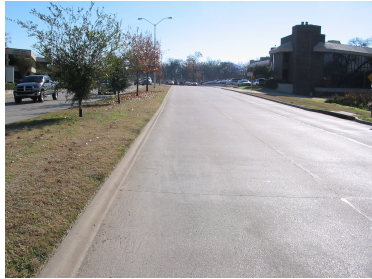
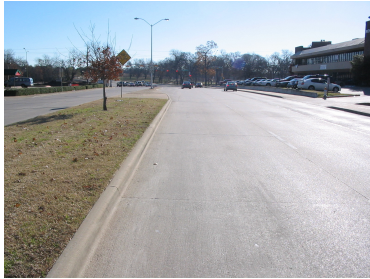
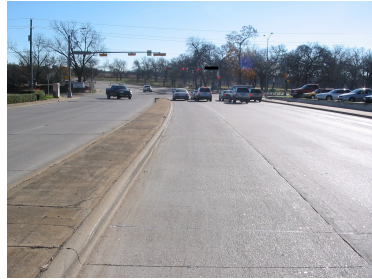
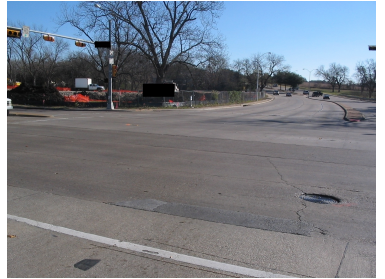
Occupant: 2004-49-260-2-1

Nr. Quarter Turns	No rollover
Impact Speed	998
Total, Longitudal, and Lateral δV	21 -18 11
Est. δV with sequence number	DELTA V CODED 1
CDC	No data No data No data No data
Damage (C1-C6)	No data No data No data No data
Crush (L and D)	No data No data
Object Contacted 1	No data
Object Contacted 2	No data

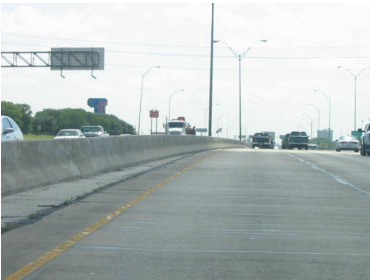
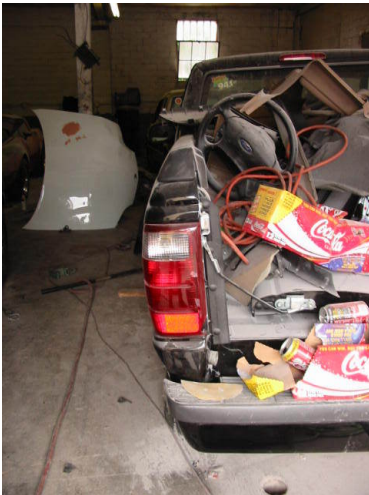
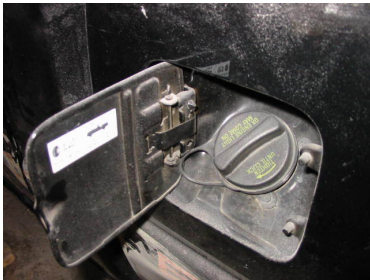
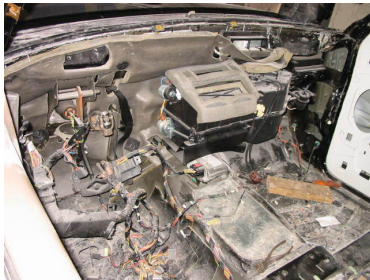
Occupant: 2004-50-74-1-1

Nr. Quarter Turns	No rollover
Impact Speed	999
Total, Longitudal, and Lateral δV	999 999 999
Est. δV with sequence number	9 5
CDC	99 R D A W 99
Damage (C1-C6)	0 0 0 0 0 0
Crush (L and D)	0 0
Object Contacted 1	VEHICLE NO. 3
Object Contacted 2	VEHICLE NO. 2

AIS Level	Injury Description	Contacts
3=Serious	Unconscious on admission, length <1 hour	Unknown SOURCE
1=Minor	Facial skin laceration, minor	Unknown SOURCE
1=Minor	Scalp laceration, minor	Unknown SOURCE
1=Minor	Thoracic skin abrasion	Belt webb/buckle
1=Minor	Upper extremity skin abrasion	Belt webb/buckle
1=Minor	Upper extremity skin abrasion	Unknown SOURCE

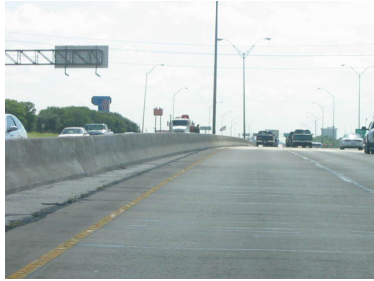
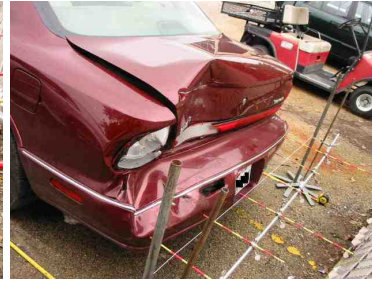
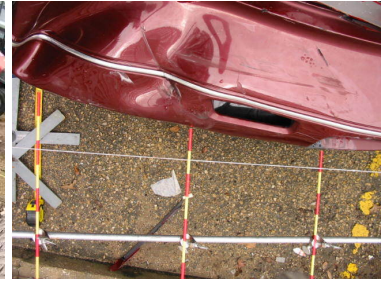
Occupant: 2004-50-74-2-1

Nr. Quarter Turns	No rollover
Impact Speed	998
Total, Longitudal, and Lateral δV	25 -24 -9
Est. δV with sequence number	DELTA V CODED 3
CDC	1 F D E W 2
Damage (C1-C6)	10 14 20 26 33 33
Crush (L and D)	162 0
Object Contacted 1	CONCRETE BARRIER
Object Contacted 2	VEHICLE NO. 1

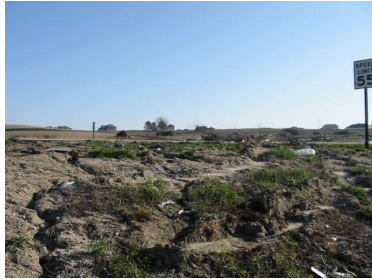
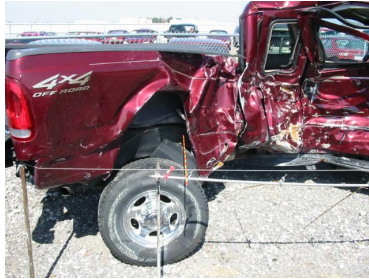
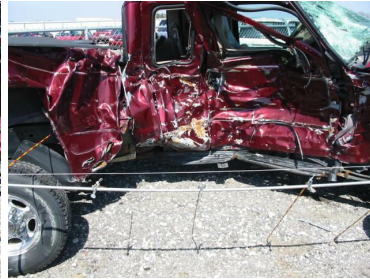
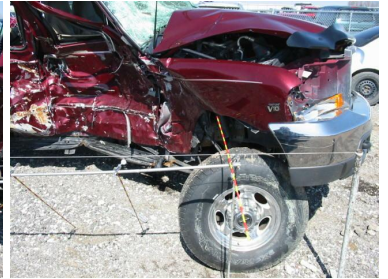
Occupant: 2004-74-55-1-1

AIS Level	Injury Description	Contacts
6=Maximum	Brain stem laceration	Right interior
2=Moderate	Cervical vertebral body fracture, no cord injury NFS	Right interior
3=Serious	Lung contusion, uni-lateral	Transmiss lever
2=Moderate	Splenic laceration, minor (tear<3cms deep, no major vessel)	Belt webb/buckle
3=Serious	Cerebral subarachnoid hemorrhage	Right interior
1=Minor	Scalp laceration, minor	Right interior
1=Minor	Facial skin laceration, minor	Right interior
1=Minor	Leg skin abrasion	Belt webb/buckle
1=Minor	Leg skin abrasion	Transmiss lever
1=Minor	Leg skin abrasion	Steering rim
1=Minor	Upper extremity skin abrasion	Right interior
1=Minor	Upper extremity skin abrasion	Belt webb/buckle
1=Minor	Upper extremity skin contusion	Belt webb/buckle

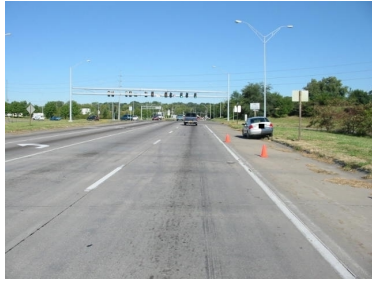
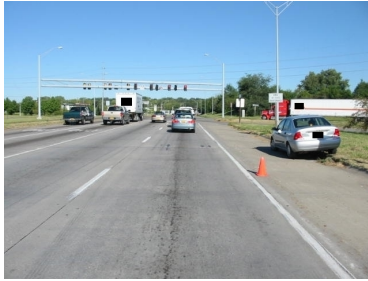
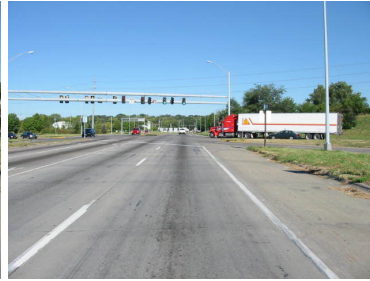
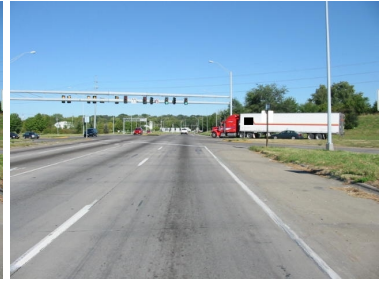
Occupant: 2004-74-215-1-1

AIS Level	Injury Description	Contacts
1=Minor	Awake on admission, never unconscious	Windshield
1=Minor	Facial skin abrasion	Windshield
1=Minor	Facial skin contusion	Windshield

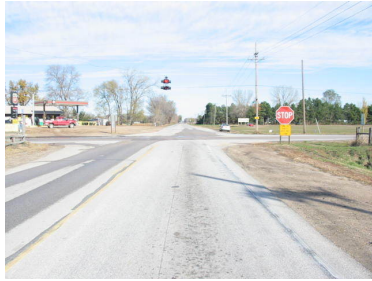
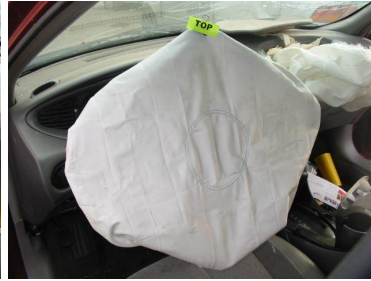
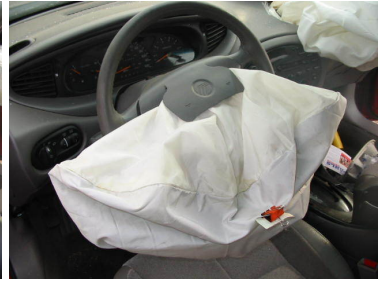
Occupant: 2004-74-247-1-1

Nr. Quarter Turns	No rollover
Impact Speed	998
Total, Longitudal, and Lateral δV	18 -14 -12
Est. δV with sequence number	DELTA V CODED 1
CDC	1 R Z A W 3
Damage (C1-C6)	6 18 22 22 23 0
Crush (L and D)	220 -135
Object Contacted 1	VEHICLE NO. 2
Object Contacted 2	0

AIS Level	Injury Description	Contacts
3=Serious	Cervical pedicle fracture, no cord injury	Head restraint
2=Moderate	Awake on admission, unconscious <1 hour	Head restraint
1=Minor	Facial skin abrasion	Flying glass

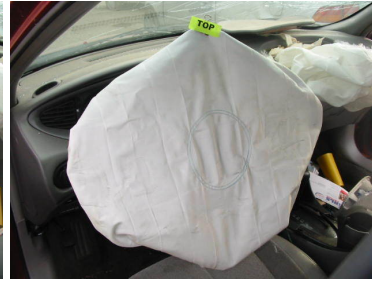
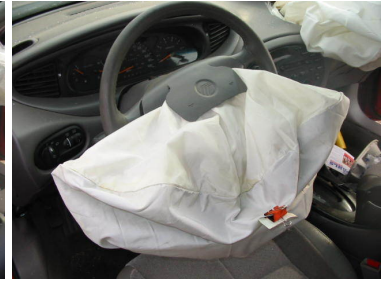
Occupant: 2004-74-247-1-2

Nr. Quarter Turns	No rollover
Impact Speed	998
Total, Longitudal, and Lateral δV	18 -14 -12
Est. δV with sequence number	DELTA V CODED 1
CDC	1 R Z A W 3
Damage (C1-C6)	6 18 22 22 23 0
Crush (L and D)	220 -135
Object Contacted 1	VEHICLE NO. 2
Object Contacted 2	0

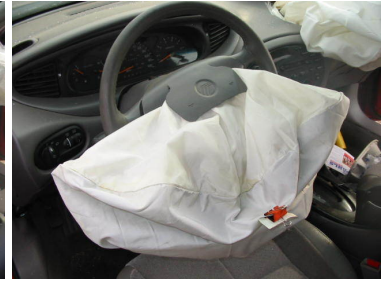
Occupant: 2004-74-247-1-4

Nr. Quarter Turns	No rollover
Impact Speed	998
Total, Longitudal, and Lateral δV	18 -14 -12
Est. δV with sequence number	DELTA V CODED 1
CDC	1 R Z A W 3
Damage (C1-C6)	6 18 22 22 23 0
Crush (L and D)	220 -135
Object Contacted 1	VEHICLE NO. 2
Object Contacted 2	0

AIS Level	Injury Description	Contacts
2=Moderate	C-spine dislocation no bone or cord involvement NFS	Other occupants
1=Minor	Scalp laceration, minor	Flying glass
1=Minor	Scalp laceration, minor	Flying glass

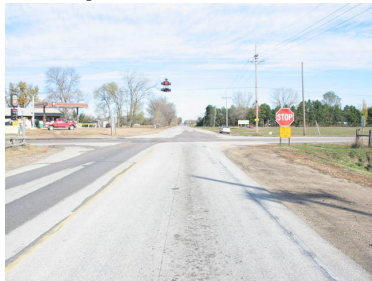
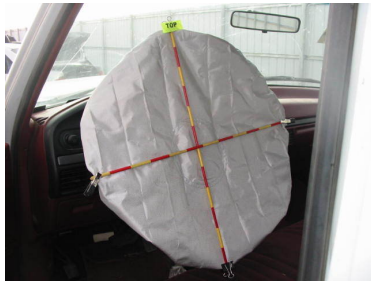
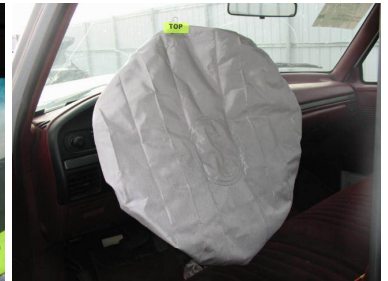
Occupant: 2004-74-247-2-1

Nr. Quarter Turns	No rollover
Impact Speed	998
Total, Longitudal, and Lateral δV	15 -10 12
Est. δV with sequence number	DELTA V CODED 1
CDC	10 F D E W 2
Damage (C1-C6)	0 1 22 29 19 35
Crush (L and D)	180 110
Object Contacted 1	VEHICLE NO. 1
Object Contacted 2	0

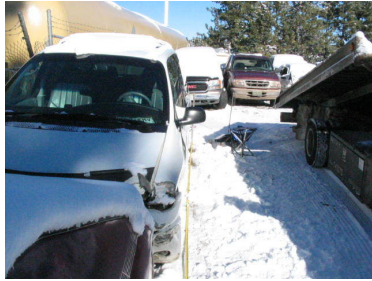
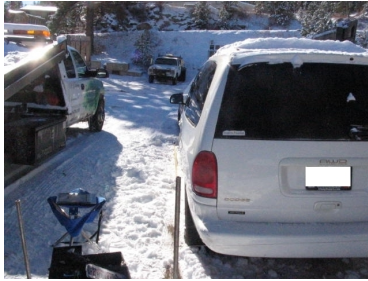
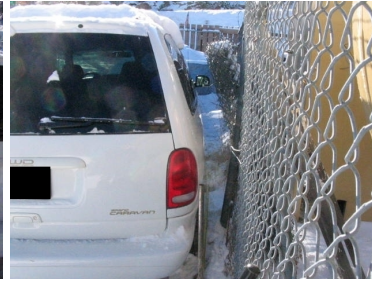
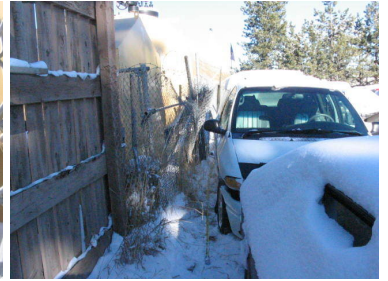
Occupant: 2004-75-180-1-1

Nr. Quarter Turns	No rollover
Impact Speed	998
Total, Longitudal, and Lateral δV	17 -13 -11
Est. δV with sequence number	DELTA V CODED 1
CDC	1 F D E W 1
Damage (C1-C6)	13 13 11 5 5 6
Crush (L and D)	166 -21
Object Contacted 1	VEHICLE NO. 2
Object Contacted 2	0

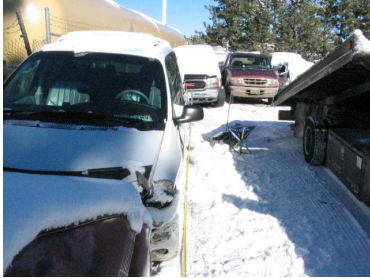
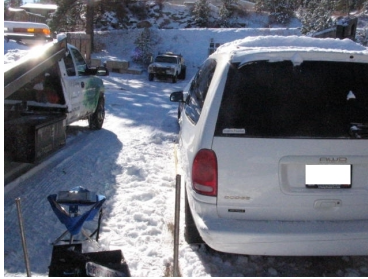
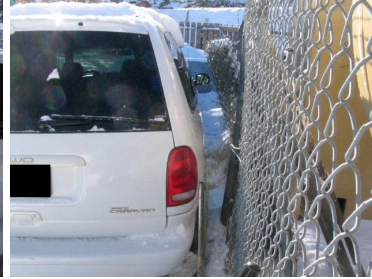
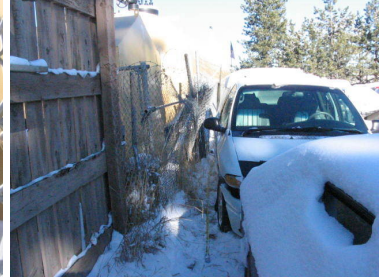
Occupant: 2004-75-180-1-2

Nr. Quarter Turns	No rollover
Impact Speed	998
Total, Longitudal, and Lateral δV	17 -13 -11
Est. δV with sequence number	DELTA V CODED 1
CDC	1 F D E W 1
Damage (C1-C6)	13 13 11 5 5 6
Crush (L and D)	166 -21
Object Contacted 1	VEHICLE NO. 2
Object Contacted 2	0

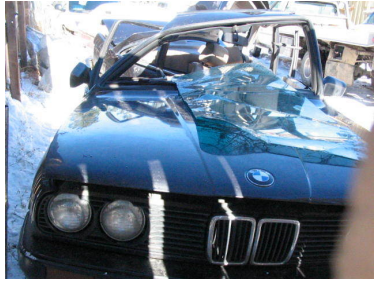
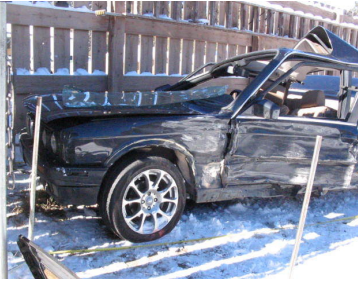
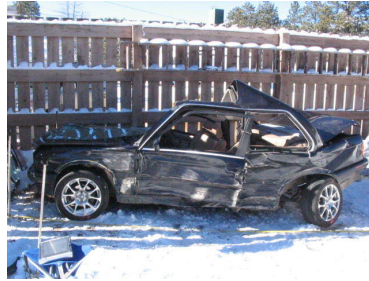
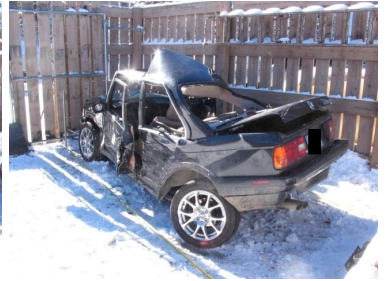
Occupant: 2004-75-180-2-1

Fire Occurrence	No fire
Fire Origin	No fire
Location of Fuel Leakage	Unknown
Type of Fuel Tank	Metallic
Fuel Tank Location	Forward of rear axle, left side
Fuel Cap Location	Right side, behind rear axle
Fuel Tank Damage	Deformed
Fuel Type	Gasoline

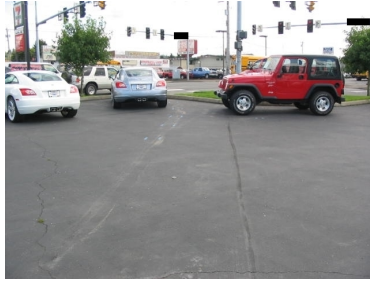
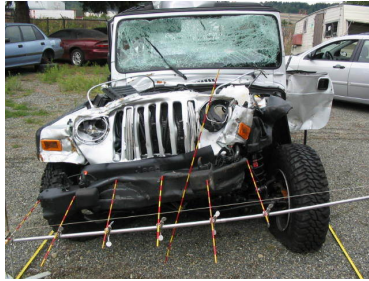
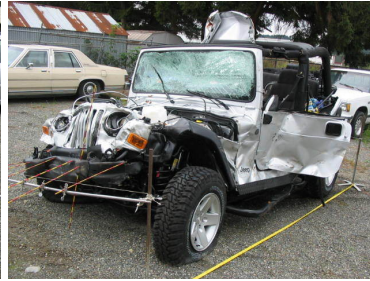
Occupant: 2004-81-107-1-1

Nr. Quarter Turns	No rollover
Impact Speed	998
Total, Longitudal, and Lateral δV	42 -40 14
Est. δV with sequence number	DELTA V CODED 1
CDC	71 F D E W 2
Damage (C1-C6)	39 22 37 39 27 30
Crush (L and D)	160 0
Object Contacted 1	VEHICLE NO. 2
Object Contacted 2	MEDIUM POLE

AIS Level	Injury Description	Contacts
2=Moderate	Carpus or metacarpus fracture	Left apnel
2=Moderate	Awake on admission, unconscious <1 hour	Steering comb
1=Minor	Facial skin laceration, minor	Steering comb
1=Minor	Thoracic skin abrasion	Left interior
1=Minor	Upper extremity skin laceration, minor	Left apnel
1=Minor	Leg skin abrasion	Knee bolster

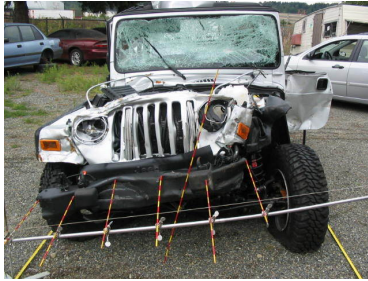
Occupant: 2004-81-107-1-2

Nr. Quarter Turns	No rollover
Impact Speed	998
Total, Longitudal, and Lateral δV	42 -40 14
Est. δV with sequence number	DELTA V CODED 1
CDC	71 F D E W 2
Damage (C1-C6)	39 22 37 39 27 30
Crush (L and D)	160 0
Object Contacted 1	VEHICLE NO. 2
Object Contacted 2	MEDIUM POLE

AIS Level	Injury Description	Contacts
4=Severe	Rib fxs (=>1), open/displaced/comminuted,& hemo-/pneumo thx	Belt webb/buckle
3=Serious	Femoral shaft fracture	Center panel
2=Moderate	Splenic laceration, minor (tear<3cms deep, no major vessel)	Belt webb/buckle
1=Minor	Abdominal skin abrasion	Belt webb/buckle
1=Minor	Upper extremity skin laceration, minor	Center panel

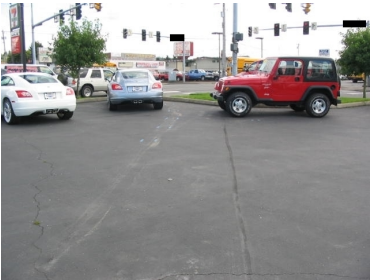
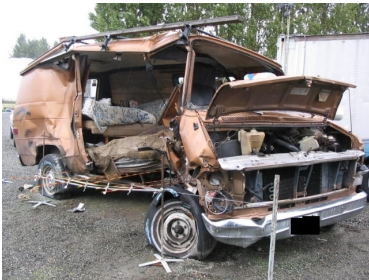
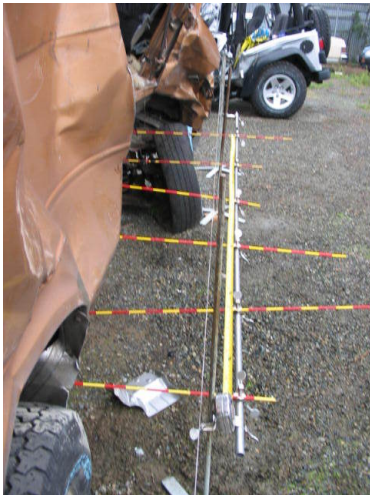
Occupant: 2004-81-107-2-1

Nr. Quarter Turns	No rollover
Impact Speed	998
Total, Longitudal, and Lateral δV	35 -12 -33
Est. δV with sequence number	DELTA V CODED 1
CDC	2 R P E W 5
Damage (C1-C6)	30 46 60 89 75 67
Crush (L and D)	196 55
Object Contacted 1	VEHICLE NO. 1
Object Contacted 2	Not IN TRAN LGTVEH

AIS Level	Injury Description	Contacts
3=Serious	Cerebral subarachnoid hemorrhage	Other occupants
3=Serious	Cerebral subarachnoid hemorrhage	Other occupants
3=Serious	Cerebral brain swelling, mild	Other occupants
3=Serious	Cerebral brain swelling, mild	Other occupants
2=Moderate	Hepatic contusion, minor (subcapsular, <503=Serious	Pelvic fracture, open/displaced/comminut
Transmiss lever		
2=Moderate	Pelvic fracture, closed	Transmiss lever
2=Moderate	Pelvic fracture, closed	Transmiss lever
2=Moderate	Lumbar fracture of transverse process without cord injury	Transmiss lever
2=Moderate	Lumbar fracture of transverse process without cord injury	Transmiss lever
1=Minor	Scalp contusion	Left B pillar
1=Minor	Leg skin contusion (hematoma)	Transmiss lever
1=Minor	Leg skin abrasion	Left apnel
1=Minor	Leg skin abrasion	Floor
2=Moderate	894004	Transmiss lever
