Crash Reports

Prepared by Ken Digges

1 Case 2004-2-4

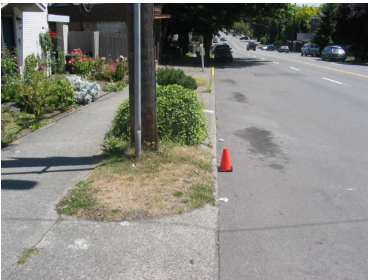
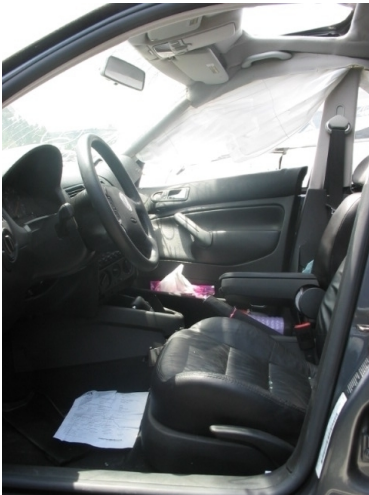
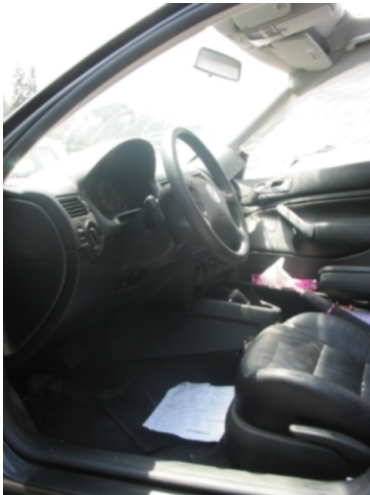
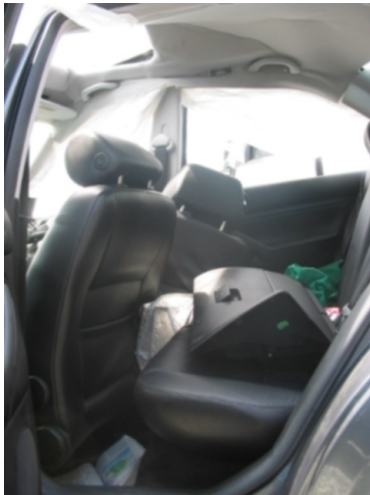
Occupant: 2004-82-77-1-1

AIS Level	Injury Description	Contacts
5=Critical	Cerebral diffuse axonal injury	Right interior
3=Serious	Cerebral contusions, multiple, unilateral, small (<30ccs)	Right interior
3=Serious	Unconscious on admission, length <1 hour	Right interior
1=Minor	Leg skin contusion (hematoma)	Transmiss lever
1=Minor	Upper extremity skin contusion	Seat, back
1=Minor	Neck skin contusion (hematoma)	Right interior

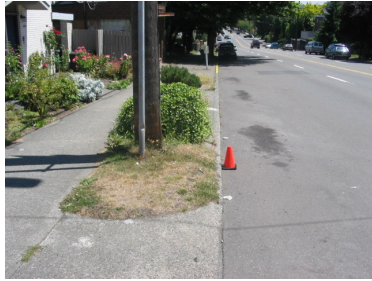
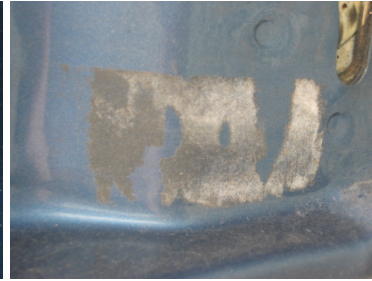
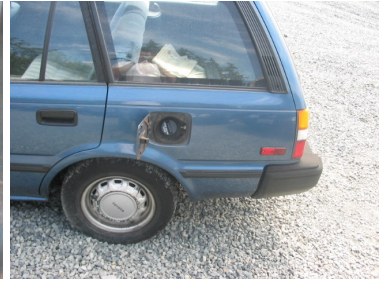
Occupant: 2004-82-77-2-1

Fire Occurrence	No fire
Fire Origin	No fire
Location of Fuel Leakage	No fuel leakage
Type of Fuel Tank	Metallic
Fuel Tank Location	Forward of rear axle, centered
Fuel Cap Location	Left side, behind rear axle
Fuel Tank Damage	No damage
Fuel Type	Gasoline
