Alternative Fuel Tanks for Pickups with Sidesaddle Tanks

ABSTRACT

Seventeen full-scale crash tests were conducted to evaluate technologies to reduce the vulnerability of sidesaddle tanks on full size GM pickup trucks manufactured during the period 1973-1987. These vehicles were alleged by the U.S. Department of Transportation to be vulnerable in severe side impacts. The test program was intended to evaluate designs that would reduce vulnerability in all crash directions. The best test results were obtained by two strategies that relocated the tank to less vulnerable locations. The two locations were: (1) in the cargo bed (bed mounted tank) and (2) underneath the bed, ahead of the rear axle and between the frame rails (center-mounted tank). Tanks mounted in these locations were subjected to a series of crash tests that simulated severe front, side, rear and rollover crashes. The crash environment for these tests was more severe than required by FMVSS 301 "Fuel System Integrity". Designs were developed for the bed mounted tank and the center-mounted tank that survived the series of multi-directional crash tests with fuel leakage less than that permitted by the FMVSS 301 standard.

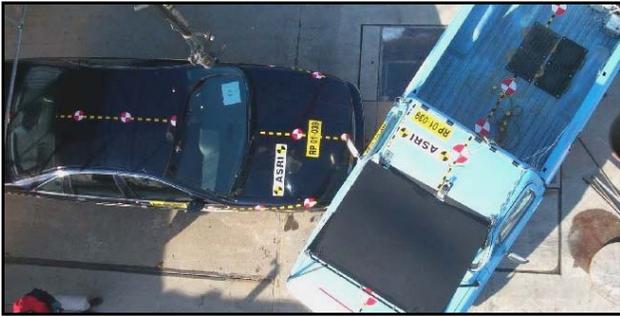
Figure 1. Typical vehicle alignment in side impact tests with a Caprice as the bullet vehicle.

The crashworthiness of the selected tank systems was evaluated under various full-scale crash configurations. The pickup trucks used in the test were 1985 through 1987 two-wheel drive Chevrolet or GMC ½ or ¾ ton pickups. One four-wheel drive pickup was tested. For the side impacts, the bullet vehicle was either a Chevrolet Caprice or a FMVSS 301 moving barrier. The impact speed was nominally 80.0 km/h (50 mph) for the Caprice and 64.0 km/h (40 mph) for the barrier. For the Caprice, the angle of impact was 60° from the front of the truck and inline with a point on the truck's centerline located between the cab and the truck bed. For the FMVSS 301 rigid moving barrier, the impact was perpendicular to the longitudinal axis of the truck and centered on the space between the truck bed and the cab. The typical set-up for the side impact Caprice tests and the moving barrier side impact test are shown in Figure 1 and Figure 2.

The side impact test with the Chevrolet Caprice as the bullet vehicle, as shown in Figure 1 did not challenge the tank in the bed location. The pickup damage was located below the bed of the truck, and the tank was well protected. To provide a more challenging test, an FMVSS 301 rigid faced moving barrier was used, as shown in Figure 2. However, the barrier speed was increased from 32 km/h (20 mph) to 64 km/h (40 mph). The bed-mounted tank passed this test.

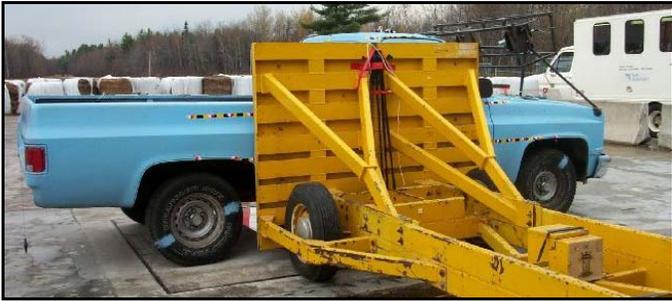
Figure 2. Alignment of the FMVSS 301 barrier for side collision.

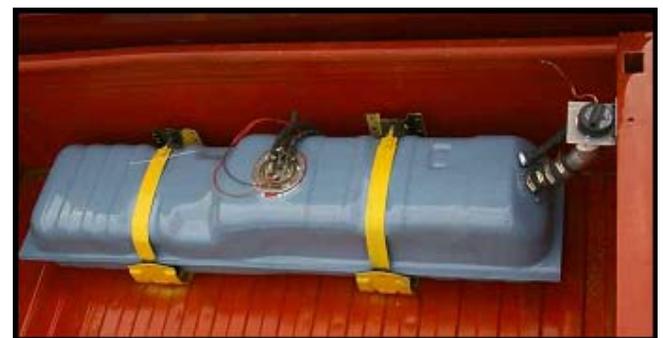
The bed-mounted system consisted of relocating a standard OEM steel tank and brackets, normally installed in the sidesaddle position, into the bed of the truck. Standard mounting brackets were used with additional holes drilled in the brackets such that they could be bolted vertically into the floor of the truck bed. A typical installation is shown in Figure 3.

Figure 3. OEM bed tank installation with OEM brackets.

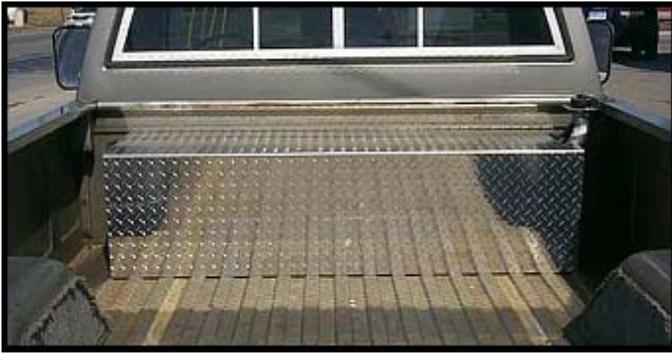
The tank was covered by a 3 mm thick aluminum checker plate shield for protection from shifting cargo. The shield installation is shown in Figure 4. The shield weighed 15.8 kg and cost approximately \$215. Other miscellaneous hardware required for the bed installation cost \$40. The installation time for the bed tank and shield was 3 hours. Installation procedures for this tank were documented in a report [Fournier et al, January 15 2003].

Figure 4. Typical in-bed installation of an OEM tank with shield

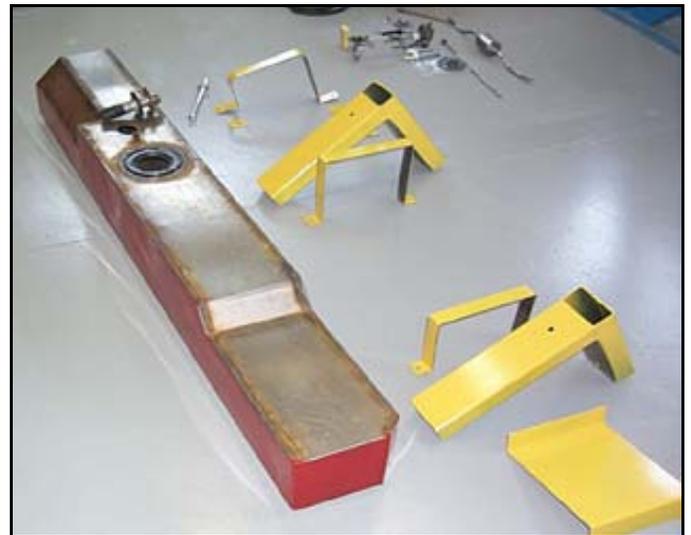
Figure 5. Center-mounted tank with mounting brackets.

located on the same side. In this configuration, connecting a center-mounted tank to the filler neck would require a fuel hose that was marginally longer than that used by the original fuel system. However, for later model years, 1982 to 1987, the fuel tank was relocated to the left side of the truck. To maintain a comparably short filler tube for the center tank, the exhaust system would have to be re-routed to the right side of the drive shaft, freeing the left side for the center tank. This was done for the first truck that was crash tested. However, this exhaust modification introduced a higher cost to the retrofit. Therefore, for the remaining trucks the center tank was installed on the right side, with the filler tube to be routed from the filler door located on the left side of the truck to the tank spout. The center-mounted tank and its associated supports are shown in Figure 5. Figure 6 and Figure 7 show the tank installed in a pickup.

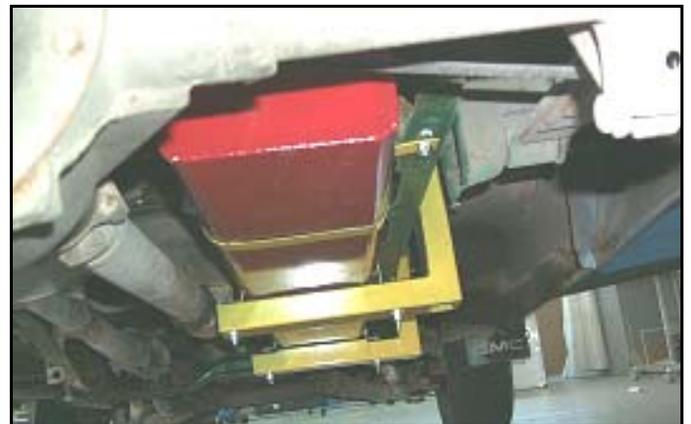
Figure 6. Typical center-mounted tank installation – rear view.

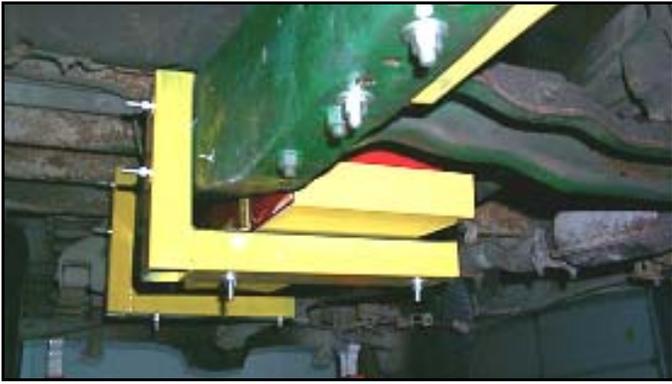
Figure 7. Typical center-mounted tank installation – front view.

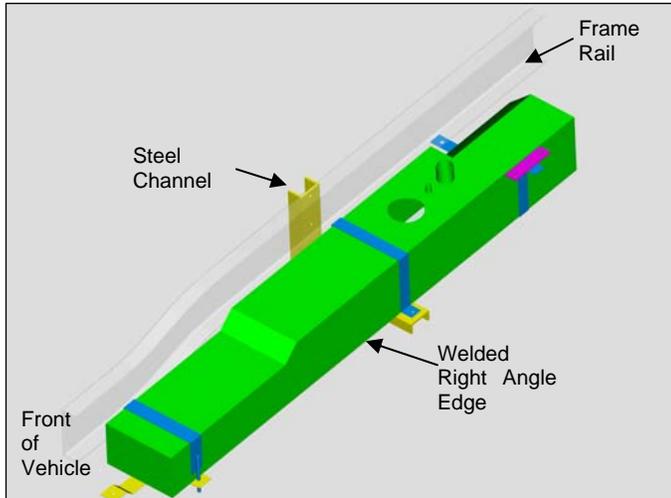
The design of the center-mounted tank and its associated mounting brackets evolved based on information gained during the test program, incorporating features to improve its crashworthiness. The early design is shown in Figure 8. The tank was fabricated by welding together steel plates that formed the top, bottom, sides and ends of the tank. Side crash tests suggested several design improvements. The most

significant was the elimination of the welded seams for the bottom tank plate. Severe crimping occurred at the corner seams in Test 038, resulting in a small leak.

Figure 8. Early configuration of center-mounted tank and supports.

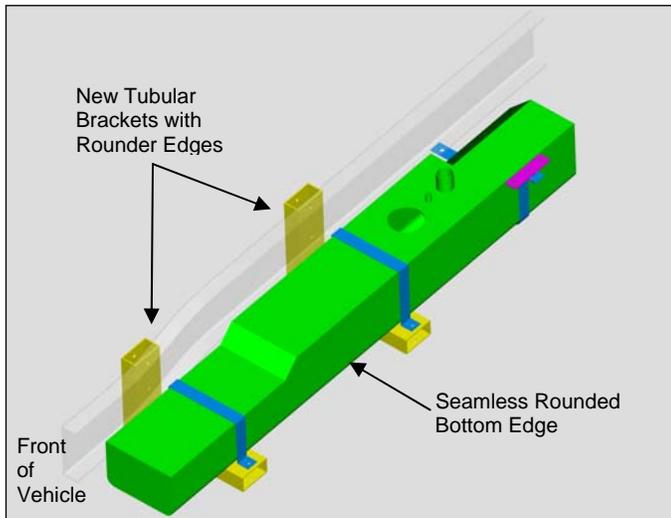
From the fourth test (039) onwards, the tank was modified so that the bottom and two sides were formed from a single plate. A 25.4 mm radius to the lower longitudinal edges of the tank was maintained. The purpose of the radius was to reduce localized stress resulting from folding a right angle edge in on itself when loaded. Additionally, the material for the middle bracket was changed from steel channel with right angle edges to steel tubing with rounded and thus less aggressive edges. Loading on the tank from these brackets would therefore be more evenly distributed, decreasing the possibility of tearing of the tank from concentrated edge loads from the brackets. The resulting design is shown in Figure 9.

Figure 9. Modifications to improve side-impact protection.

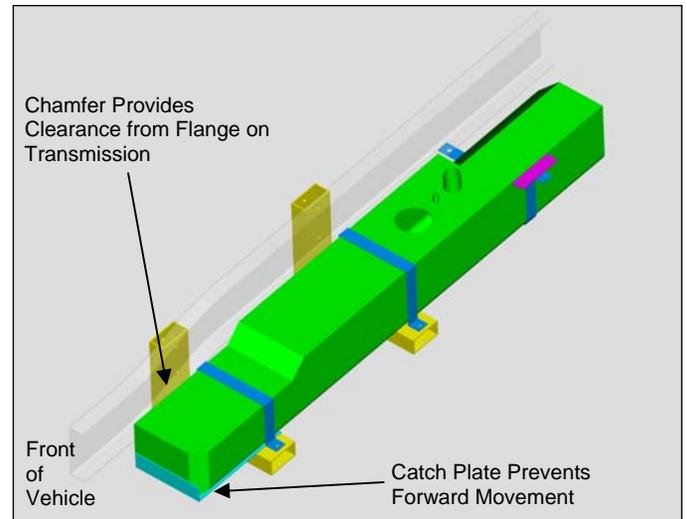
In addition, it was observed that the transmission moved rearward during a severe frontal crash. One of the transmissions available in the pickups contained a flange that could cause a stress concentration if it impacted the tank corner. To address this possibility, the tank corner closest to the transmission was modified to include a flattened region as shown in Figure 10.

Figure 10. Modifications to Improve frontal- impact protection

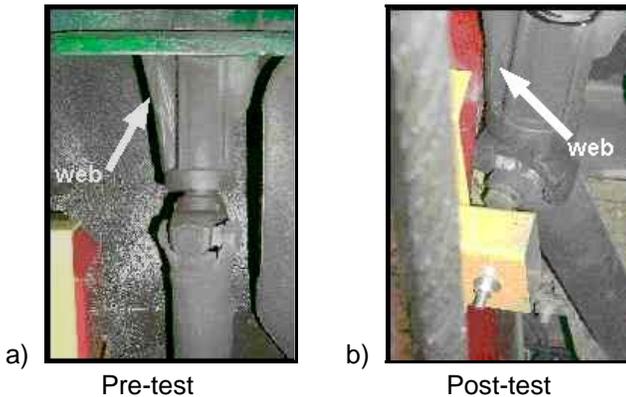
Relocating the tank between the frame rails reduces its vulnerability to side impact, but may increase vulnerability in some other crashes. In severe crashes into a rigid frontal barrier the engine and transmission move rearward. An aggressive web on one of the alternative transmission produced a leak in one frontal barrier test. In addition, the drive shaft may buckle in the direction of the tank causing damage. Figure 11 shows the location of the aggressive transmission web and the drive shaft relative to the tank before and after a frontal crash test.

Figure 11. Drive shaft and transmission clearance in severe frontal crash – before (a) and after (b).

The final center-mounted tank design addressed both of these undesirable loadings. The transmission contact was mitigated by increasing the tank to transmission clearance and by chamfering the corner of the tank to reduce the stress concentration when contact occurs. The drive shaft contact was addressed by maintaining OEM drive shaft clearance for center-mounted tanks and by positioning the tank brackets to resist drive shaft loading. The tank thickness of 1.52 mm provided added protection compared with 0.86 mm in the OEM tank.

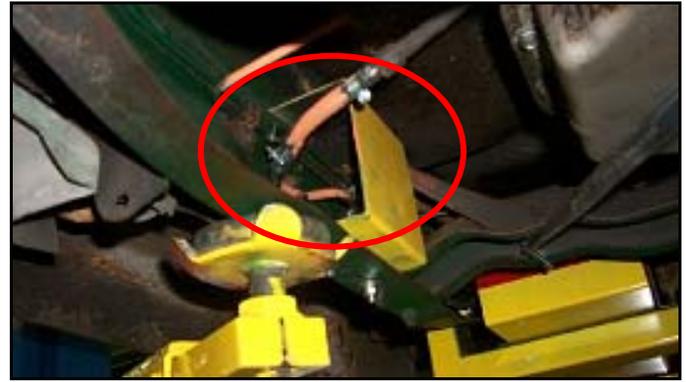
The Caprice impact produced extensive deformation to the pickup frame. In some cases, the fuel lines and/or fuel tank selector valves were severed by being pressed between the inside of the frame and the engine. This problem was aggravated in one test in which the exhaust manifold had been removed. In that test, the fuel line was severed when entrapped between the frame and a flange on the transmission. To improve the survivability of fuel lines, a structural shield was added inside the frame to protect the fuel filter. The shield is shown in Figure 12. No fuel line ruptures occurred on tests with the shielding in place.

Figure 12. Shielding plate to protect fuel lines from entrapment by the transmission.

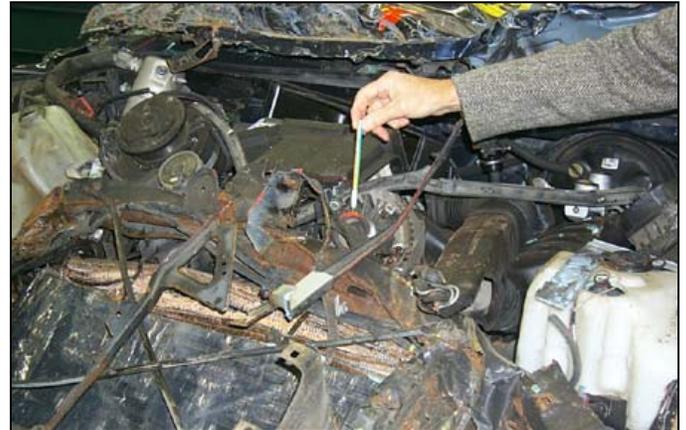
It was found that the front hood of the bullet Caprice was peeled away in the side impact tests. As a result, many sharp edges were exposed. In addition, the battery, electrical wiring, and hot engine surfaces were exposed providing possible ignition sources. Figure 13 shows the protruding alternator and other sharp edges that scraped the bottom of the pickup tank in a crash test. For the center-mounted tank, the hard points resulted in scraping and minor gouging of the tanks. However, no leakage occurred from this source in any tests of the center-mounted tank.

Figure 13. Caprice engine compartment after test showing hard points that contacted the fuel tank.
